**ALBERTA TRANSPORTATION SPRINGBANK OFF-STREAM RESERVOIR PROJECT  
RESPONSE TO CEEA INFORMATION REQUEST PACKAGE 3, AUGUST 31, 2018**

**APPENDIX IR13-1 NATIONAL RESEARCH COUNCIL CANADA  
PHYSICAL MODEL STUDY REPORT**

## Physical Model Study of the Springbank Off-stream Storage Project Diversion Structure on the Elbow River

Paul Knox, Andrew Cornett, Mitchel Provan  
Ocean, Coastal and River Engineering  
NRC Technical Report: OCRE-TR-2016-028

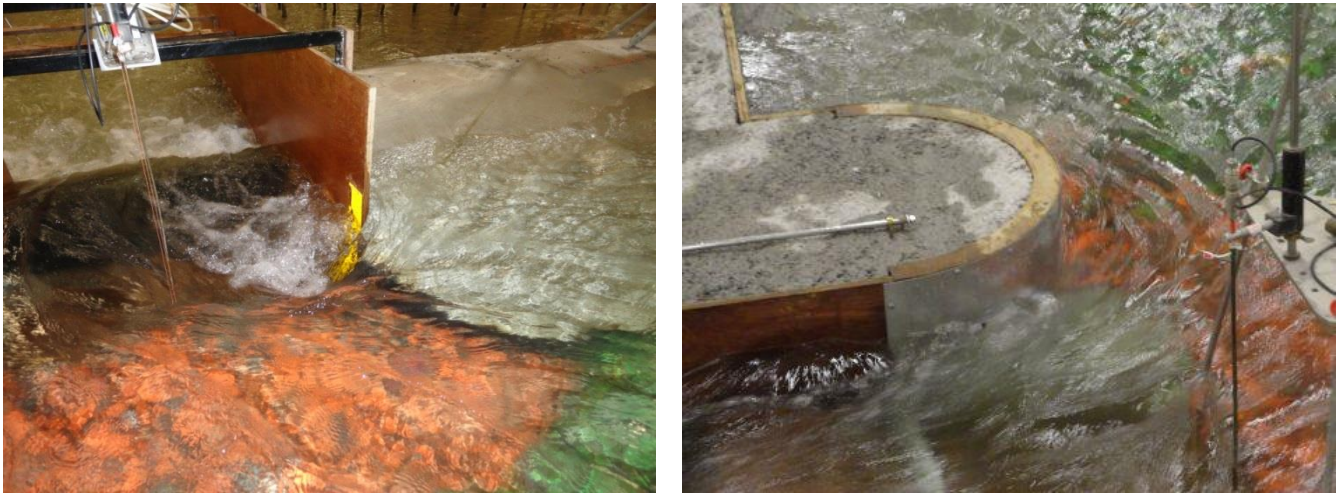
Figure 163. Wakes generated by the retaining wall on the RHS of the service spillway – left: straight wall of the initial design, right – circular design for TSD-H.

of Figure 162). High velocities were observed along the LHS training wall of the service spillway indicating the potential for erosion or scour at this location. The modification to the RHS retaining wall, changing the plan shape to a circular design, showed an improvement on the entrance flows over the straight wall design used in test series A-C (see Figure 163).

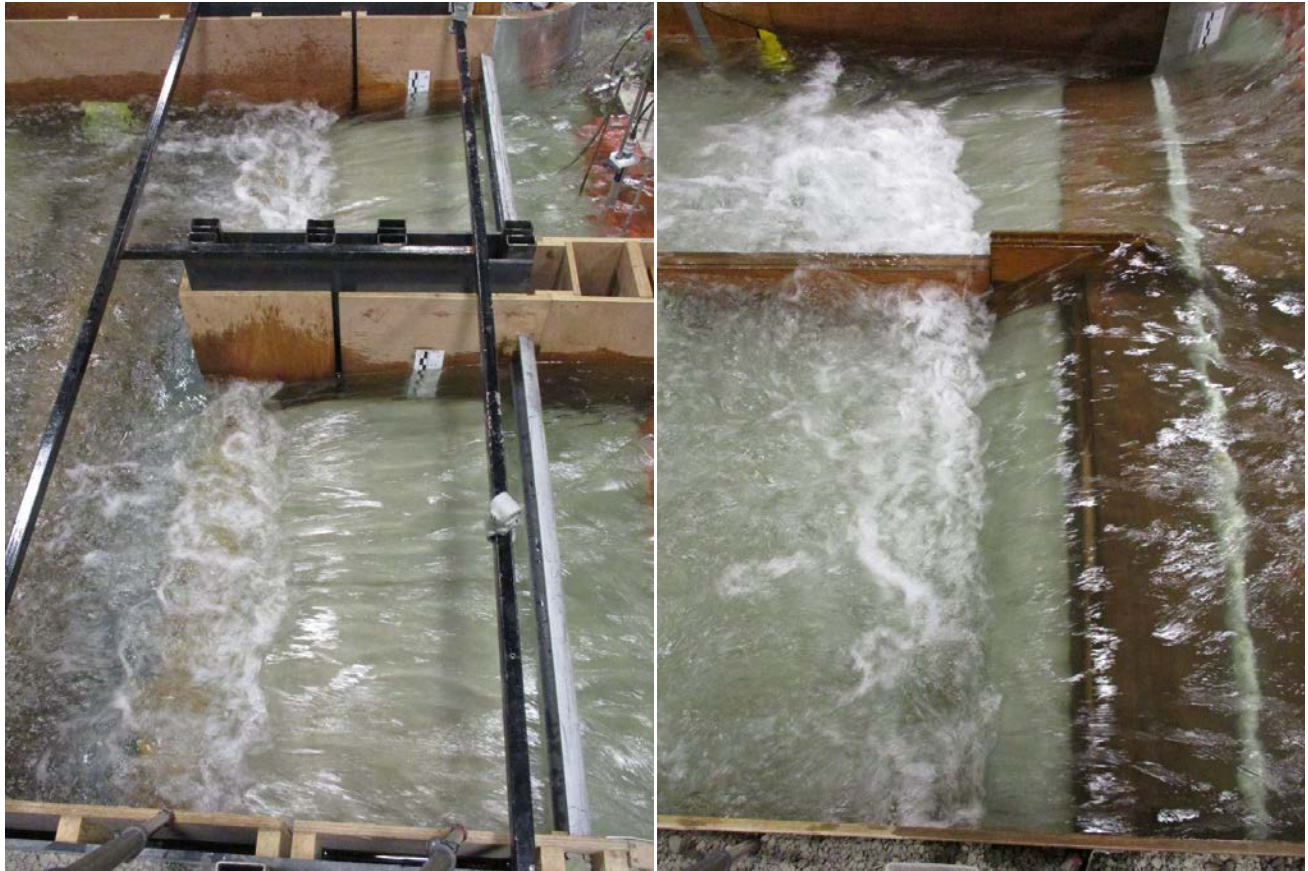
- Diversion inlet gates were fully raised (open).
- Left hand side service spillway Obermeyer gate set to 1212.57 m.
- Right hand side service spillway Obermeyer gate set to 1210 m.

Figure 164. Flow through the diversion inlet structure (left) and service spillway (right) during the  $1240 \text{ m}^3/\text{s}$  case (b) flood condition.

The target flow split for the 1240 m<sup>3</sup>/s flow condition is to have 600 m<sup>3</sup>/s in the diversion channel and 640 m<sup>3</sup>/s in the main channel. For this test case the gate settings provided by Stantec provided a flow split that matched the targets very well; the recorded flow over the diversion channel weir was 611 m<sup>3</sup>/s and the recorded flow over the main channel weir was 675 m<sup>3</sup>/s (the total flow was 1286 m<sup>3</sup>/s - refer to Table 31 for the flow splits and the water levels). Again, the water level in the LHS of the service spillway (WP8) is slightly lower compared to the RHS (WP9), while the water levels were relatively even across the diversion inlet structure (WP's 6 and 7). The flow through the diversion inlet bays appeared to be relatively even and the hydraulic jump was stable (see the left hand side of Figure 164). In the service spillway there was more flow through the RHS since the Obermeyer gates were lower here. The hydraulic jump was influenced by the wake stemming from the circular retaining wall (see the right side of Figure 164). Again, modifying the RHS retaining wall to a circular design showed an improvement on the entrance flows. The wake from this retaining wall is shown in Figure 165, along with the wake stemming from the pier nose in the diversion.

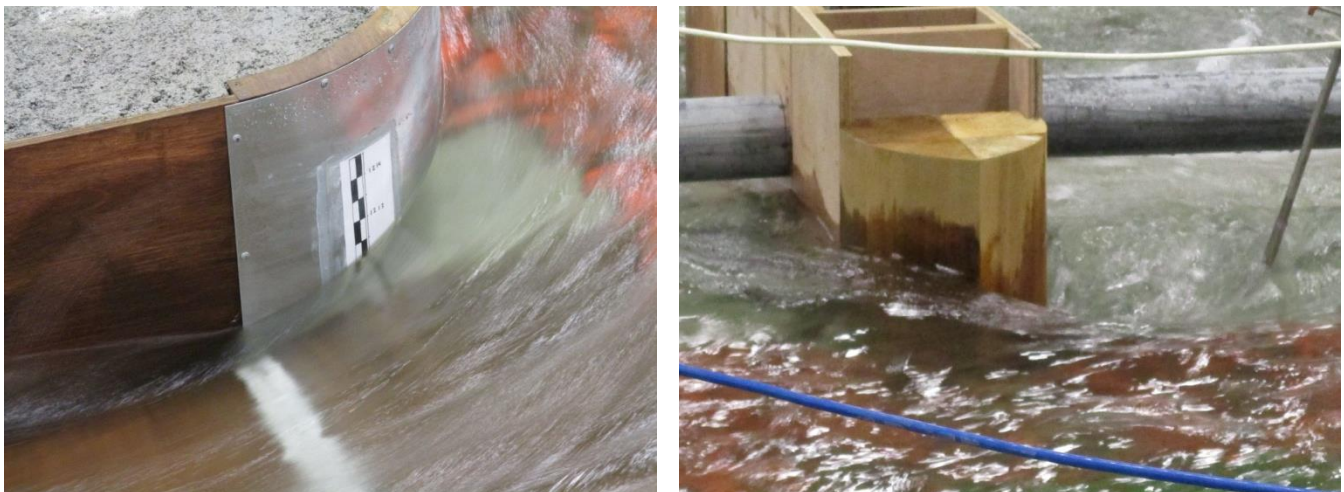
Figure 165. Wakes generated by the retaining wall on the RHS of the service spillway (left), and the RHS of the diversion inlet stemming from pier nose 2 (right).

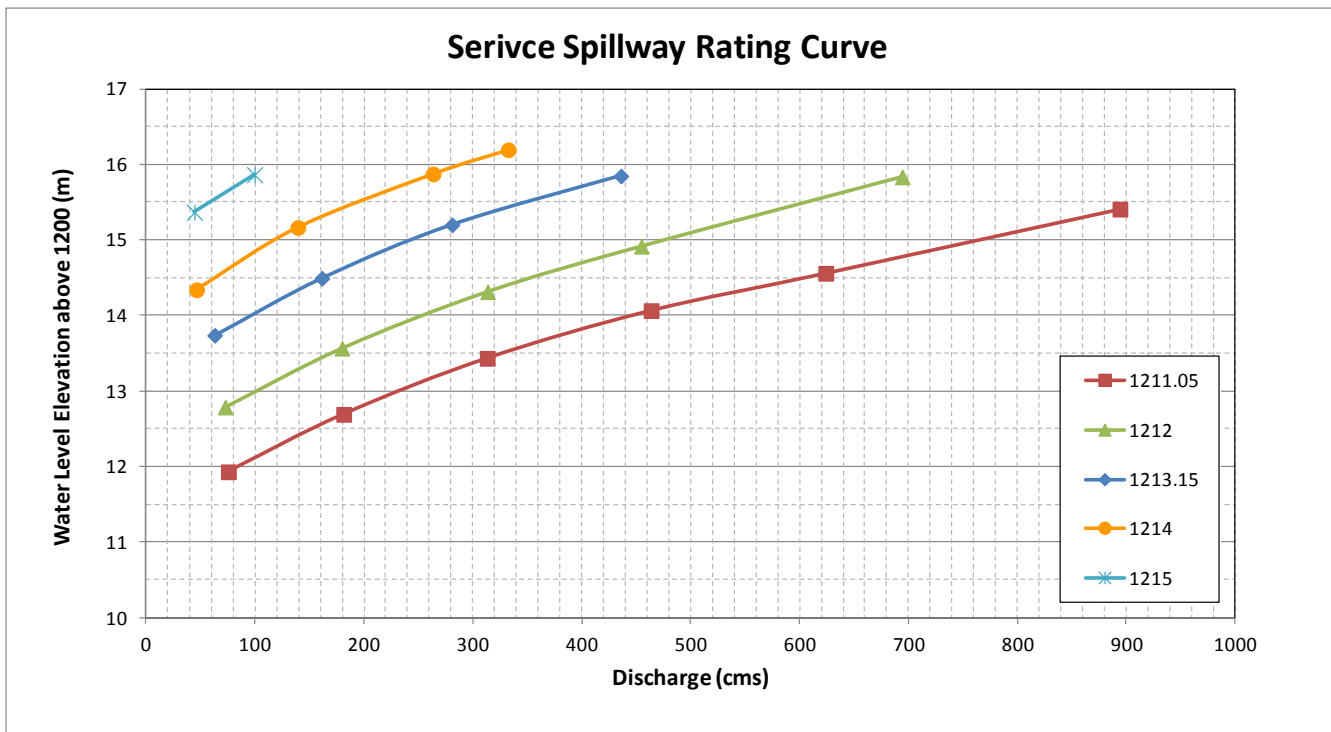
Figure 166. Rating curves for the service spillway Obermeyer gates - upstream water level elevation versus discharge for the various gate setting elevations.

Test series F investigated the water level elevation at the upstream end of the service spillway for various flows and settings on the Obermeyer gates. Rating curves were developed that relate the water level elevation (stage) to the flow discharge for an array of gate settings. Both of the Obermeyer gates on the left and right side of the service spillway were set to the same elevation for each test. The instruments were arranged in Sensor Layout 5 and their location can be seen in Figure 77. Only the flow over the service spillway was of interest during this test series, therefore the diversion inlet gates were closed. The data measured by the water level probes just upstream of the service spillway were used (WP8 and WP9) and their rating curve information is given in Table 32 and Figure 166. Note that the water level information is given in metres above the 1200m elevation, therefore a water level of 11.94m corresponds to a water level elevation of 1211.94m.

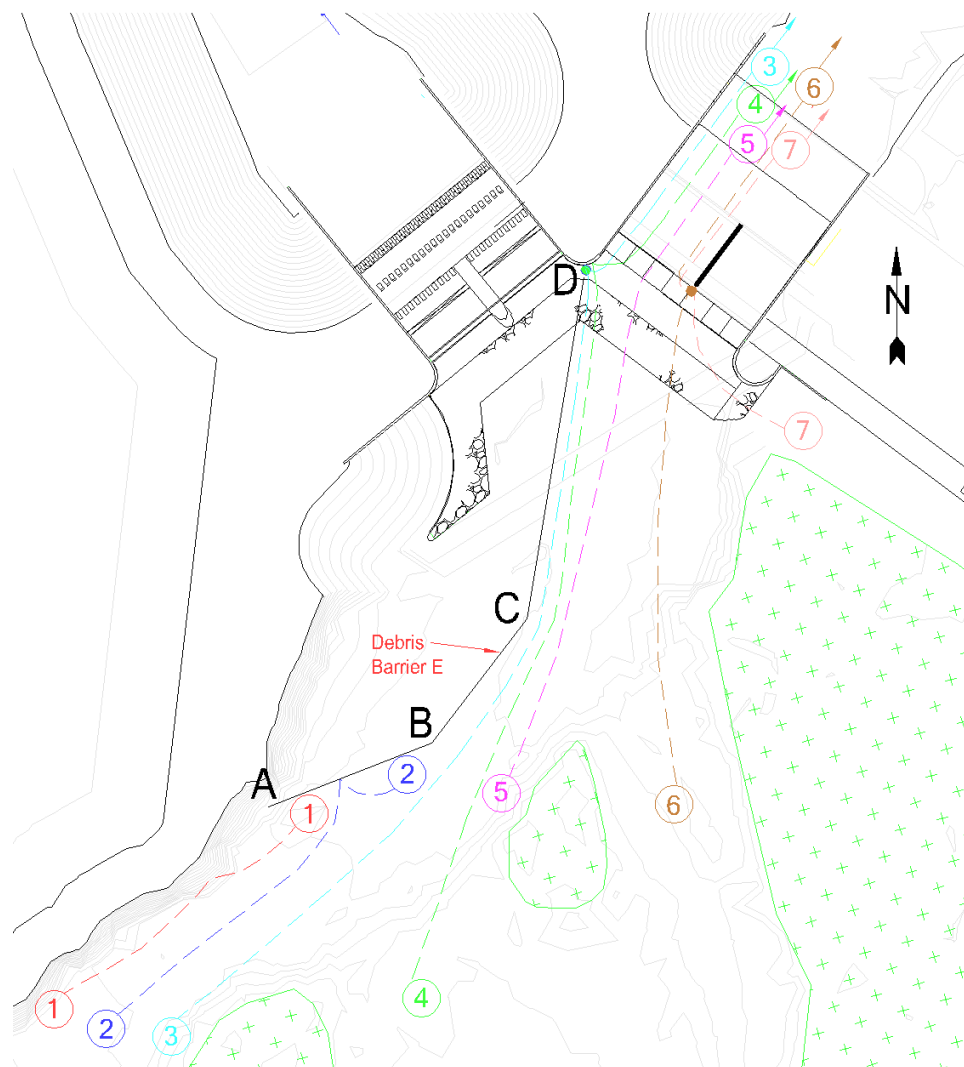
Figure 167. Debris pathways for TSG,  $320\text{m}^3/\text{s}$  flow conditions with debris barrier E.

The gate settings for the 320m<sup>3</sup>/s flow utilized the diversion inlet gate in the fully raised position, and the service spillway Obermeyer gates set to 1211.05m on the 24m wide left-hand side (LHS) and 1215m on the 18m wide right-hand side (RHS). The setting was intended to direct 160m<sup>3</sup>/s through the service spillway and 160m<sup>3</sup>/s through the diversion. Again, model tree debris was inserted into the model in one of seven locations (1-7) as shown in Figure 167 during the tests. Table 33 shows a summary of the debris behaviour at this flow condition. For ease of description, debris barrier E was

divided into legs AB, BC and CD as shown in the figure. Debris inserted into the left hand side of the western floodplain (locations 1 and 2) collected on leg AB and the debris tended to tumble along the barrier coming to rest at point B. Here, debris would collect and protrude out into the river beyond point B. When larger rafts of trees originated at location 2 the debris rafts bridged across from the debris barrier (at point B) to the standing forest in the floodplain, thus blocking the river channel (see Figure 168). At the end of the tests at  $320\text{m}^3/\text{s}$ , there was some debris caught in the barrier on leg AB, but legs BC and CD were clear of debris. In general the debris from locations 3-7 would pass through the LHS of the service spillway. Some of the single debris entries would remain caught in the hydraulic jump beyond the service spillway gate, but this debris would eventually be knocked downstream by later debris passing over the crest gates. Large rafts of debris tended to pass all the way through the structure and not hang at the hydraulic jump.

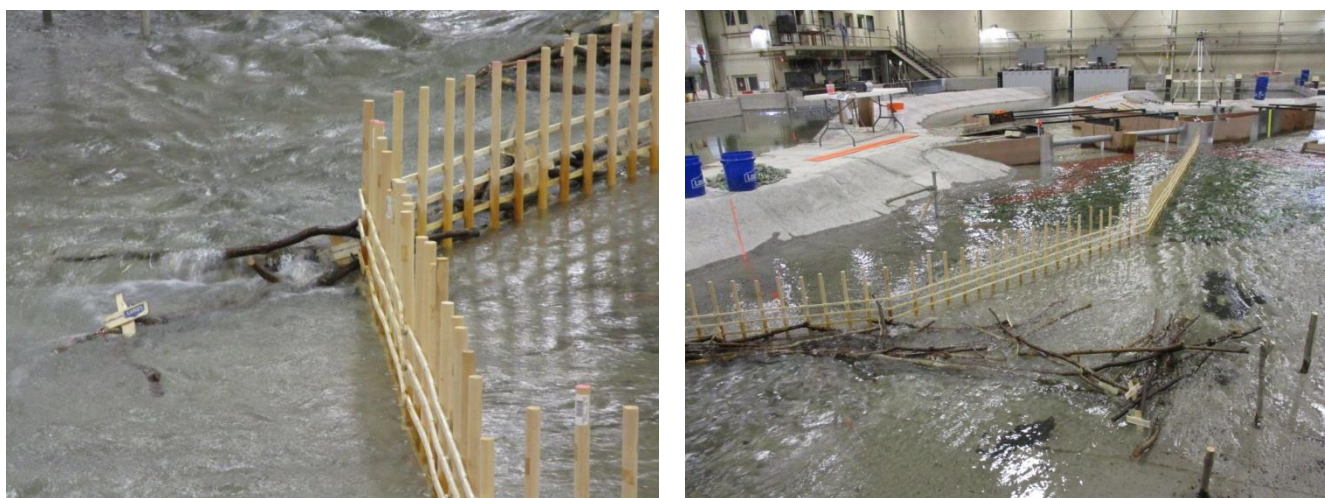
Figure 168. Debris being caught on the barrier and protruding out into the river (left), and this phenomenon continuing to bridge across the river against the standing trees producing a jam (right).

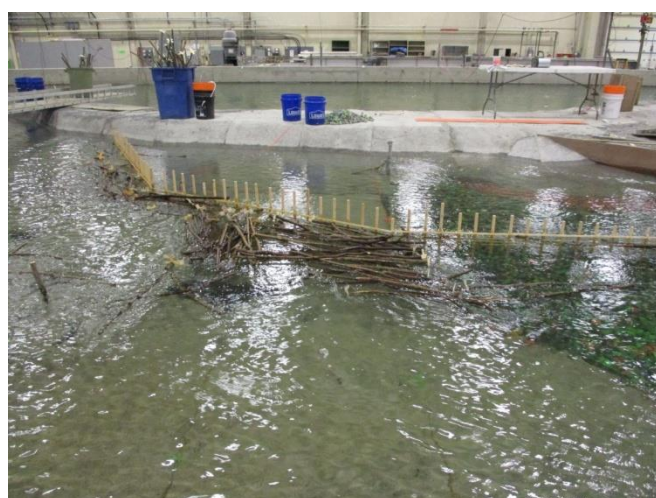
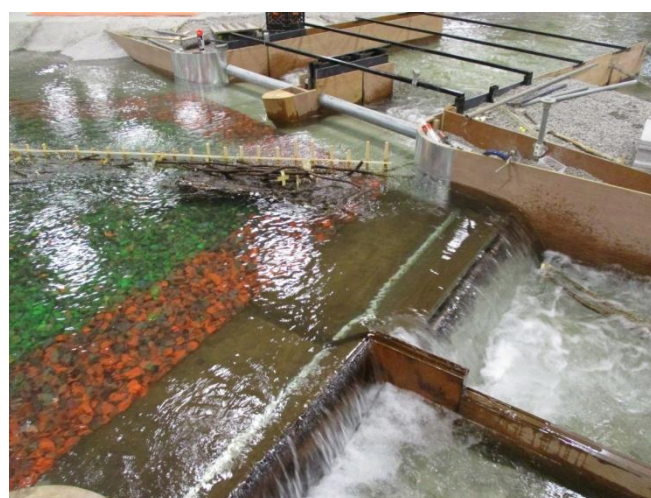
Figure 170. Debris left on barrier at the end of the 760m<sup>3</sup>/s tests for leg AB and BC (left) and at the end of the barrier on leg CD (right).

through the service spillway. At the end of the tests much debris remained on the barrier on all three legs (see Figure 170).

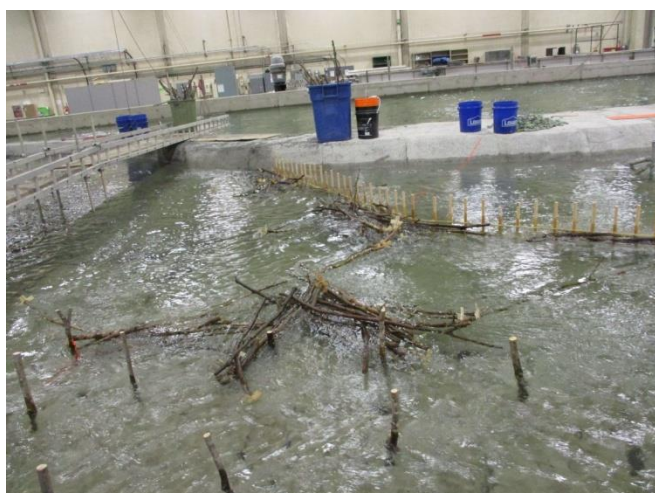
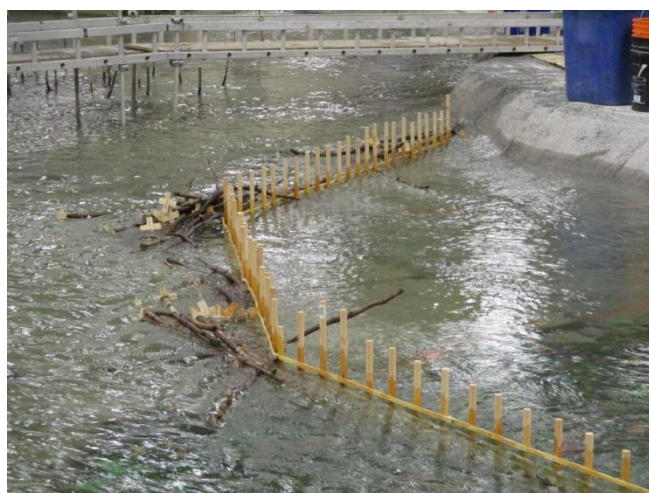
Figure 172. Left - Debris being caught on the barrier and protruding out into the river and this phenomenon continuing to bridge across the river against the standing trees producing a jam. Right – debris trapped in the barrier at the end of the tests.

thus blocking the river channel (see Figure 172, left). At the end of the tests at 1240m<sup>3</sup>/s, there was debris caught in the barrier at the B and C vertices (see Figure 172, right). The model tree debris rafts ran along the straight legs of the barrier and then became trapped as the raft pivoted around the corners at points B and C. Leg CD was clear of model debris at the end of the tests.

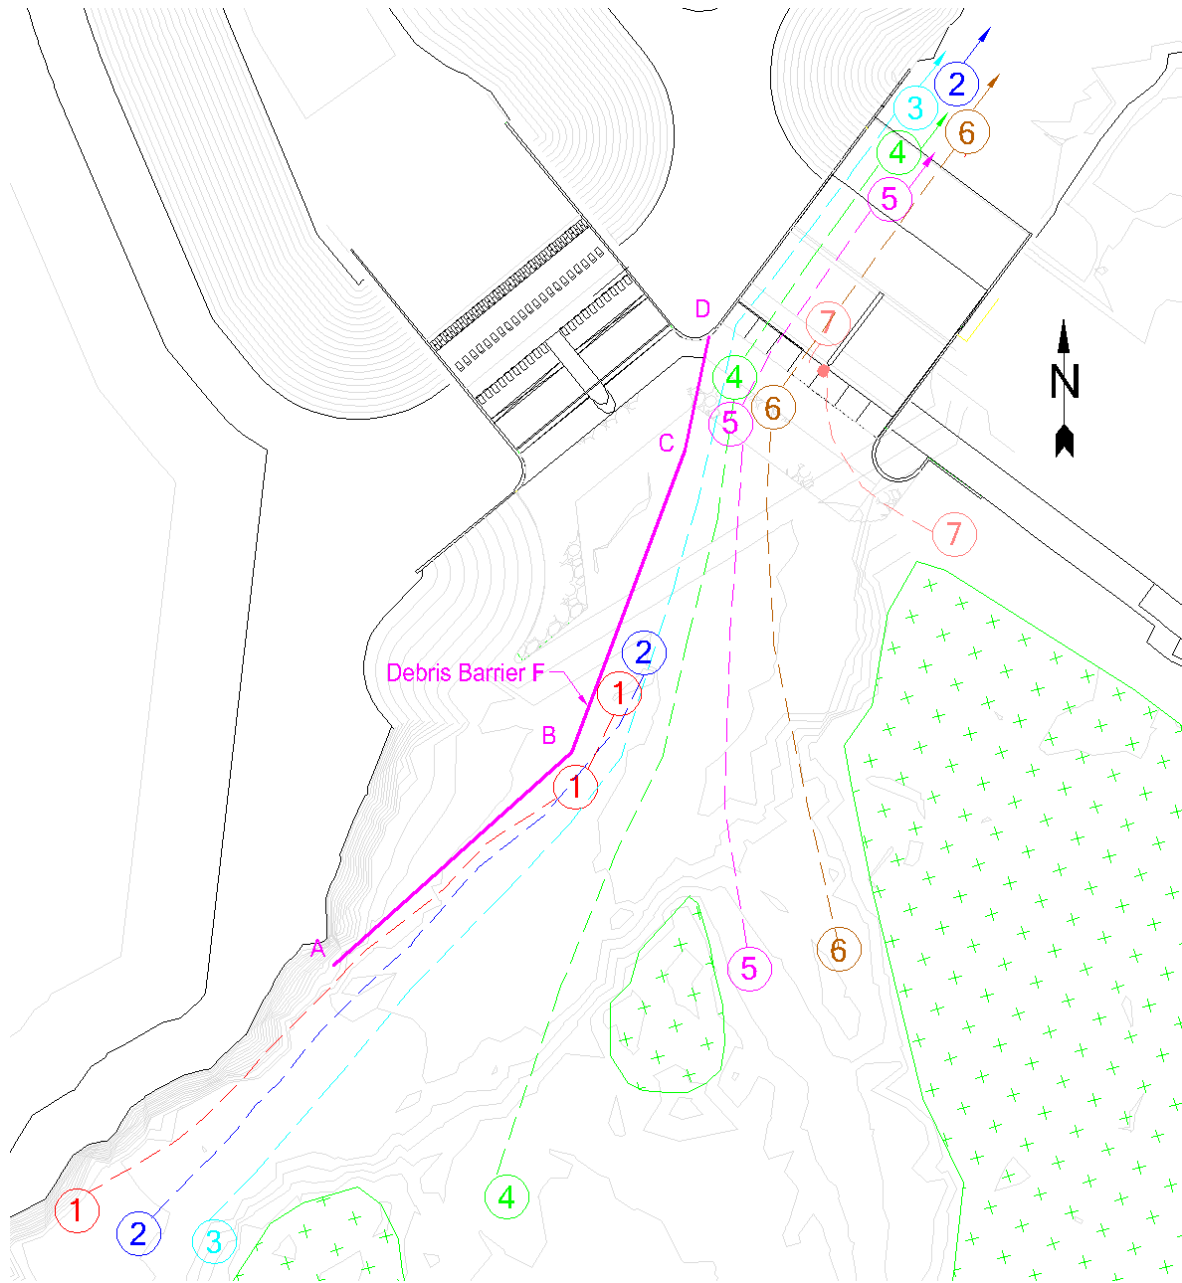
Figure 173. Debris pathways for TSH, 320 m<sup>3</sup>/s flow conditions with debris barrier F.

The gate settings for the 320m<sup>3</sup>/s flow utilized the diversion inlet gate in the fully raised position, and the service spillway Obermeyer gates set to 1211.05m on the 24m wide left-hand side (LHS) and 1215m on the 18m wide right-hand side (RHS). These settings were intended to direct 160m<sup>3</sup>/s through the service spillway and 160m<sup>3</sup>/s through the diversion, which was close to the measurements made in the model (178m<sup>3</sup>/s in the diversion and 142m<sup>3</sup>/s through the main channel). Again, model tree debris was inserted into the model in one of seven locations (1-7) as shown in Figure 173 during the tests. Table 36 shows a summary of the debris behaviour at this flow condition. For ease of description, debris barrier E was divided into legs AB, BC and CD. Debris inserted into the left hand side of the western floodplain (locations 1 and 2) bounced along leg AB before coming to rest close to point B. At other debris deployment locations, the model trees would often catch in the debris barrier at leg CD. During the deployment of the rafts of ten debris units, the trees bridged across from the barrier and jammed at the LHS of the service spillway. This jam did not permit the passage of any further debris causing a larger jam by the end of the tests at this flow rate (see Figure 174).

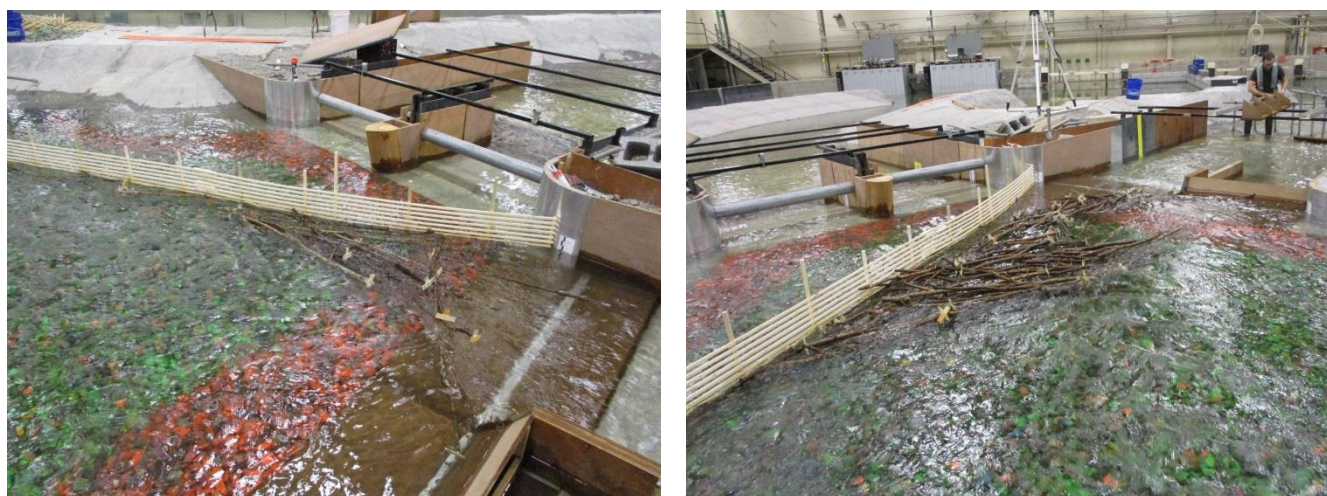
Figure 174. Debris being caught at the downstream end of the barrier and bridging across the LHS of the service spillway to start a jam (left), and the jam building through the testing program (right).

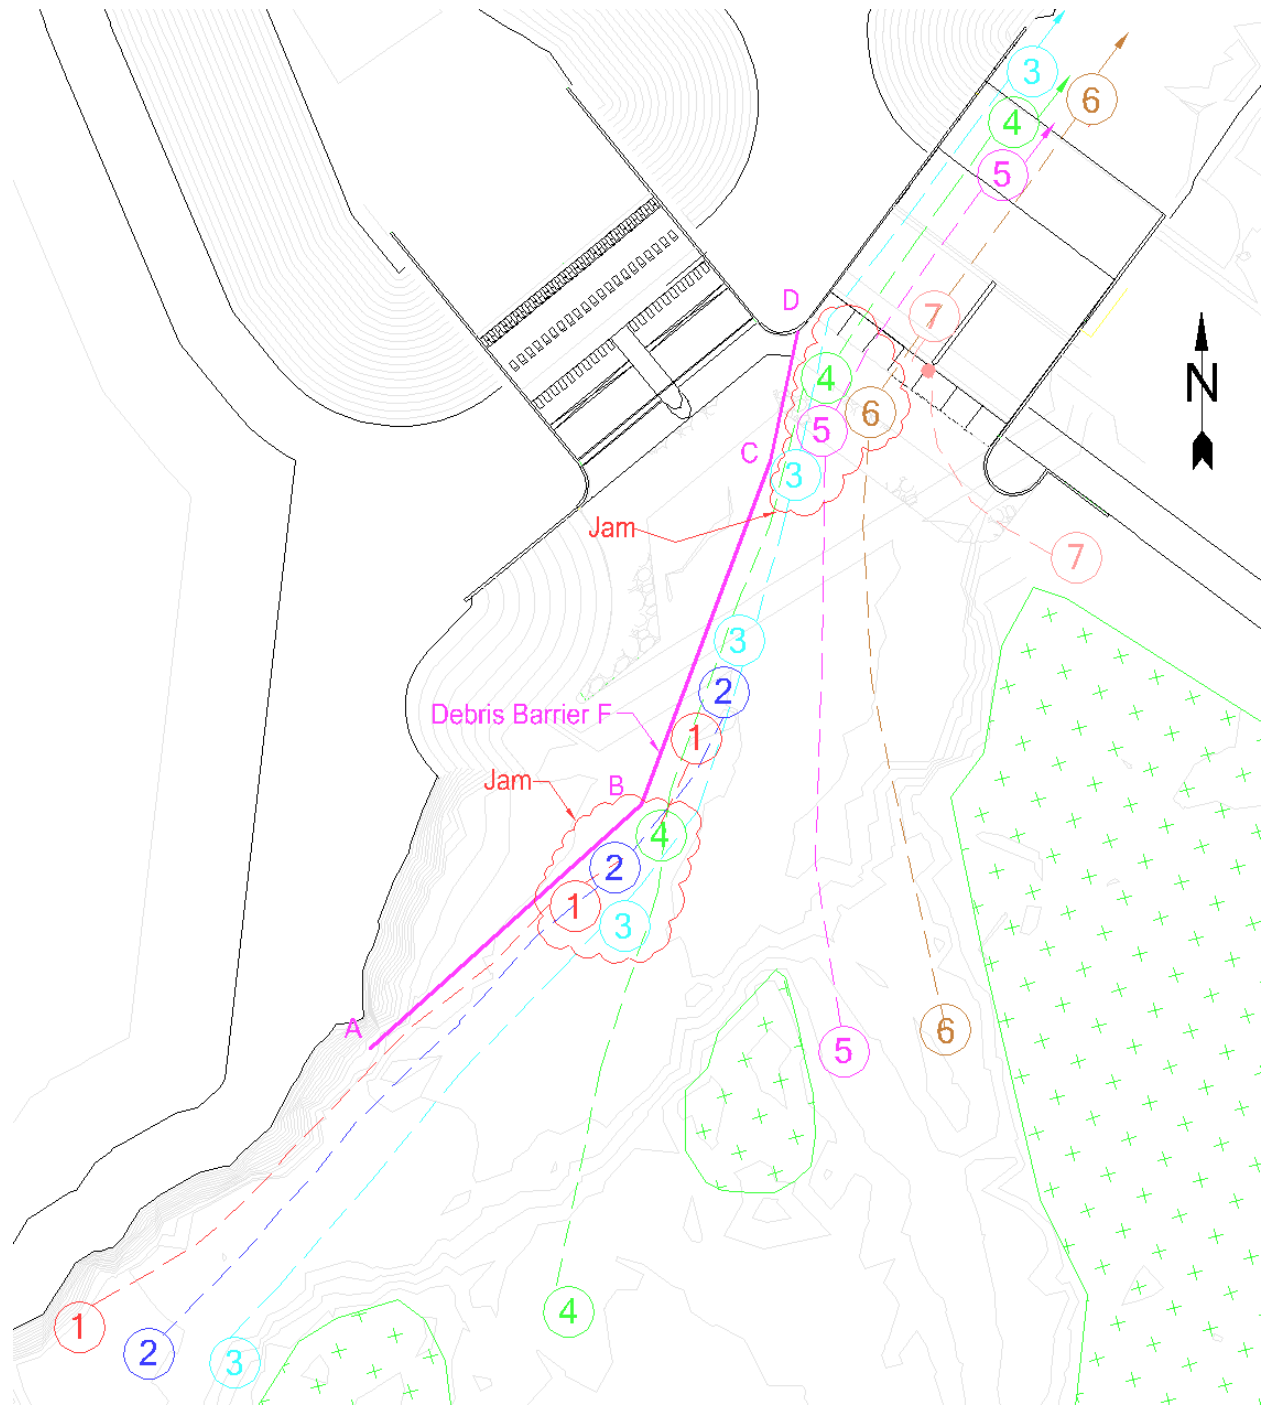
Figure 175. Debris pathways for TSH, 500m<sup>3</sup>/s flow conditions with debris barrier F.

The case (a) gate settings for the 500m<sup>3</sup>/s flow utilized the diversion inlet gate in the fully raised position, and the service spillway Obermeyer gates set to 1212m on the 24m wide left-hand side (LHS) and 1215m on the 18m wide right-hand side (RHS). The total flow through the river floodplain was 516m<sup>3</sup>/s and the flow splits through the diversion inlet and the service spillway were 331m<sup>3</sup>/s and 185m<sup>3</sup>/s, respectively. Again, model tree debris was inserted into the model in one of seven locations (1-7) as shown in Figure 175 during the tests. Table 37 shows a summary of the debris behaviour at

this flow condition. For ease of description, debris barrier F was divided into legs AB, BC and CD. Debris inserted into the left hand side of the western floodplain (locations 1 to 4) was trapped on the barrier along leg AB and created a debris jam at point B. Some of the debris in the jam eventually drifted off and collected on the barrier at the downstream end (leg CD). At other debris deployment locations, the model trees would often catch in the debris barrier at leg CD, and a second debris jam was created in front of the LHS of the service spillway (see Figure 176).

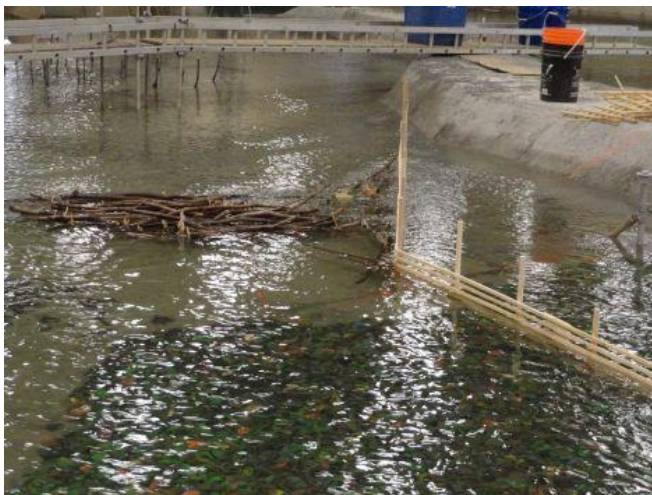
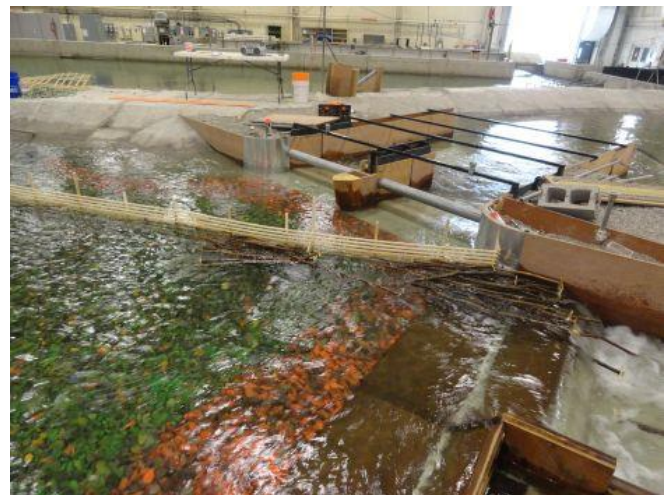
Figure 176. Debris caught on the upstream end of the barrier (leg AB) and protruding out into the river (left), debris caught at the downstream end of the barrier (leg BC) and on the LHS Obermeyer gate (right).

At the end of the tests, the upstream debris jam consisted of approximately 90 trees (see Figure 176, left) and the downstream jam was slightly smaller (~ 35 trees - see Figure 176, right). Gate operations were undertaken to try and remove the trees from the barrier. Initially the LHS Obermeyer gate was lowered to 1210m and this removed approximately 20 of the 35 trees from the jam close to the diversion inlet and passed them through the LHS of the service spillway. The diversion inlet gates were then closed and the other 15 trees drifted off the debris barrier and through the LHS as well. As the backwater effect raised the water level in the upstream floodplain, the large raft at Point B on the barrier moved slightly downstream and away from the barrier. The diversion inlet gates were then opened and approximately 60% of this jam floated downstream and through the LHS of the service spillway.

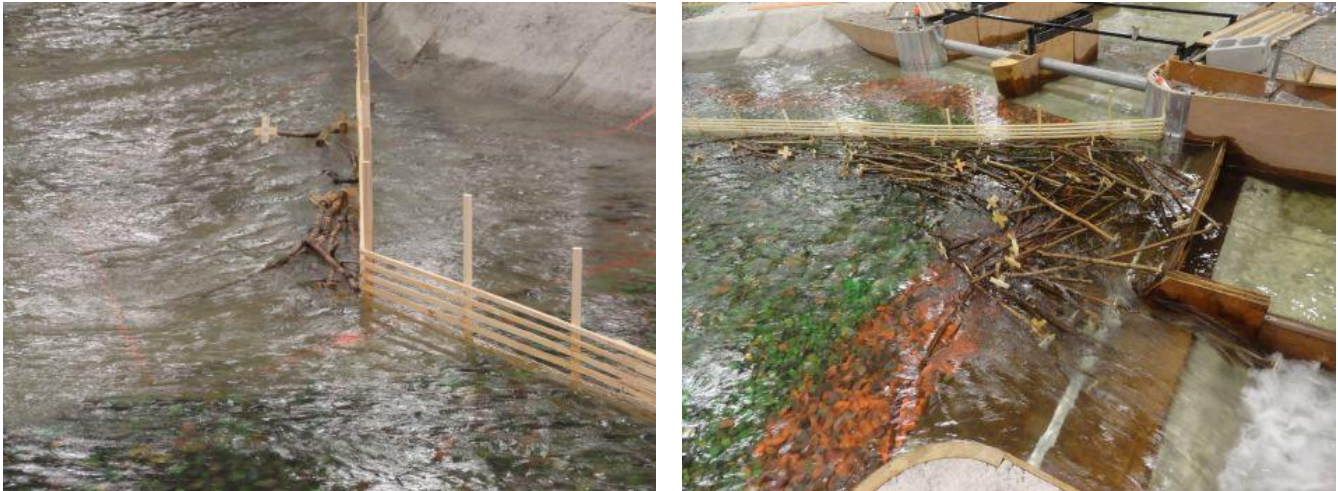
Figure 177. Debris caught on the upstream end of the barrier (leg AB) at the end of the Case B tests (left) and at the downstream end of the barrier (leg BC) in front of the raised LHS Obermeyer gate (right).

A separate case was run for the 500 m<sup>3</sup>/s flow condition with the Obermeyer gates at the service spillway reversed – the LHS was higher (1215m) and the RHS was lower (1211.05m). This setting created a stagnation zone at the downstream end of the debris barrier in front of the raised gate on the LHS and caused more debris to collect in this location. However, the large debris jam that occurred at the upstream end of the debris barrier (leg AB) for case (a) was not as large (see Figure 177).

At the end of the tests, there was a large debris jam of approximately 130 trees collected at the downstream end of the barrier in front of the raised LHS Obermeyer gate, and a smaller number of trees (~10) caught in the upstream barrier in leg AB. Gate operations were then undertaken to try and remove the trees from the barrier. The LHS Obermeyer gate was lowered and almost all the trees from the downstream jam passed through the LHS of the service spillway. Only seven trees remained caught around the central pier between the Obermeyer gates (see Figure 178). The small number of trees in the upstream portion of the barrier (leg AB) were not affected by any gate operations and remained caught in the upstream barrier.

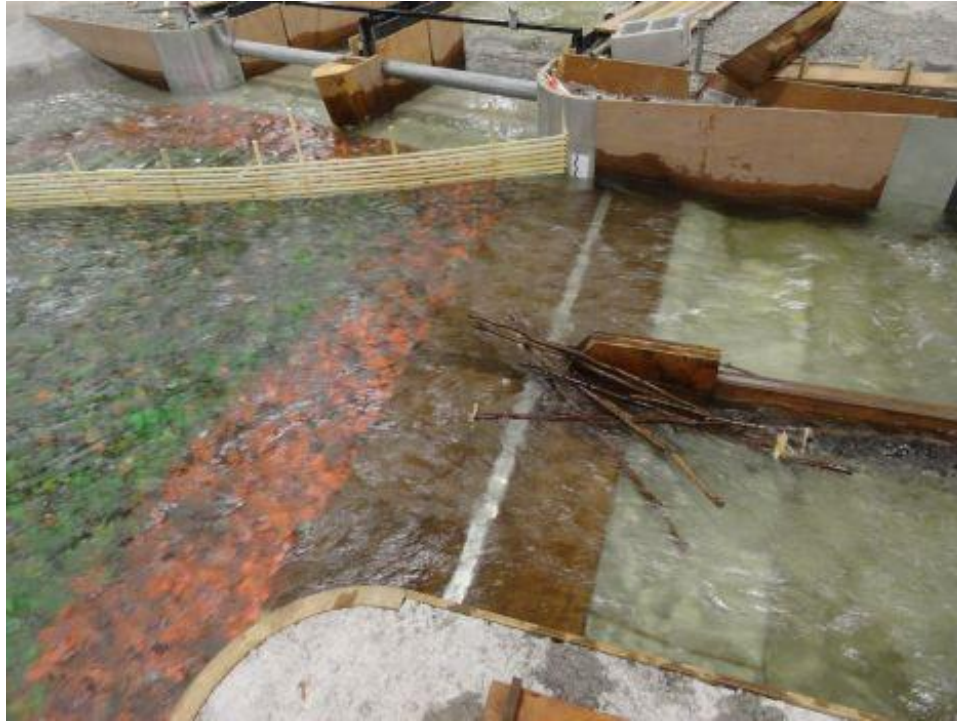
Figure 178. Debris remaining caught on the dividing pier after lowering the Obermeyer gates after all of the gate operations of the  $500\text{m}^3/\text{s}$  Case B flow condition.

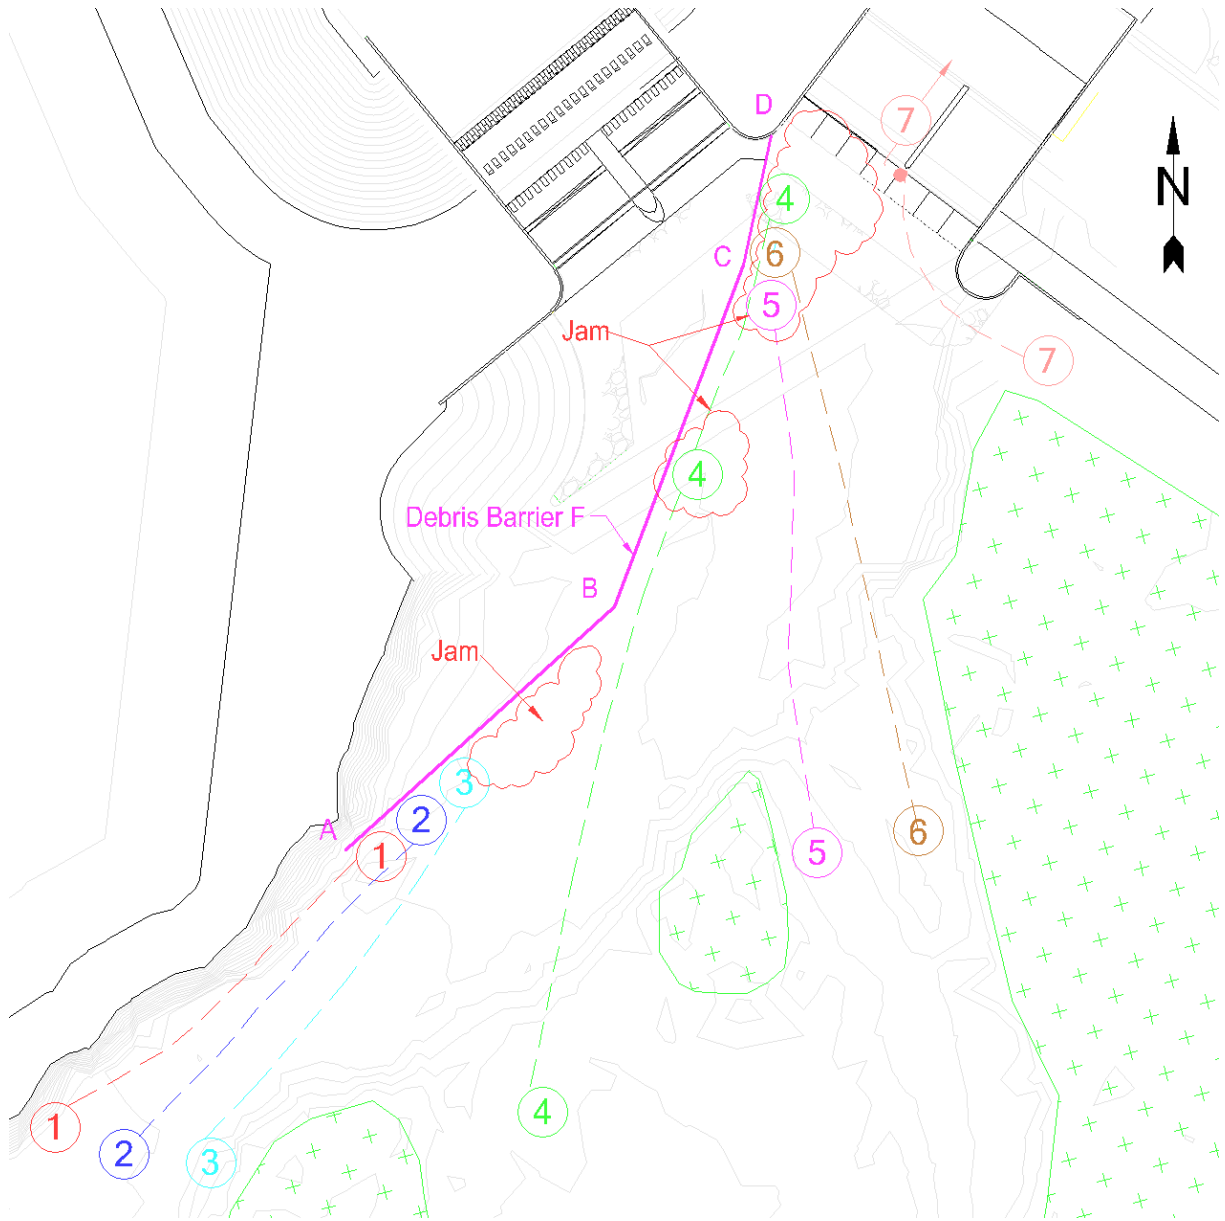
Figure 179. Debris pathways for TSH, case (a)  $760 \text{ m}^3/\text{s}$  flow conditions with debris barrier F.

The diversion inlet gate was in the fully raised position, and the service spillway Obermeyer gates were set to 1213.4m on the 24m wide left-hand side (LHS) and 1215m on the 18m wide right-hand side (RHS) for the case (a) tests. The setting was intended to direct  $160\text{m}^3/\text{s}$  through the service spillway and  $600\text{m}^3/\text{s}$  through the diversion, and this was represented well in the model ( $563\text{m}^3/\text{s}$  through the diversion inlet and  $188\text{m}^3/\text{s}$  through the service spillway). Again, tree debris was inserted into the model in one of seven locations (1-7) as shown in Figure 179 during the tests. Table 38 shows a summary of the debris behaviour at this flow condition. The relatively larger amount of flow passing through the diversion inlet (behind the barrier) compared to the service spillway drew the woody debris into the debris barrier much more than the other flow conditions. Debris originating from the left hand side of the western floodplain (locations 1, 2 and 3) collected on leg AB. On almost the entire floodplain (locations 1-6) the debris was sucked into and pinned up against the debris barrier by the flow. Only debris inserted in the model near the floodplain berm at the RHS of the service spillway (location 7) had a significant portion pass through the service spillway. At the end of the tests much debris remained on the barrier on all three legs (see Figure 180).

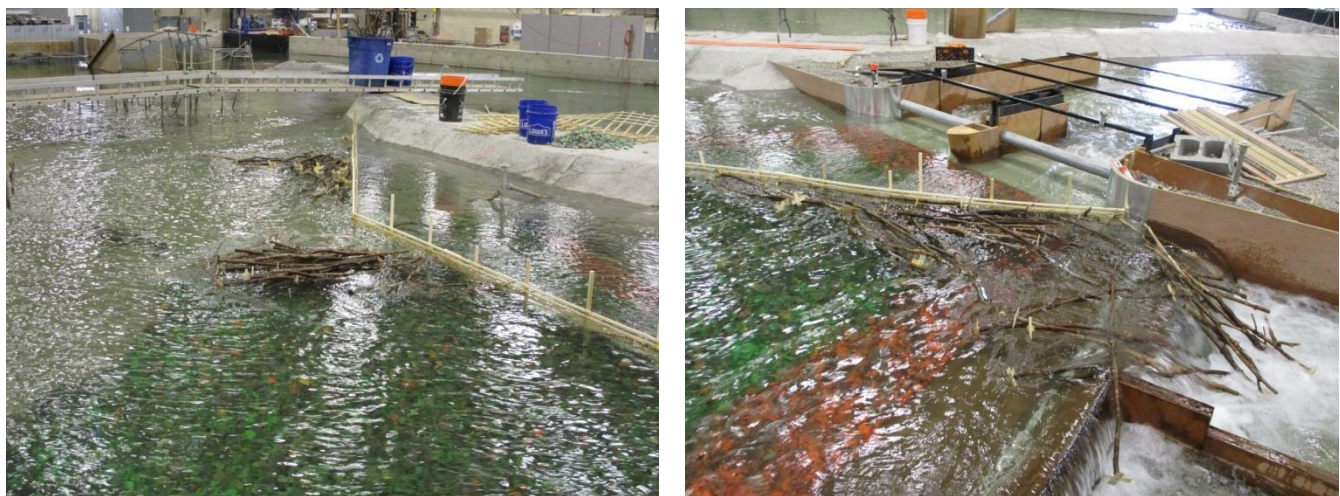
Figure 180. Debris left on barrier at the upstream end (left) and at the end of the barrier bridging across to the central pier in the service spillway (right).

At the end of the 760m<sup>3</sup>/s case (a) debris tests, with the large debris raft (~100 trees) caught in front of the diversion, efforts were made to drop the diversion inlet gates as well as the LHS Obermeyer gate to try and clear the debris jam. The diversion inlet gates were lowered first and some of the debris that was caught on the Obermeyer gate was freed. Also the jams further upstream on the barrier at AB and BC floated off of the debris barrier and came further downstream. After lowering the Obermeyer almost all (~90%) of the debris trapped on the debris barrier was freed and passed through the LHS of the service spillway.

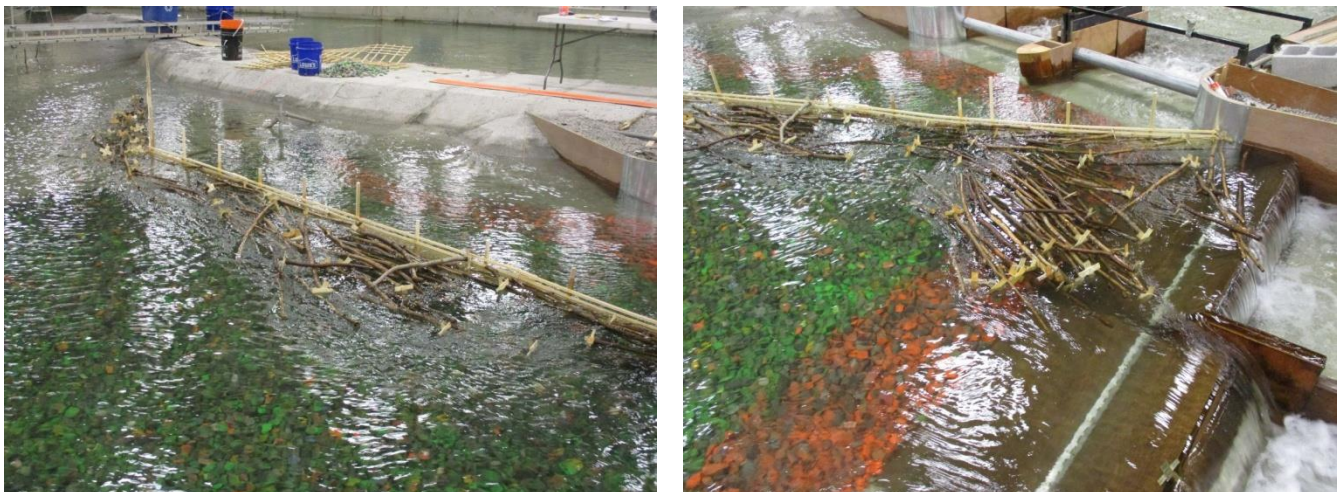
Figure 181. Debris caught on the upstream end of the barrier (left) and at the downstream end of the barrier (right) in front of the raised LHS Obermeyer gate at the end of the tests.

A separate case was run for the  $760\text{m}^3/\text{s}$  flow condition with the Obermeyer gates at the service spillway reversed – the LHS was higher (1215m) and the RHS was lower (1213.15m). In the model these gate settings produced a flow split of  $553\text{m}^3/\text{s}$  through the diversion inlet and  $200\text{m}^3/\text{s}$  through the service spillway. Again, with the relatively larger amount of flow directed towards the diversion inlet (and through the debris barrier) all of the debris deployed in the upstream floodplain at locations 1-6 from Figure 179 were trapped in the debris barrier. Raising the Obermeyer gate on the LHS of the service spillway, instead of the RHS as it was in case (a), served to trap even more debris as a large stagnation zone in front of the raised gate was created. At the end of the case (b) tests there were debris jams along all three legs (AB, BC, CD) of debris barrier F (see Figure 181).

After the debris had been deployed in the model a large debris jam of approximately 120 trees collected at the downstream end of the barrier in front of the diversion inlet and the raised LHS

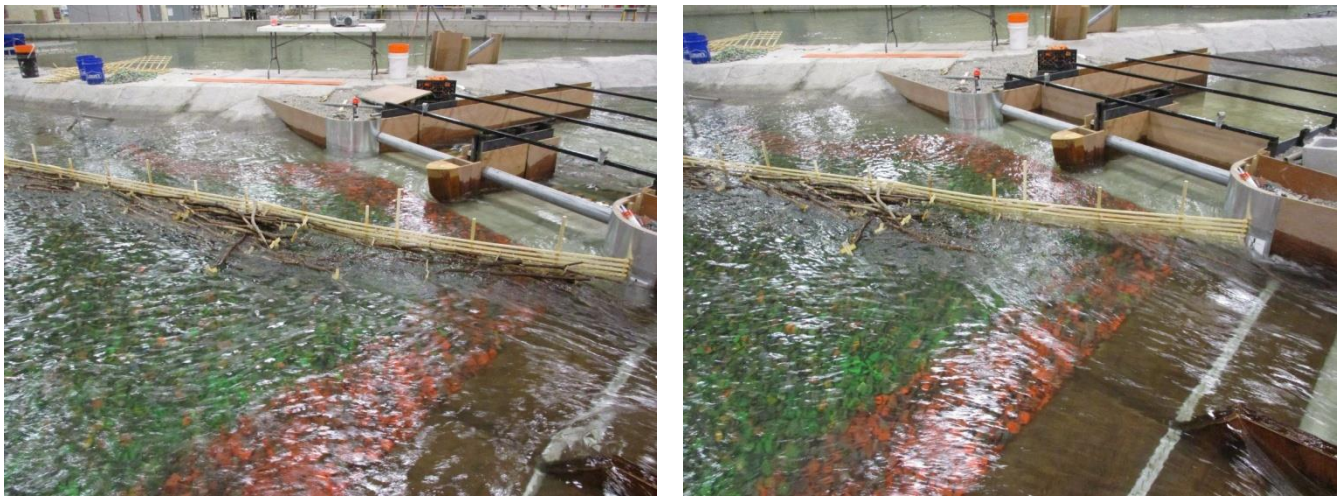
Figure 182. Gate operations to removed trees caught in debris barrier F. Left – dropping the LH Obermeyer gate to 1210 removed ~80 trees from the barrier. Right – lowering the diversion inlet gates and the RH Obermeyer gate removed ~15 trees from the barrier.

Obermeyer gate, and a smaller number of trees (roughly 30) were caught in the upstream barrier in leg AB. A number of gate operations were then undertaken to try and remove the trees from the barrier. The LHS Obermeyer gate was lowered to 1210m and approximately 80 trees that were at the downstream end of the barrier drifted off and passed through the LHS of the service spillway. The diversion inlet gates were then lowered at the prescribed drop gate rate of 0.3m per minute (full scale) and none of the debris on the barrier was dislodged. The RHS Obermeyer gate was then lowered to 1210m and roughly 15 trees were removed from the downstream debris jam and passed through the LHS of the service spillway. Figure 182 shows photographs of these gate operations. Approximately 60 trees remained caught on the debris barrier after all gate operations had concluded.

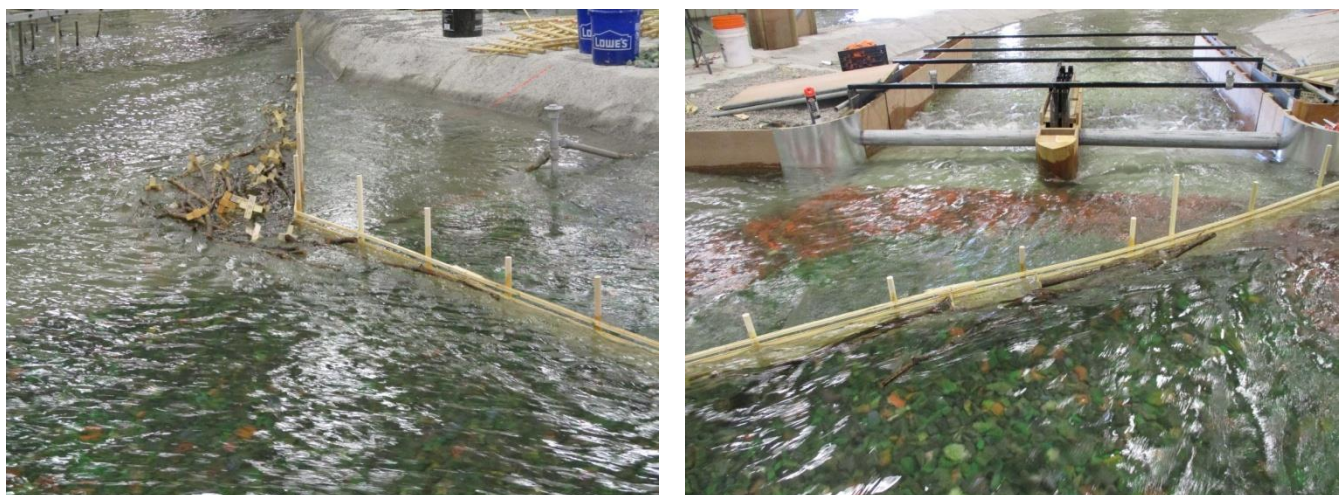
Figure 184. Debris jam at point B (left) and debris caught in the barrier in front of the diversion inlet structure (right) at the end of the TSH tests at 1240m<sup>3</sup>/s.

The gate settings for the 1240m<sup>3</sup>/s flow utilized the diversion inlet gate in the fully raised position, and the service spillway Obermeyer gates set to 1210m on the 24m wide left-hand side (LHS) and 1213.5m on the 18m wide right-hand side (RHS). The setting was intended to allow 640m<sup>3</sup>/s through the service spillway and 600m<sup>3</sup>/s through the diversion, and these targets were reasonably produced in the model (584m<sup>3</sup>/s through the diversion inlet and 654m<sup>3</sup>/s through the service spillway). Model tree debris was inserted into the model in one of seven locations (1-7) as shown in Figure 183 during the tests. Table 39 shows a summary of the debris behaviour at this flow condition. For ease of description, debris barrier F was divided into legs AB, BC and CD. Debris inserted into the left hand side of the western floodplain (locations 1, 2 and 3) collected on leg AB and along this leg debris tended to tumble along the barrier coming to rest at point B. Very little debris collected on legs BC and CD during the tests. At the end of the tests, the debris jam at point B was comprised of about 50 trees, and there were 5 trees snagged in the barrier in front of the diversion inlet structure (see Figure 184).
