ALBERTA TRANSPORTATION SPRINGBANK OFF-STREAM RESERVOIR PROJECT
RESPONSE TO NRCB AND AEP SUPPLEMENTAL INFORMATION REQUEST 1, JULY 28, 2018

Dam Safety
May 2019

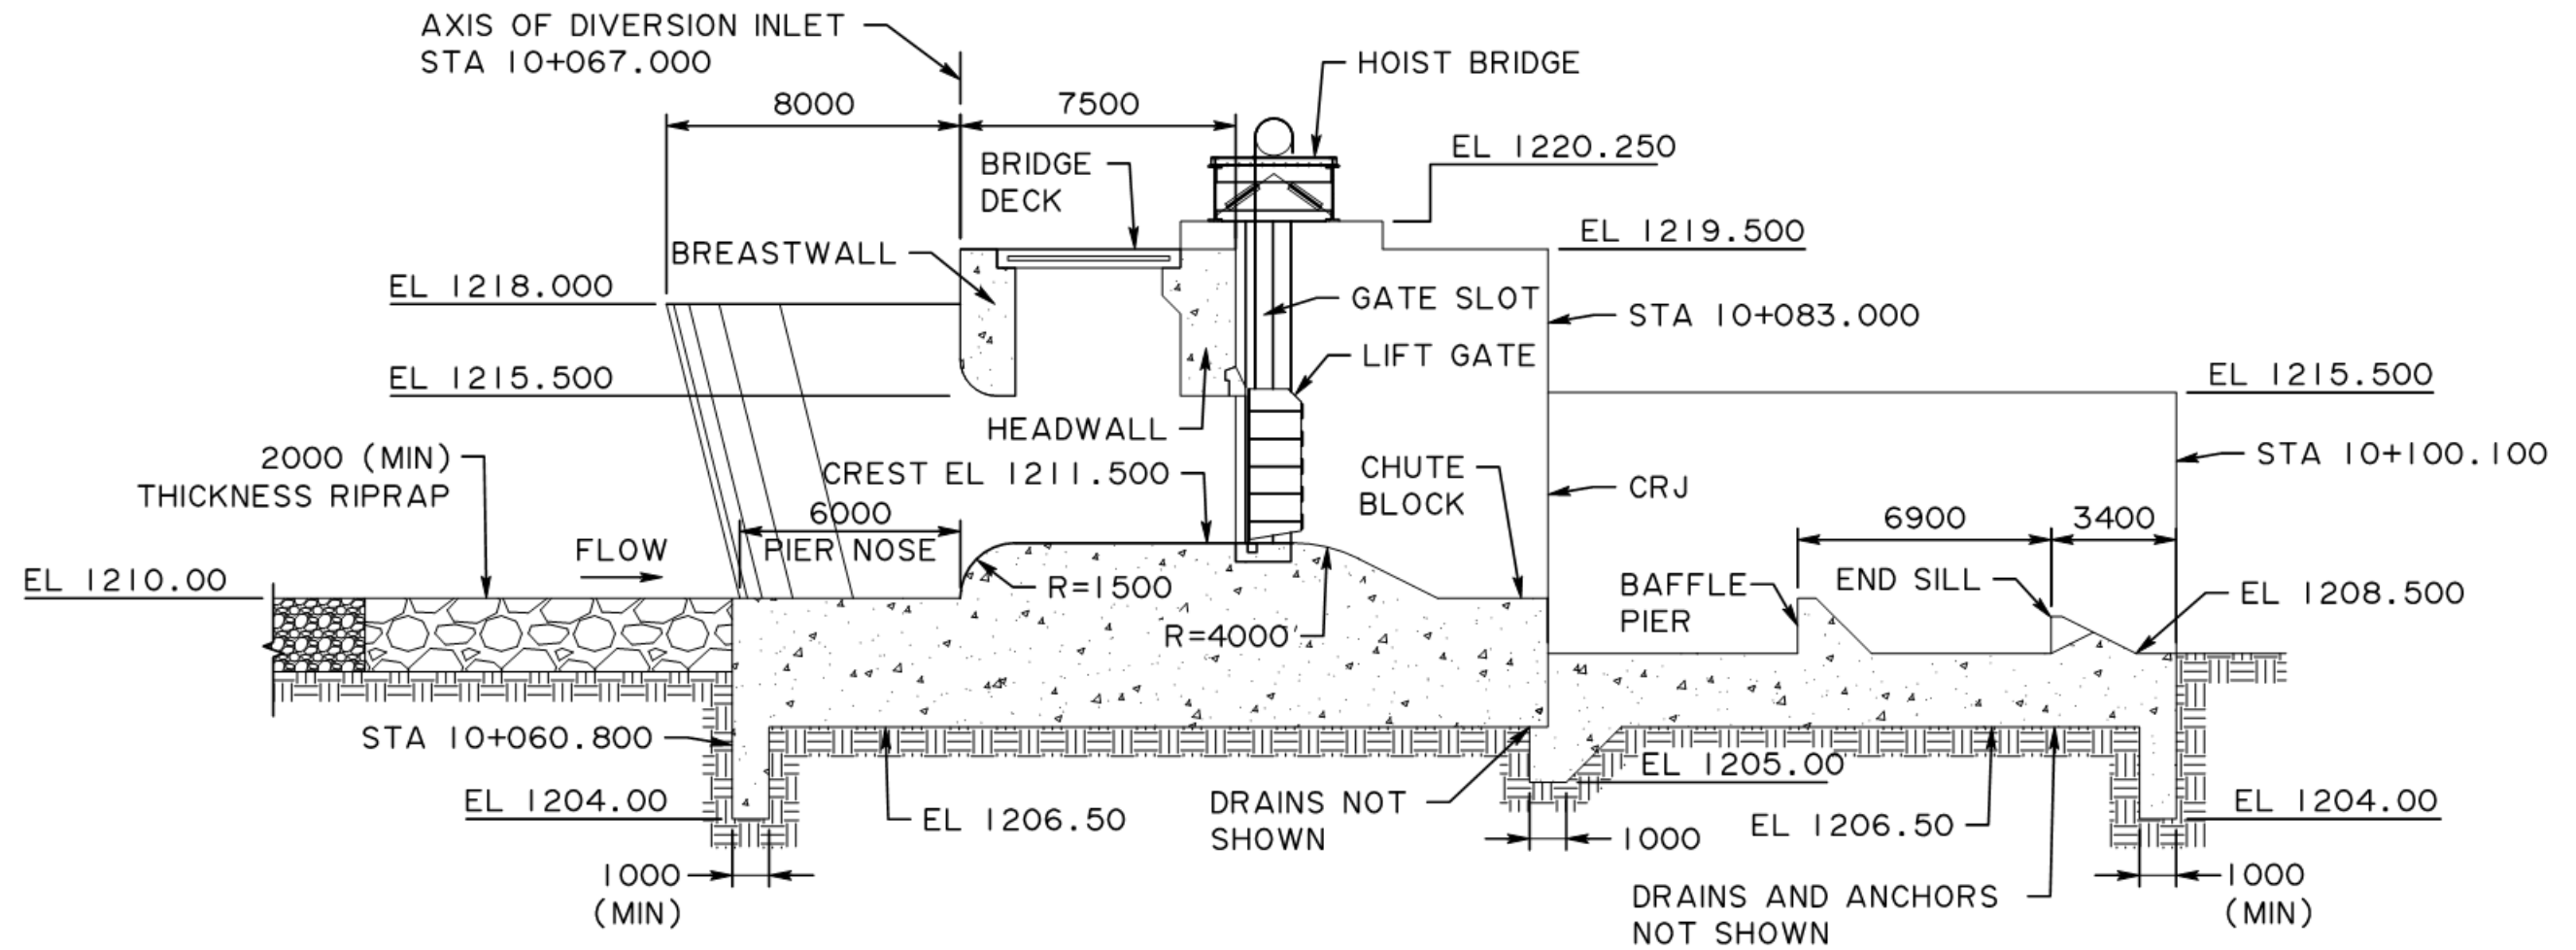
A cross section through the centerline of the diversion inlet is presented in Figure IR456-1. The design maximum discharge capacity (600 m³/s) is calculated to occur at headwater El. 1,215.8 m.

- a. The diversion inlet is a concrete gate structure located on the left bank of Elbow River at the entrance to the diversion channel. The primary elements of the diversion inlet are:
 - left abutment, retaining walls, and embankment transitions
 - two 20 m wide gate-bays with a center pier-divider and fixed crest El. 1,211.5 m
 - two 20 m wide by 4 m tall vertical lift-gates with wire-drum hoist and hoist support spanning the 20 m bay width
 - access bridge—comprising bridge deck, breastwall, and headwall—that provides access to gate equipment, vehicle access across the diversion channel entrance, and it is a debris and overtopping barrier during extreme flood events
 - stilling basin with chute blocks and end sills to provide energy dissipation and minimize channel erosion
 - right abutment, retaining walls, and embankment transitions

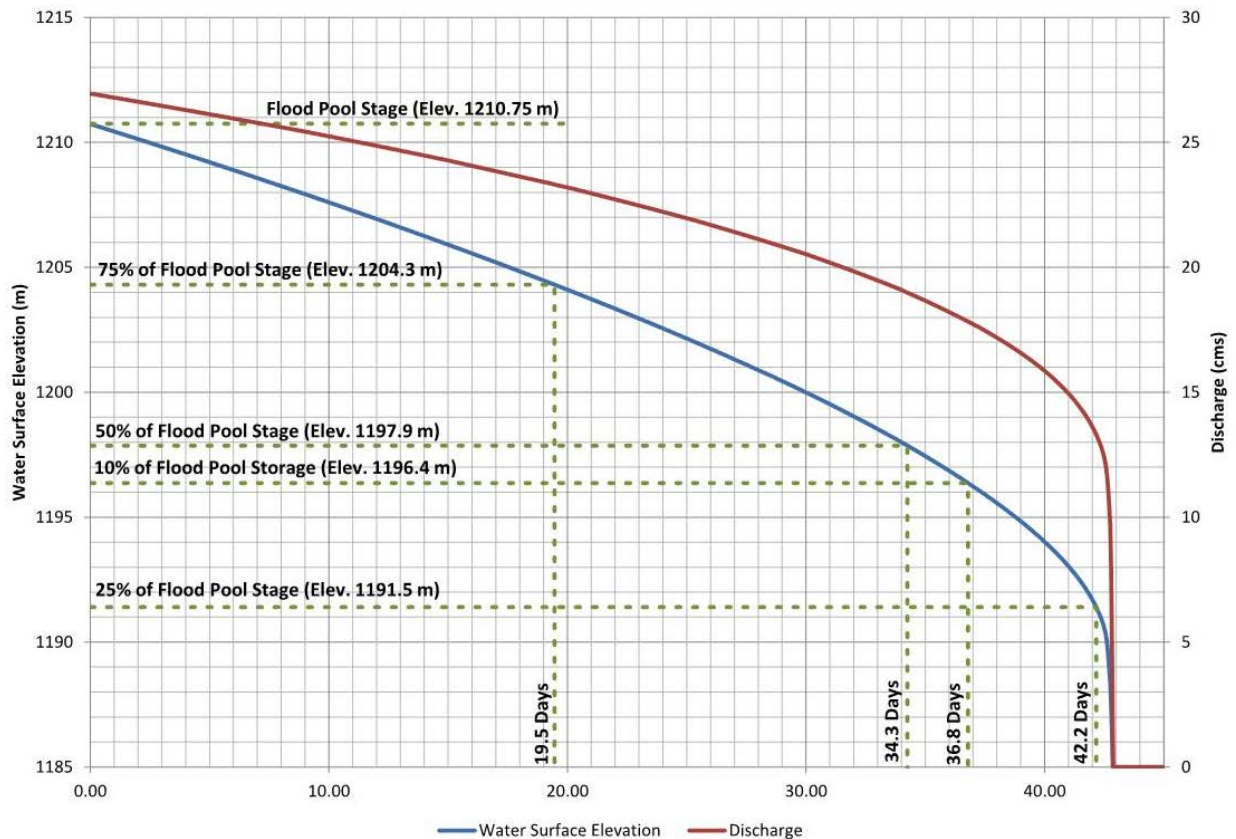
Figure IR465-1 Reservoir Drawdown from Full Service Level

Figure IR465-1 presents the drawdown rates for the off-stream reservoir with the prescribed flood pool stage identified. The blue line on the figure represents the reservoir stage over time. At each of the defined criteria stages, the elevation and drawdown time are noted. As an example, the 75% stage (El. 1,204.3 m) is achieved in 19.5 days, which meets the minimum criteria of 20 to 30 days.

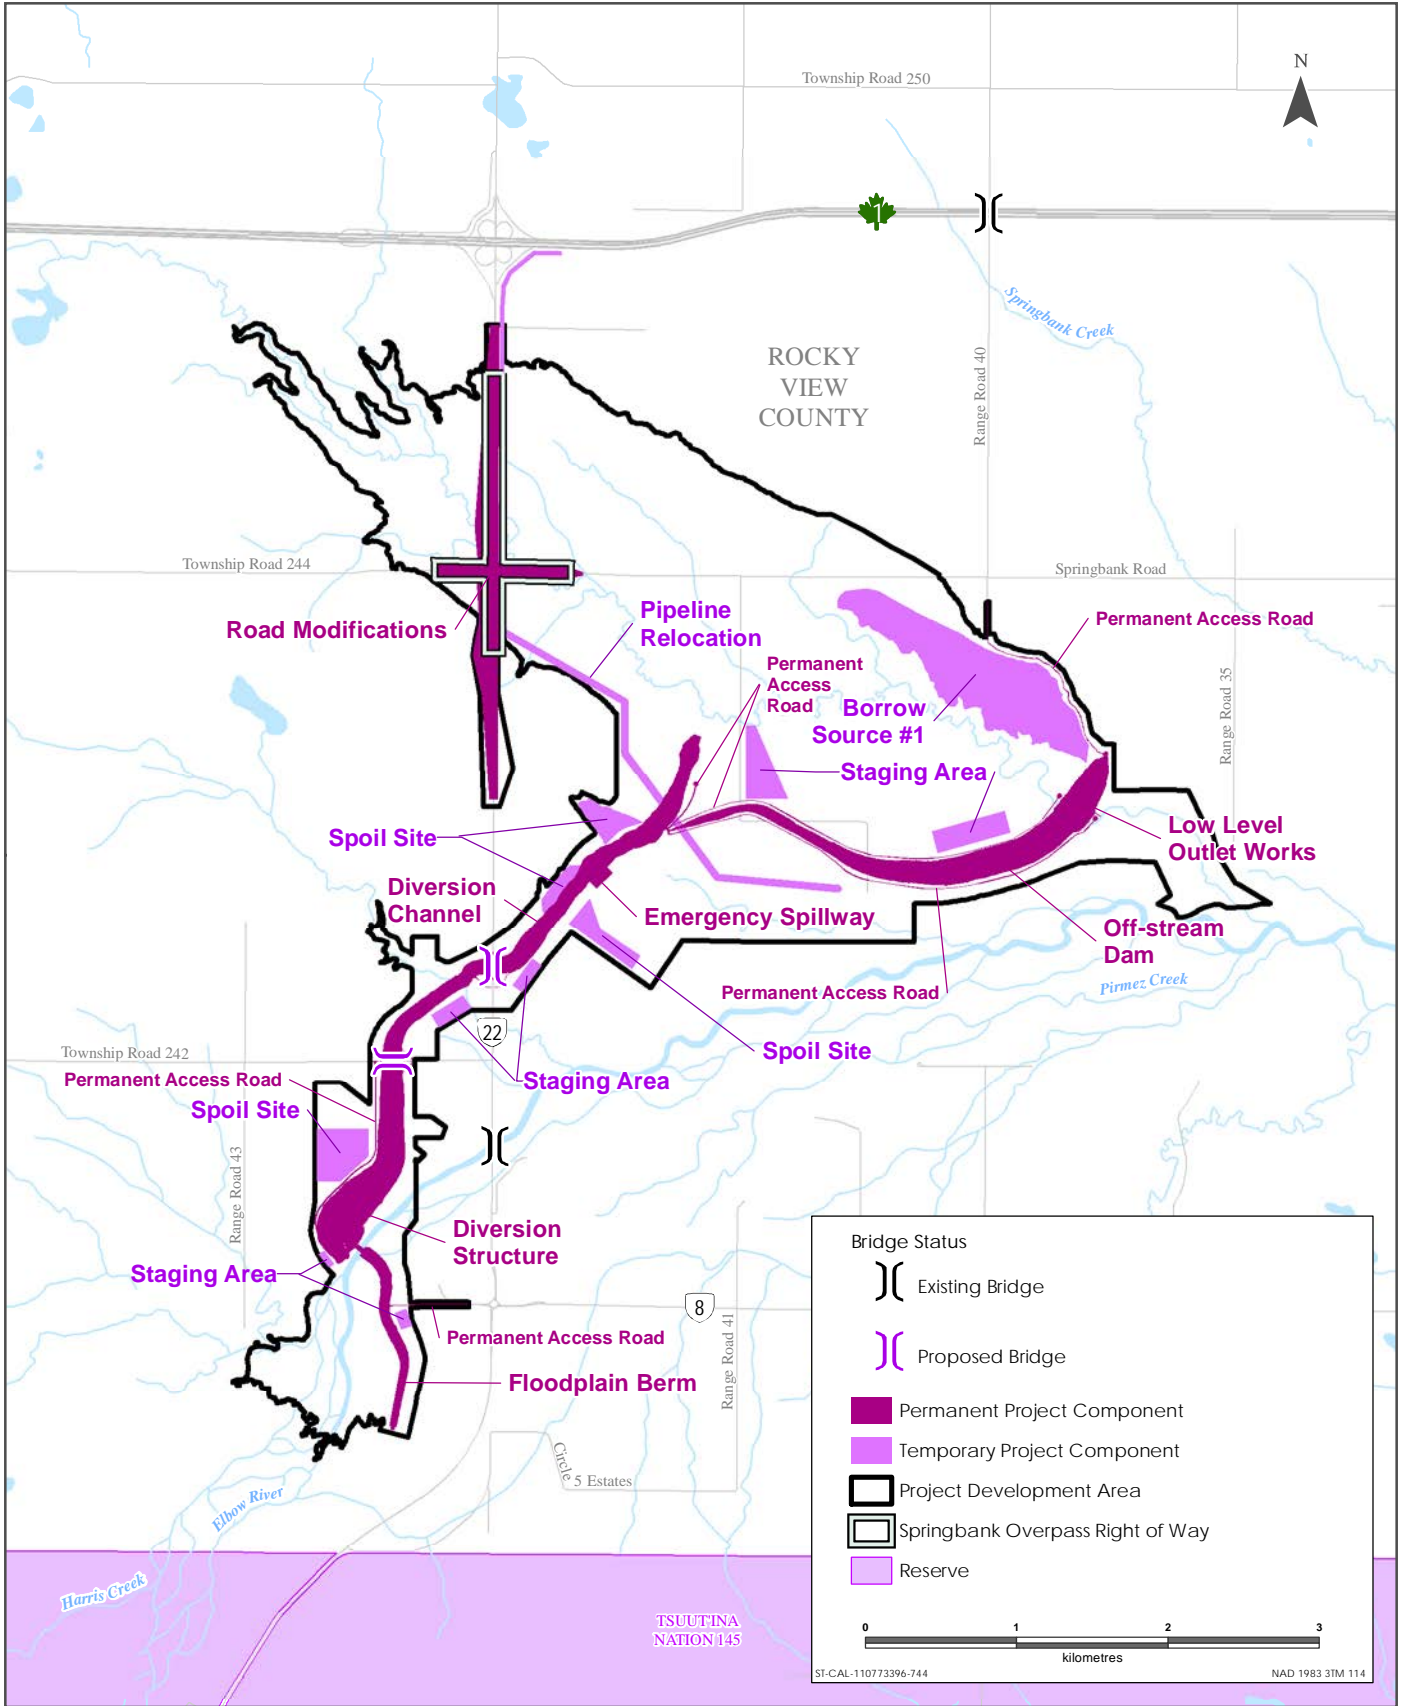
Permanent and Temporary Features of the Project

- a. The reference to Figure 3-1 is incorrect. The reference should have stated Volume 4, Appendix D, Figure 2-2. Figure IR482-1 (a duplicate of Figure 2-2) illustrates the temporary construction laydown areas (staging areas).

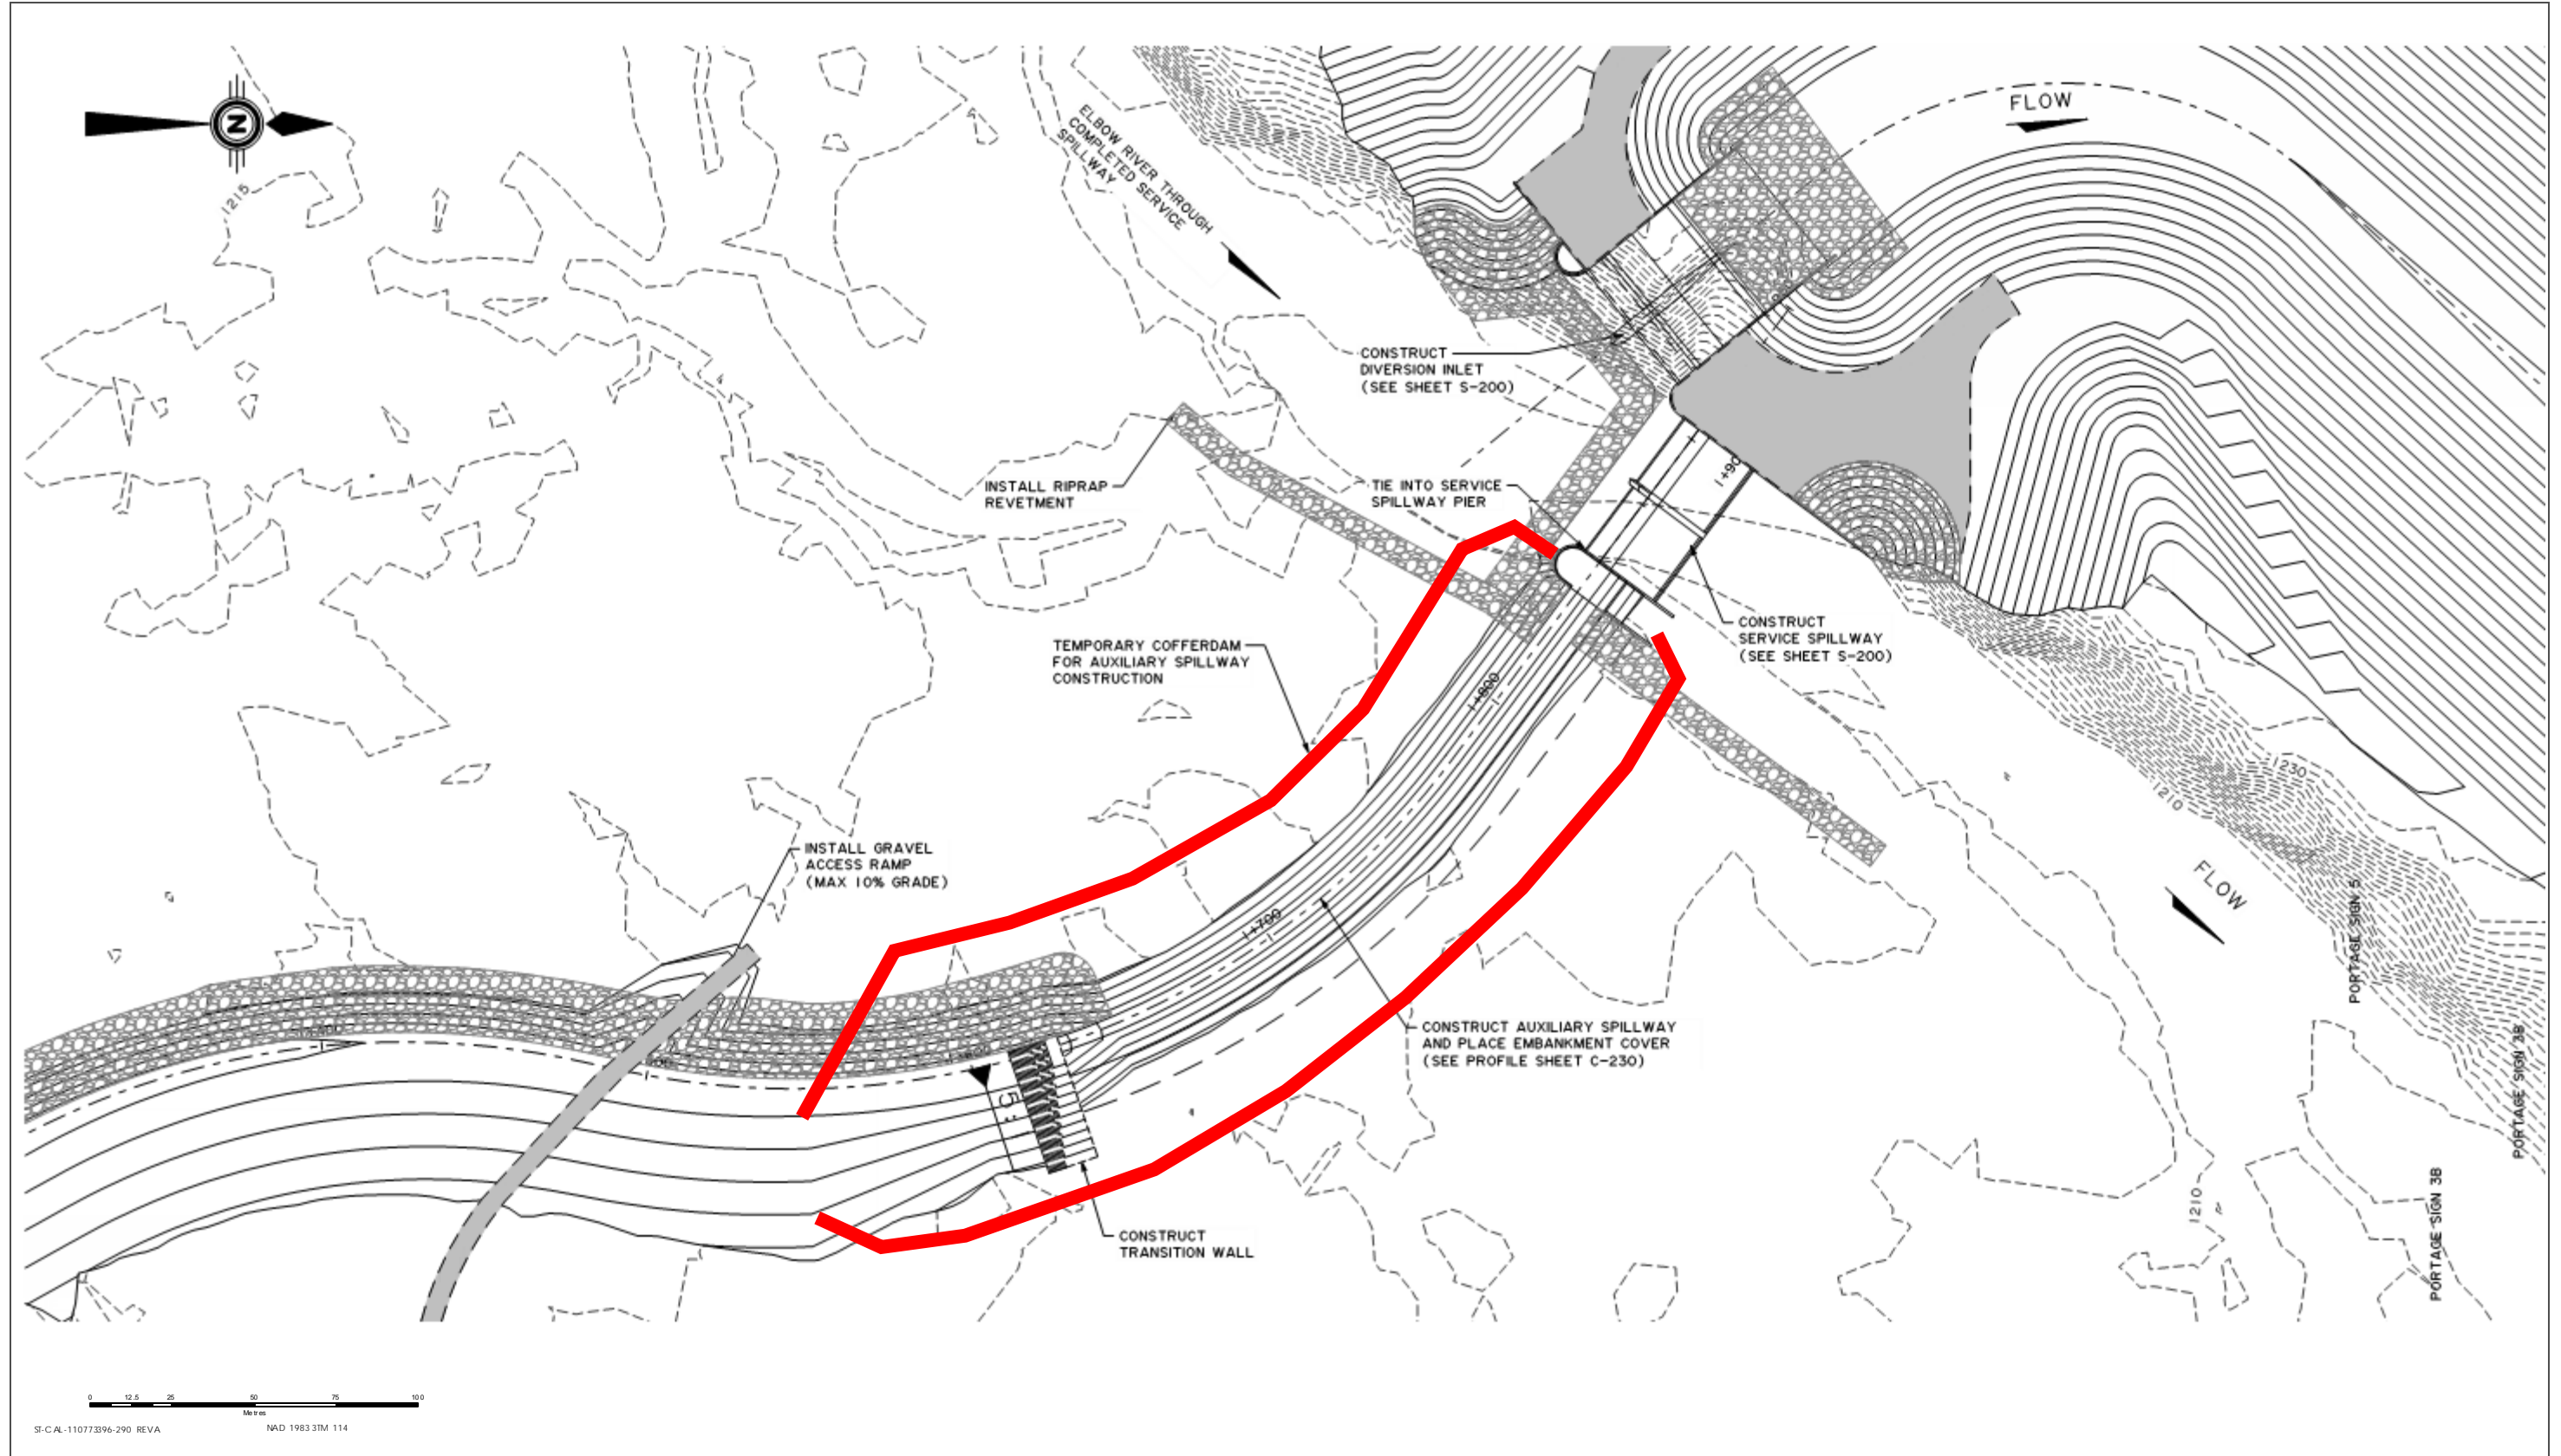
- b. Construction of the service spillway will include the right abutment pier. Following construction of the service spillway, the river channel will be re-diverted through the service spillway and the isolation works for the auxiliary spillway will tie-in with the right abutment pier, which is constructed to an elevation higher than the 1:10 year flood water surface elevation. Work within the water course is anticipated to occur within the approved instream construction windows. Figure IR487-1 provides the proposed location of cofferdams for the auxiliary spillway.

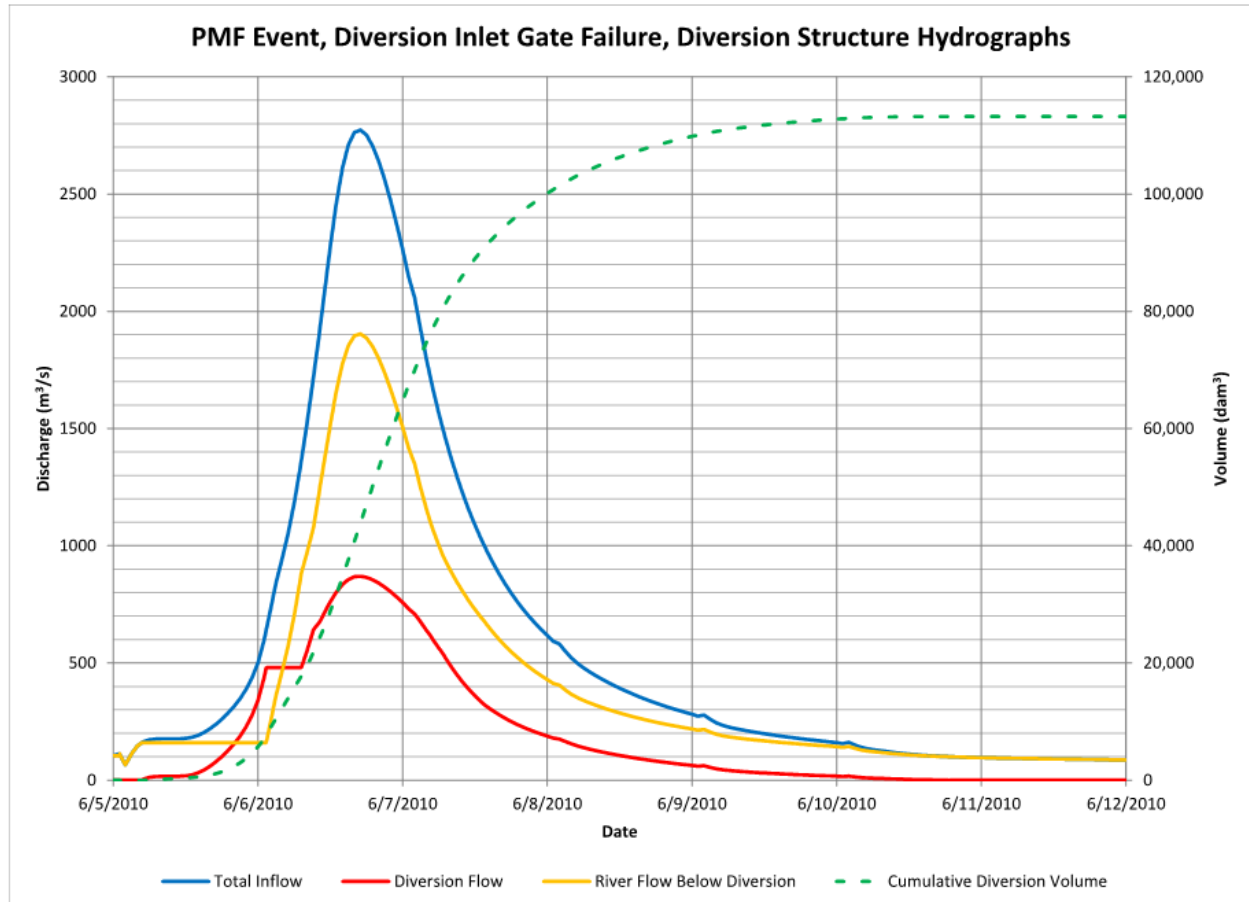
Figure IR528-1 Calculated Diversion Structure Hydrographs

Figure IR528-1 presents the calculated inflow hydrograph.

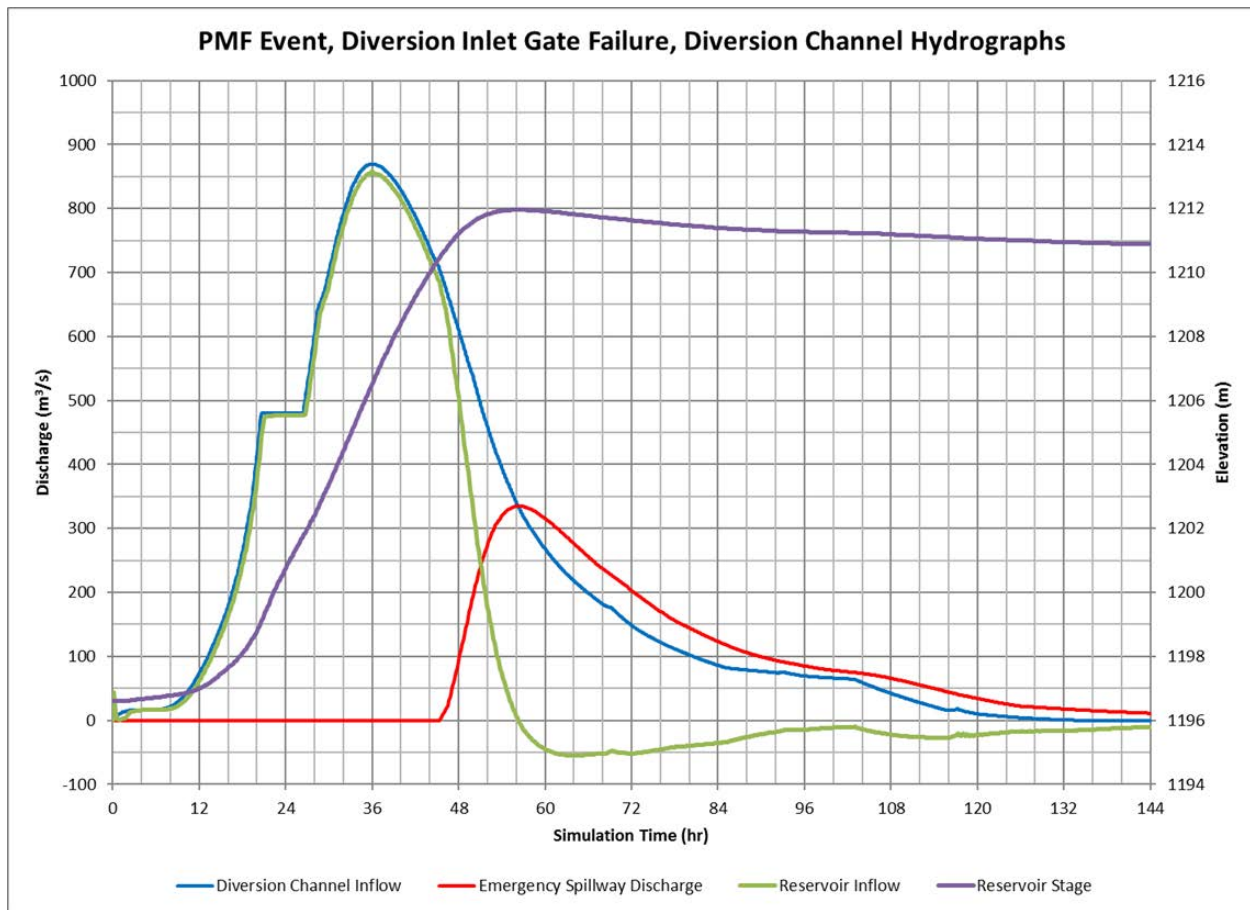
Figure IR528-2 Modelling Output for the Diversion Structure Hydrographs

The HEC-RAS model simulates the unsteady flow hydraulics of the diversion channel and the elevations of the reservoir for the calculated inflow hydrograph from the HEC-ResSim model. The emergency spillway is modelled as a lateral weir within the channel. The reservoir is modeled as a storage area at the end of the channel and provided with a stage-storage relationship. The results of the HEC-RAS model simulation are presented in Figure IR528-2.

Based on the simulation results, the maximum reservoir water level is calculated as El. 1,212 m.
