**ALBERTA TRANSPORTATION SPRINGBANK OFF-STREAM RESERVOIR PROJECT
RESPONSE TO NRCB AND AEP SUPPLEMENTAL INFORMATION REQUEST 1, JULY 28, 2018**

Physical Model Study of the Springbank Off-stream Storage Project Diversion Structure on the Elbow River

Paul Knox, Andrew Cornett, Mitchel Provan
Ocean, Coastal and River Engineering
NRC Technical Report: OCRE-TR-2016-028

December 2016

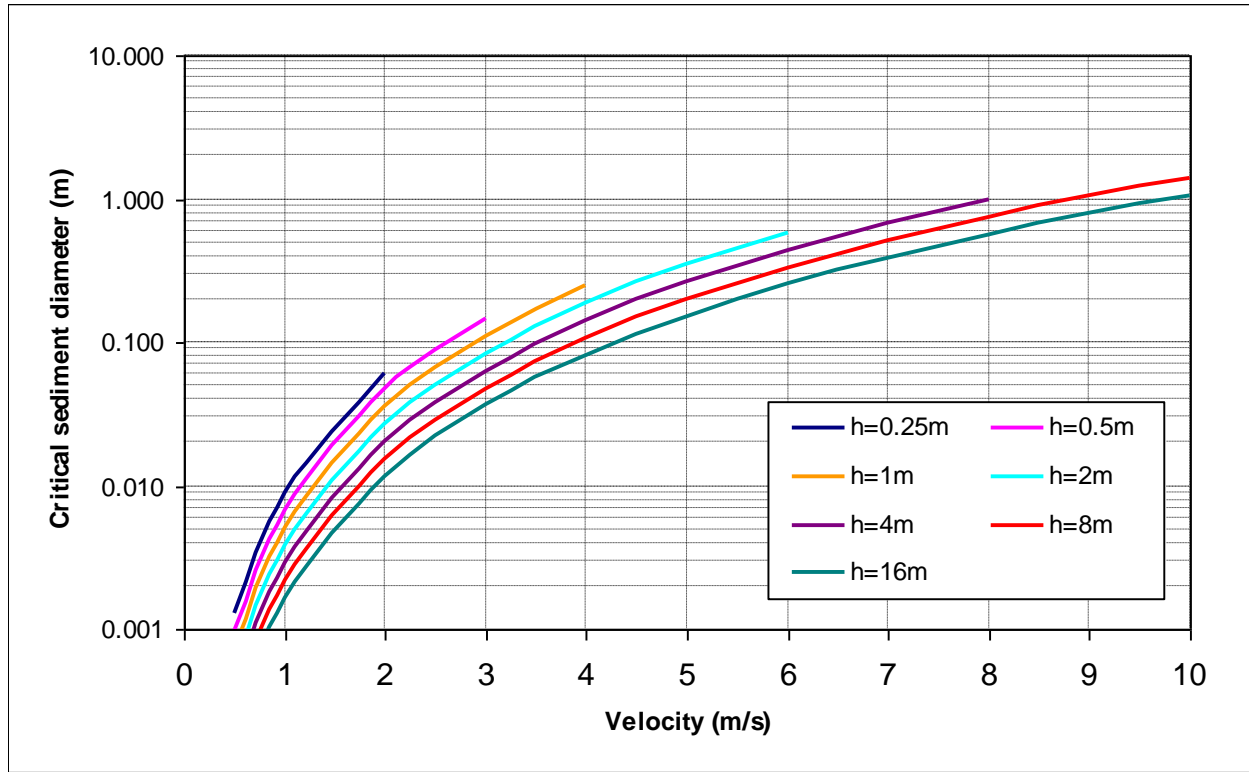
Figure 15. Threshold current speed for mobility of gravels in steady flows.

Figure 15 shows the threshold current speed plotted as a function of sediment size for various water depths. This figure can be used to guide the initial selection of riprap for a horizontal bed, once the depth averaged velocity and water depth are known. However, the reader should note that this figure does not take into account any possible flow disturbance and amplification of bed shear stress around structures such as piers, piles, caissons, sluice gates, etc. Whitehouse (1998) reports shear stress amplification factors around structures on the order of between 2 and 6. In other words, the shear stress on the bed near a structure can be up to 6 times larger than the far field shear stress. In such situations, the initial selection of riprap or armour stone should be verified through physical model tests.

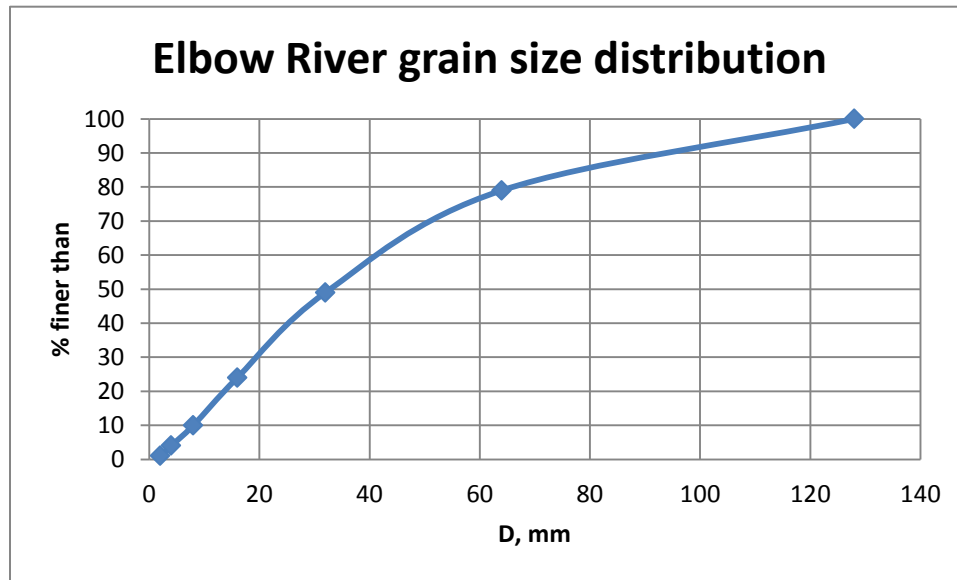
Figure 16. Typical grain size distribution at the Elbow River study site.

Stantec provided measured grain size distributions at the study site. The typical grain size distribution from these data was used as the prototype grain size distribution (Figure 16).

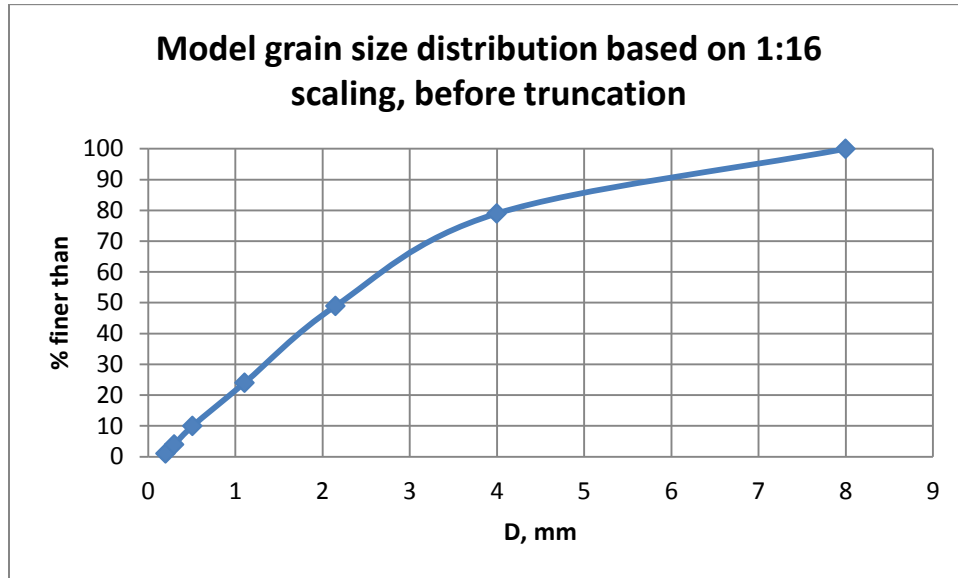
Figure 17. Model scale (1:16) grain size distribution, adjusted slightly to ensure same mobility in model as prototype based on Shields scaling.

The model scale of 1:16 was used for preliminary dimensional scaling of the bed sediments to be used for mobile bed model runs. The mobility of the 1:16 grain size distribution was evaluated based on the non-dimensional Shields criterion in both model and prototype: D^* was calculated for D_{90} , D_{50} , D_{24} , and D_{10} in both model and prototype, and hence θ_c for each fraction was calculated in model and prototype. To calculate θ_c , bed shear stress was calculated using the depth slope product ($\tau = \rho g Y S$), with S the reach average bed slope of 0.0064, and Y the flow depth during the $Q=320 \text{ m}^3/\text{s}$ flow stage ($Y_{\text{prototype}}=2\text{m}$, $Y_{\text{model}}=0.13 \text{ m}$). For the finer fractions ($D \leq D_{50}$), D_{model} was increased slightly to ensure that $[\theta_{\text{prototype}} - \theta_{c,\text{prototype}} = \theta_{\text{model}} - \theta_{c,\text{model}}]$, i.e., to ensure all fractions had the same mobility in model as in the prototype. Due to the relatively coarse bed sediments in the Elbow River, and the relatively large model scale, little adjustment was required. For example, $D_{50,\text{model}}$ was increased from 0.0020 m to 0.0022 m, and $D_{10,\text{model}}$ was increased from 0.00050 m to 0.00051 m. The resulting model grain size distribution is shown in Figure 17.

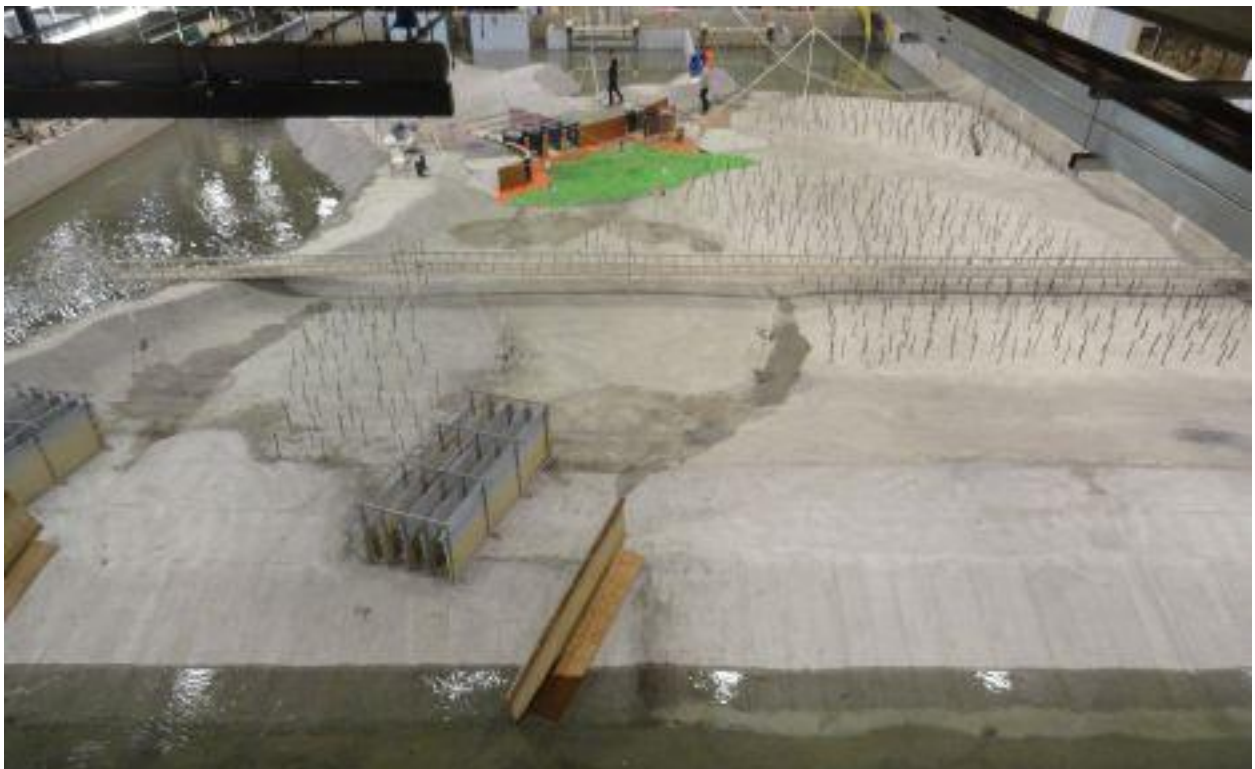
Figure 23. Photograph of the physical model after construction – looking downstream.

manner, and the model provided an excellent means of verifying the performance and optimising the design of the proposed structures, including the risks of sediment deposition and blockage due to floating debris. Scaled replicas of woody debris (logs, trees) were modelled to match debris characterisations and loading estimates provided by Stantec (see Section 3.4.4). The debris was added near the upstream model boundary and allowed to drift downstream, possibly grounding in shallows or snagging in the sluiceway or service spillway. A range of granular sediments were utilized in the model to replicate the mobility of the sediments available in the natural river bed (see Section 3.4.5). These sediments were either pre-loaded on the river bottom, or added to the flow using mechanical spreaders. The layout of the physical model is shown in Figure 20 and Figure 21 as well as the photographs of Figure 22 to Figure 26.

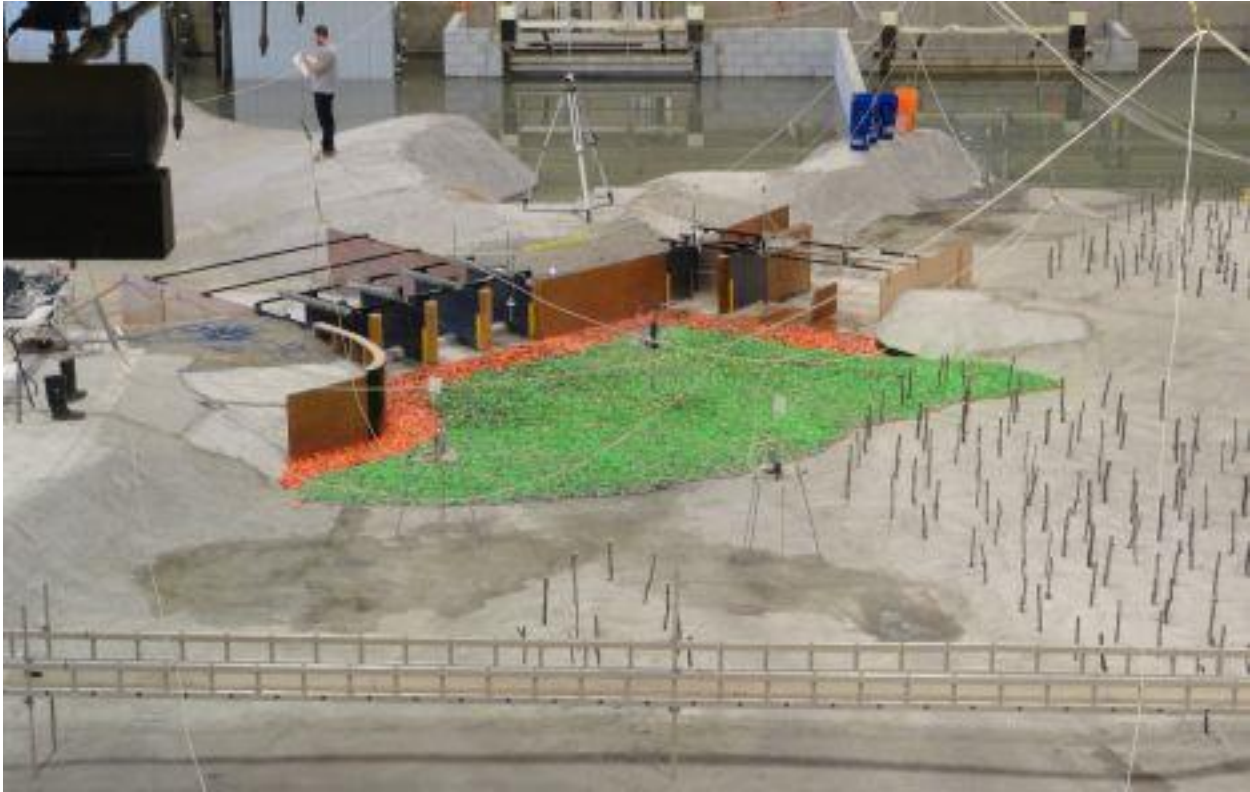
Figure 24. Photograph of the physical model after construction – looking downstream.

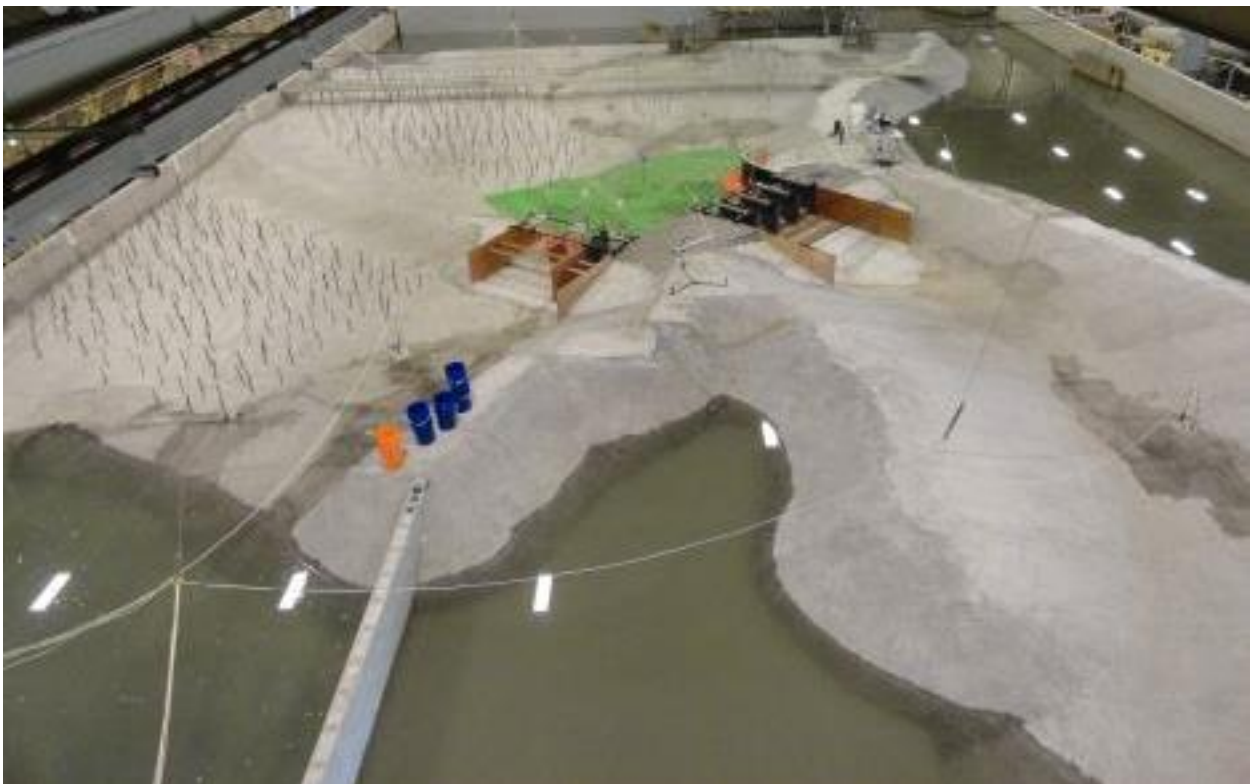
Figure 25. Photograph of the physical model after construction – looking upstream.

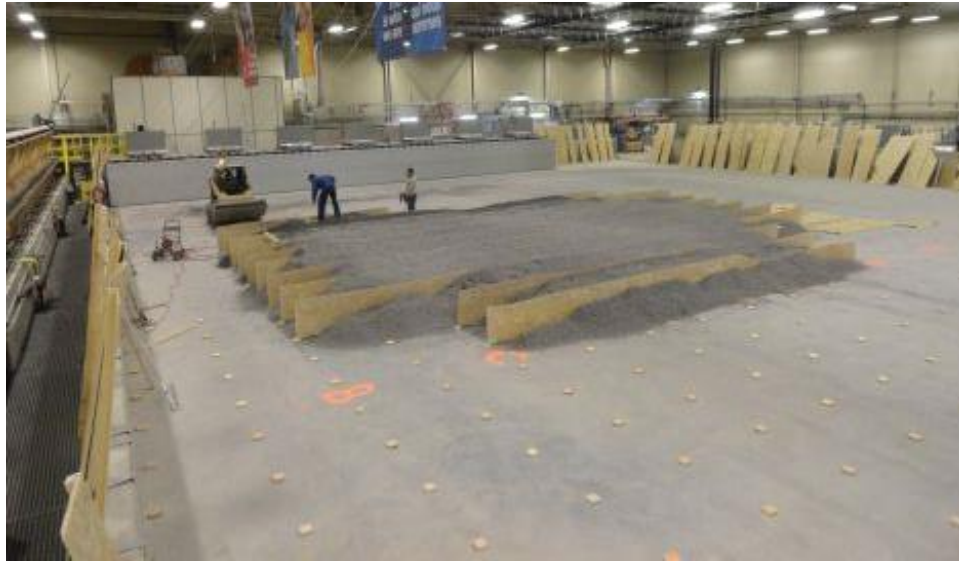
Figure 27. Fibreglass templates were erected and backfilled with fine gravel.

The concrete bathymetry was constructed using a series of fibreboard templates erected at 1m intervals (model scale, or MS) throughout the model domain. The templates, used to represent cross-sections of the riverbed, were cut to an accuracy of $\pm 2\text{mm MS}$ and were supported on the basin floor by a grid of pads leveled to within $\pm 1\text{mm MS}$. Heavy construction equipment was used to fill the templates with clear gravel once secured on top of the leveled pads. The clear gravel was then compacted with a plate tamper such that the final surface rested approximately 5cm MS below the top edge of the templates. Fine aggregate concrete was then placed on top of the gravel base and power screeded to match the elevations of the templates. Once cured, a smooth finish was achieved using a combination of hand- and mechanical-trowelling, and a roughened finish (where applicable) was achieved using a stiff broom finish on the curing concrete. Photographs showing some of the stages of the bathymetry construction are shown in Figure 27 to Figure 32.

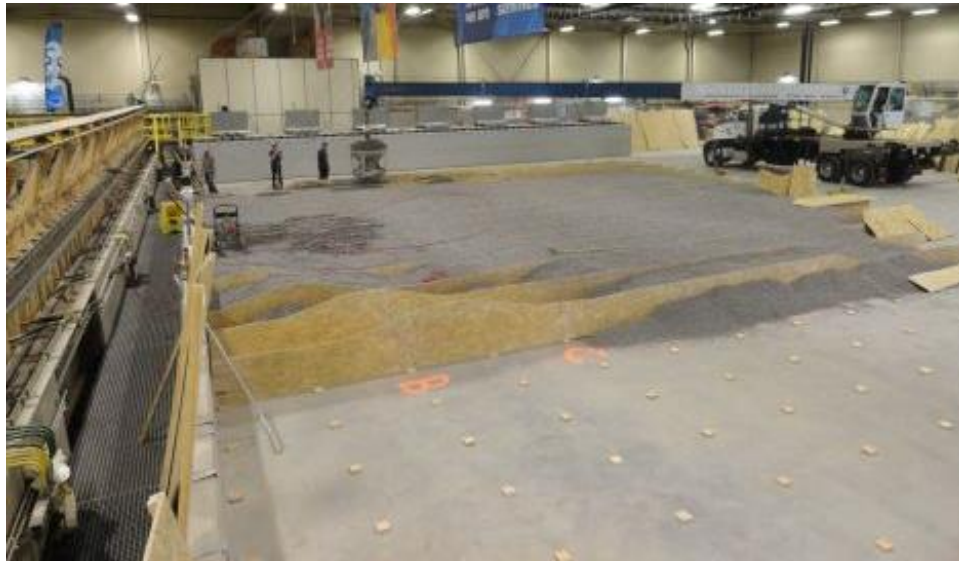
Figure 28. Heavy construction equipment was used to fill templates.

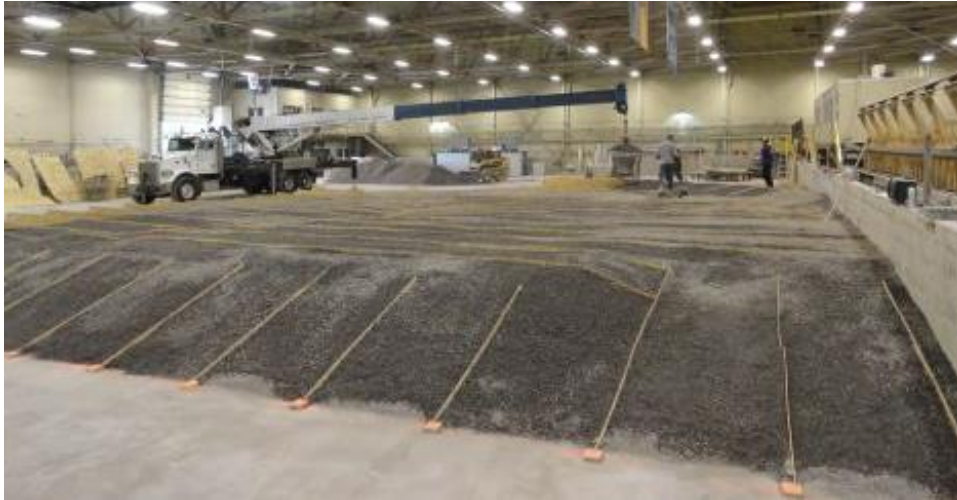
Figure 29. Heavy construction equipment was used to pour concrete.

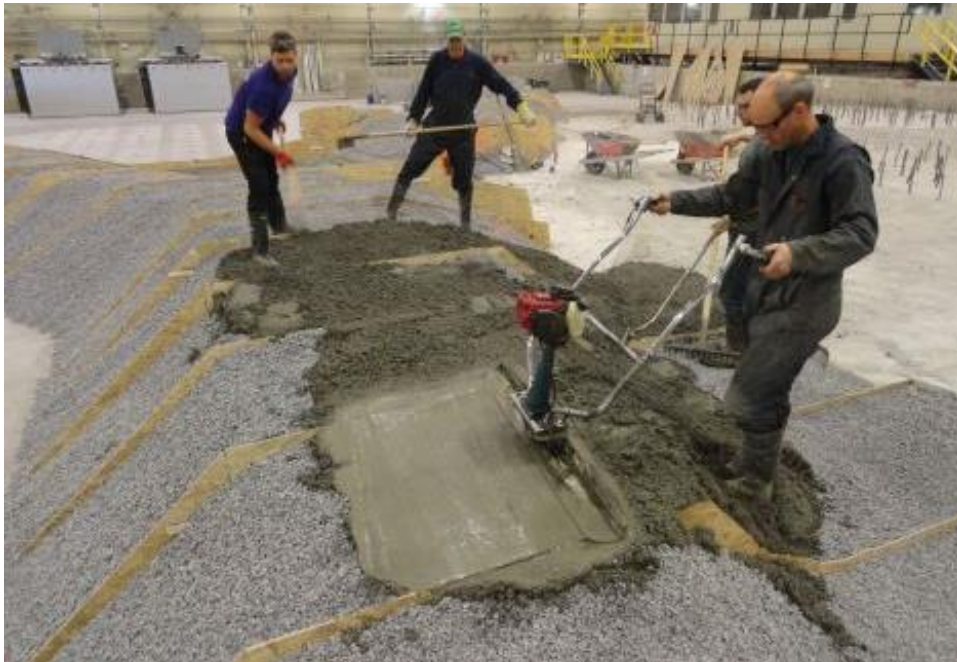
Figure 30. The concrete was screeded to match the template surfaces.

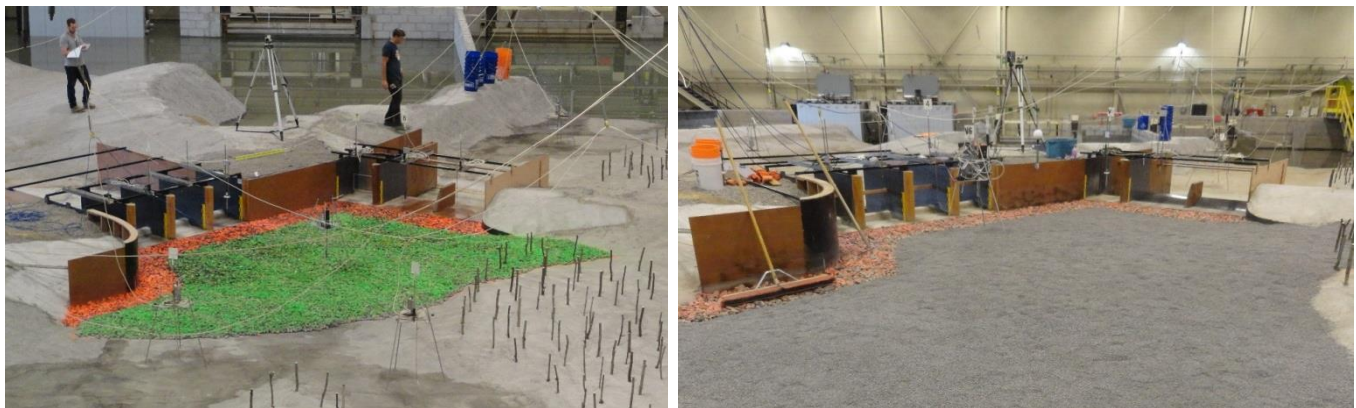
Figure 34. Left – mobile bed area of the model was filled with 210kg (green) riprap stone during clear water or debris tests. Right – model river sediments placed in the mobile bed area.

The concrete bathymetry for an area close to the diversion inlet and service spillway/sluceway was lowered to 0.5m below the actual surface level. In this area, scaled mobile river sediments were placed to investigate their mobility and the potential for erosion, scour, and accretion in the model. This mobile-bed area is shown below in Figure 33 and Figure 34. During test series where investigating sediment transport was not desired, the mobile bed area was filled with 210kg riprap stone.

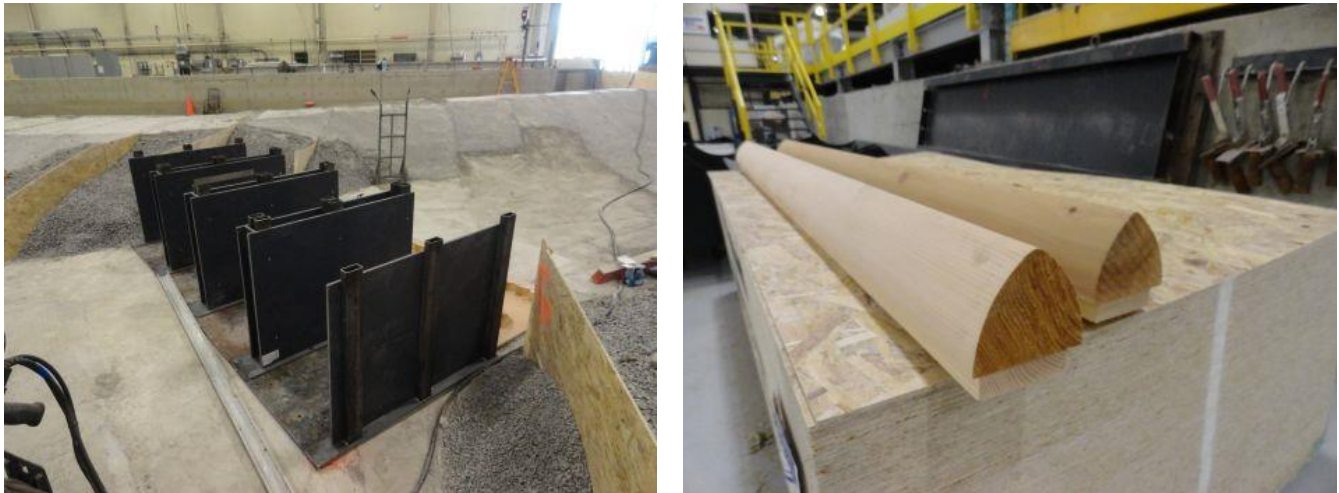
Figure 38. Left: diversion inlet pier struts and base plates installed in the basin. Right: precision milled hardwood pier noses after manufacture.

The diversion inlet structure was constructed on a $\frac{1}{2}$ " steel baseplate, and the central piers were made from hollow structural steel that was welded to the baseplate, and the piers were clad with PVC. The pier noses were precision milled from hardwood to match the prototype designs. The concrete apron of the diversion inlet was made from concrete grout, and its construction was guided by the use of a template to precisely match the profile curves. Wooden chute blocks were cut and fastened to the concrete apron of the diversion inlet apron and stilling basin. The gates for the diversion inlet were not modelled in the original design - if the model diversion inlet was to be closed, marine plywood was fastened to the back of the pier to stop the flow through the diversion inlet bays. Photographs showing some of the stages of construction for the original diversion inlet structure are shown in Figure 38 to Figure 42.

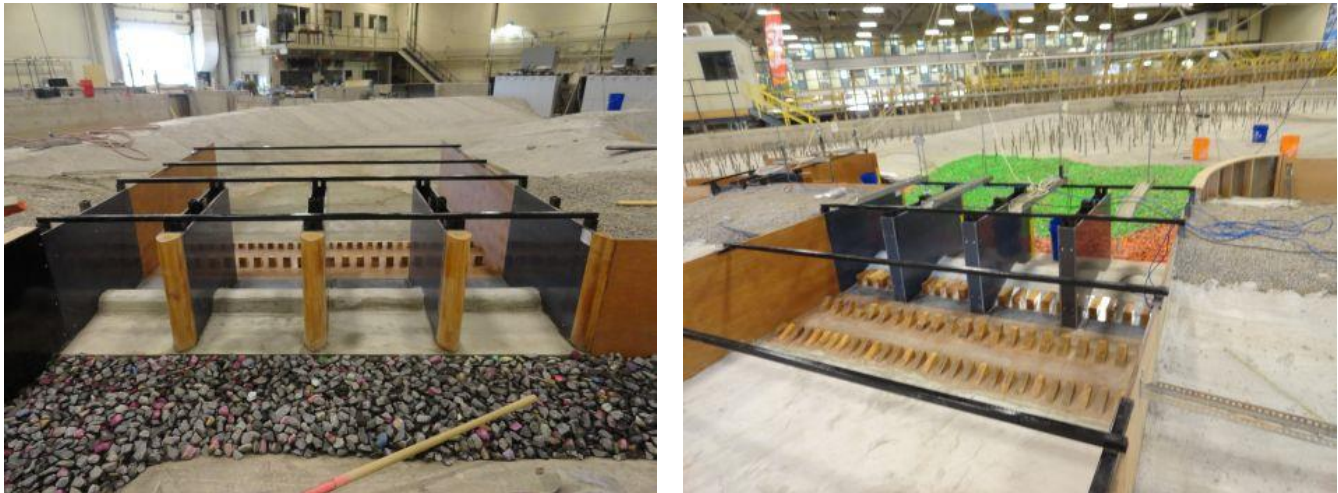
Figure 42. Left: diversion inlet looking downstream. Right: diversion inlet looking upstream (the 440kg riprap and 210kg riprap used in the mobile bed portion of the model was painted to aid in movement detection).

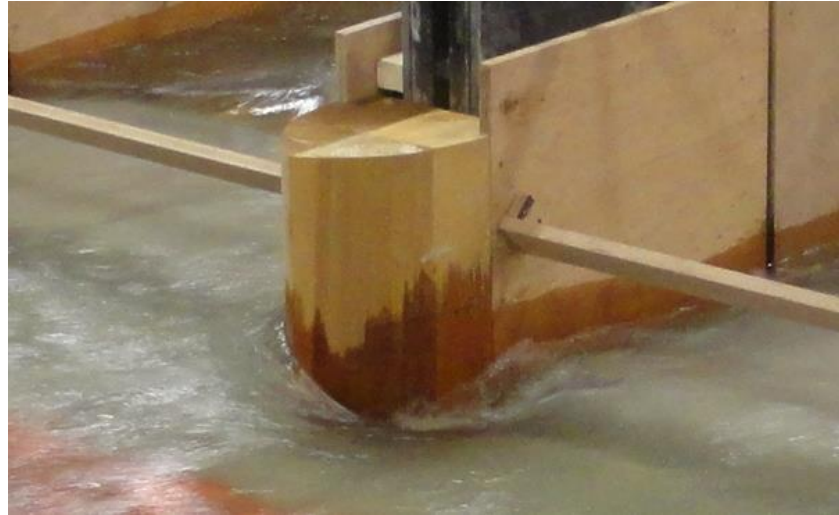
Figure 54. Pier Nose 1 design schematic and implementation in the model.

- Pier Nose 1 – curving arrowhead plan shape, apex 3.5m from the front edge of the diversion, 8m tall (see Figure 54).
- Pier Nose 2 – same curving arrowhead plan shape, apex 9.5m from the front edge of the diversion, 8m tall (see Figure 55).
- Pier Nose 3 – same curving arrowhead plan shape, adverse 1:4 slope placing the apex 8m from the front edge of the diversion inlet at the top and 6m at the bottom, 8m tall (see Figure 56).
- Pier Nose 4 – circular 1.8m diameter plan shape on the nose, 2:1 sloping profile, and was slightly shorter at 7m high off the concrete apron (see Figure 57).

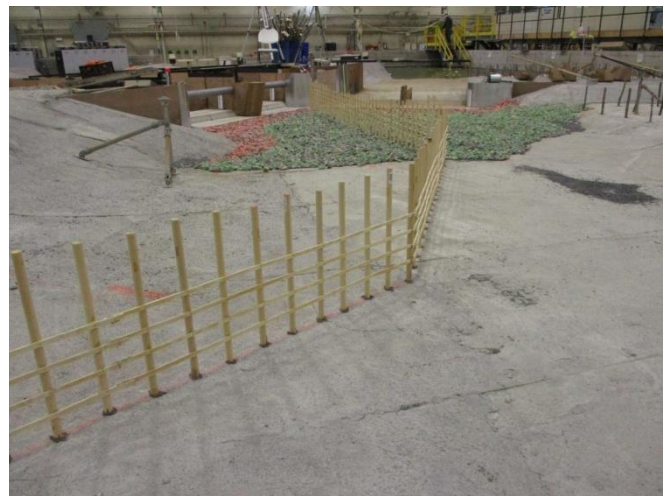
Figure 65. Debris Barrier E implementation in the model.

Debris barrier E (see Figure 63) featured three straight legs: moving from upstream, leg AB was 46m long, leg BC was 41m, and leg CD was 90m. The profile designs for the barrier are shown in Figure 64. The wall was to be made from pipe piles 300mm in diameter and spaced on 2m centers, and guide rails made from timber were to be set at elevations of 1216m, 1215m, 1214m and 1213m. These designs were replicated to scale in the model, and Figure 65 shows the barrier being constructed.

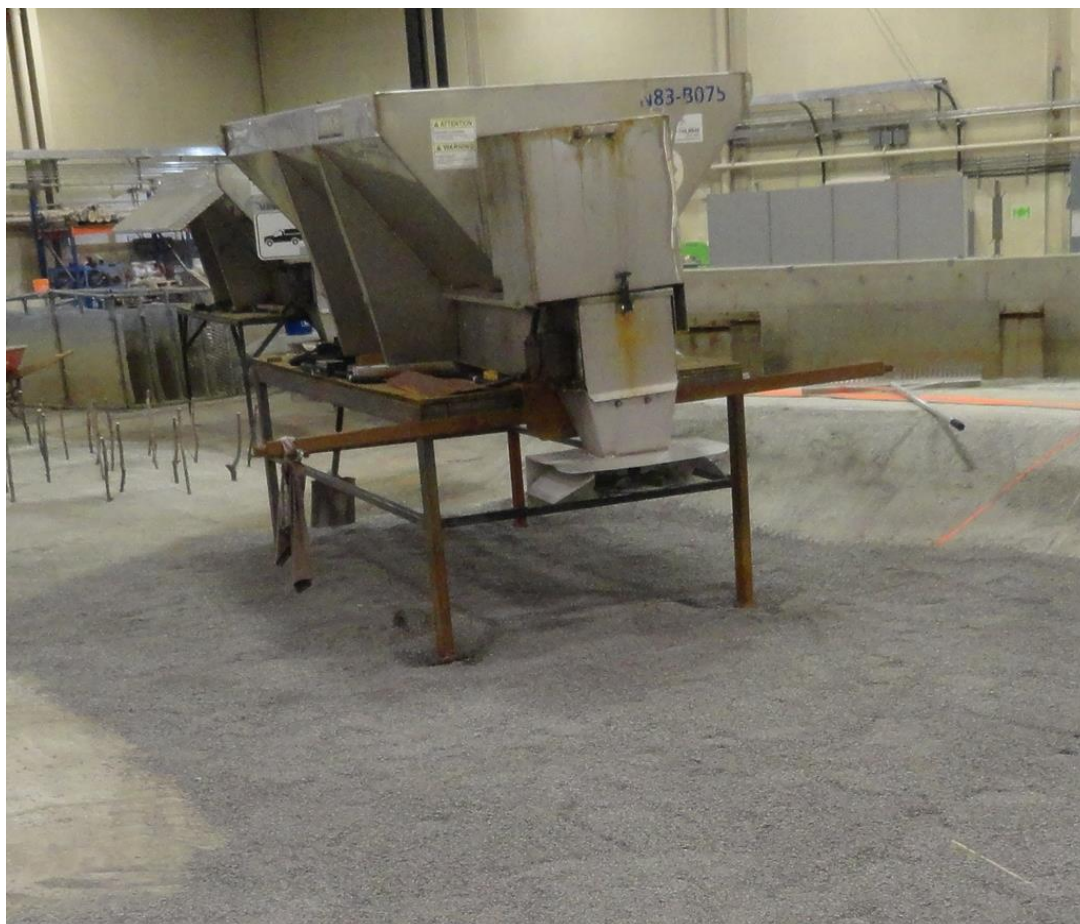
In order to match the very high sediment loads in the river, motorized spreaders were used to seed the flow with the model sediment (refer to Section 3.2.3 for the model sediment scaling). The spreaders were borrowed from the City of Ottawa (they are normally used to spread road salt) and mounted on steel support frames. Three different spreaders were used for this study and were given the following names: battery spreader, 3360 spreader and B750 spreader (shown in Figure 71). The loading rate of each spreader was calibrated prior to testing to match the sediment loading rates provided by Stantec. The calibration process included filling a spreader with a known quantity of sediment and running the spreaders until they were empty. The spreader motor and conveyor belt did not have a throttle, so the delivery rate was adjusted via the gate opening (small, medium or large) at the end of the conveyor. The delivery rates for all three spreaders for the various gate openings are shown in Table 2. Based on the calibration results the spreaders had loading rates ranging from 280 kg/s to 1800 kg/s (full scale).

Figure 71. Rock Spreader B075.

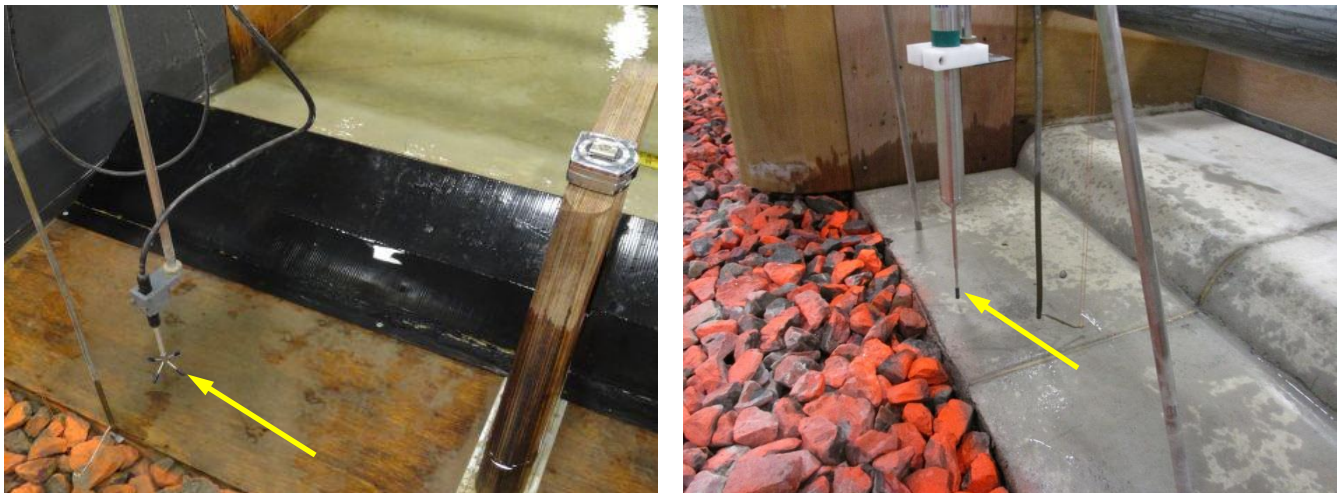
Two different types of instruments were used to measure velocities within the model, four 2-axis electromagnetic current meters developed by Alec Technologies and two 3-axis acoustic Doppler velocimeters made by Vectrino (ADV's) were utilized (see Figure 79). The height of the current meters above the river bottom was adjusted to be mid-depth for each flow condition. However the ADV sensors require 5cm (model scale) depth below the sensor for accurate readings, therefore they were not used during some of the lower flows since the depths were insufficient.

Figure 79. Three-axis acoustic Doppler velocimeter (left) two-axis electromagnetic current meter (right).

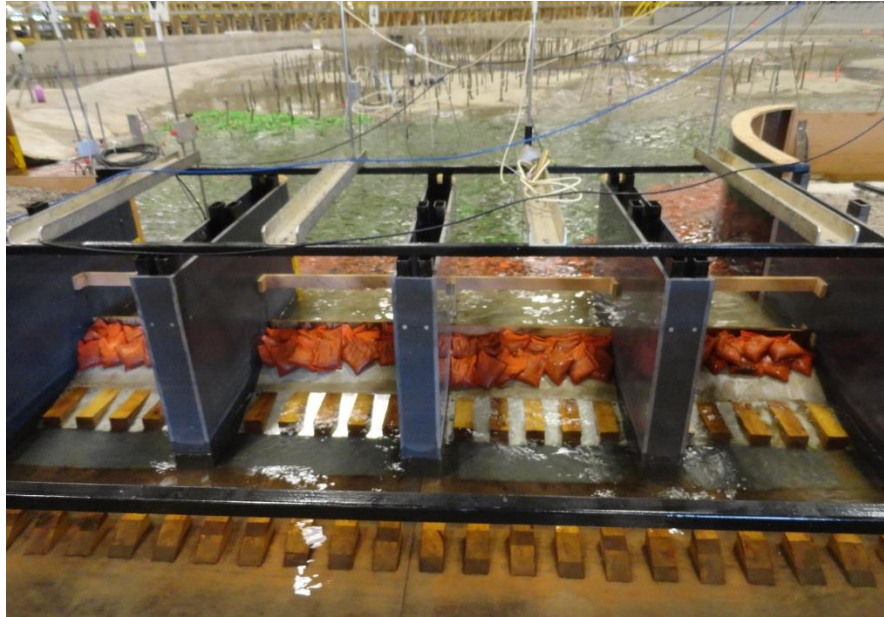
Figure 84. Blockage of the diversion channel inlet for $160 \text{ m}^3/\text{s}$ flow condition.

Similar to the $60 \text{ m}^3/\text{s}$ flow condition, the intention for the $160 \text{ m}^3/\text{s}$ flow condition was to have the entire $160 \text{ m}^3/\text{s}$ flow pass through the sluiceway and service spillway. Instead of modelling the diversion inlet gates, the flow through the diversion inlet was blocked by inserting wooden slats and sandbags into each bay opening (as shown in Figure 84).

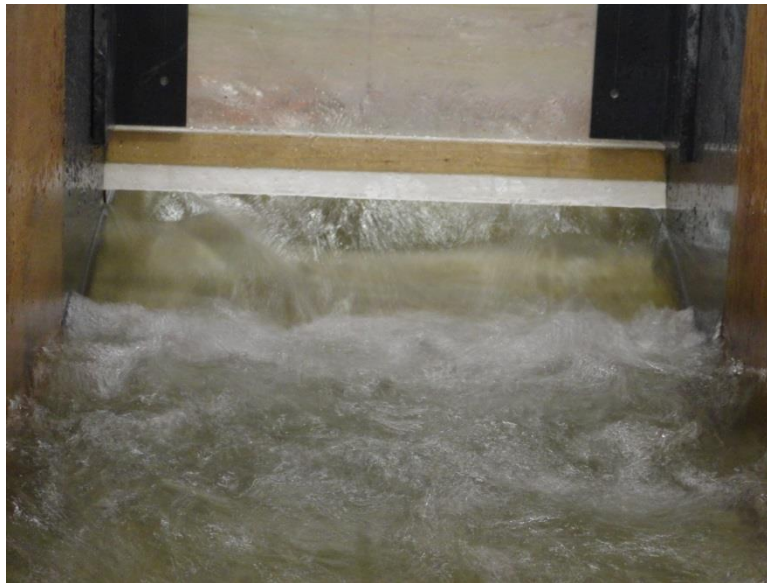
The gate settings specified by Stantec for the 320 m³/s flow condition were intended to divert 160 m³/s through the diversion channel, with the remainder passing through the service spillway to the downstream river channel. The measured flow split in the model was close to the intended targets, with 165 m³/s passing through the diversion inlet structure and 156 m³/s flowing through the service spillway/sluiceway. It was observed during testing that the sluiceway gate setting provided by Stantec (1212.1 m) did not have an influence on the flow travelling through the sluiceway. Even though the water level approximately 12m upstream of the sluiceway gate was measured at 1212.76 m (WP7), the flow accelerated substantially as it entered the sluiceway and the local water level

decreased accordingly. This allowed the flow to travel below the sluiceway gate without touching it, as shown in Figure 86 below.

Figure 86. Unobstructed flow passing under the sluiceway gate ($320 \text{ m}^3/\text{s}$).

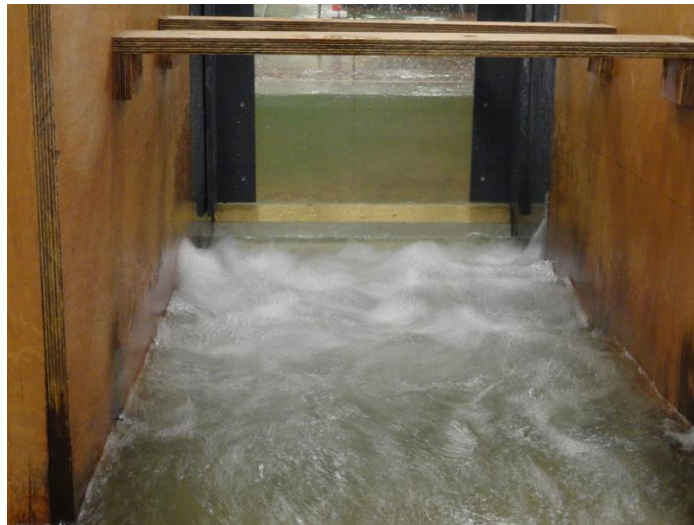
The sluiceway gate was set at an elevation of 1210.7 m, which created approximately 4.7 m of head on the upstream side of the sluiceway gate (see Figure 89). An uneven flow distribution was observed flowing over the Obermeyer gates within the service spillway. The left hand side of the service spillway appeared to be passing more flow compared to the right hand side. This imbalance in the service spillway flow distribution may be a result of the recirculation zone that was observed near the curved wall on the RHS of the service spillway.

Figure 89. Supercritical flow passing under the sluiceway gate viewed from downstream (with approximately 4.7 m of head on the upstream side of the gate).

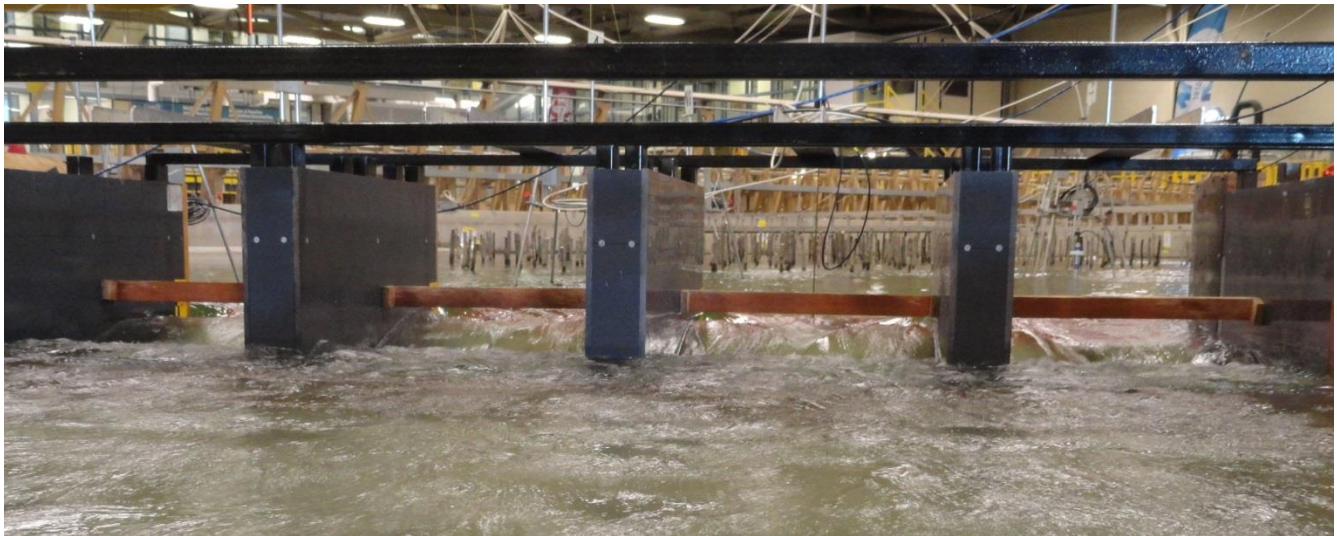
The flow through the four diversion inlet bays was more evenly distributed for this condition compared to the 320 m³/s flow scenario. The hydraulic jumps downstream of the diversion inlet gates all appeared relatively uniform in strength and location, as shown in Figure 90.

Figure 90. Turbulent flows downstream of diversion inlet gates.

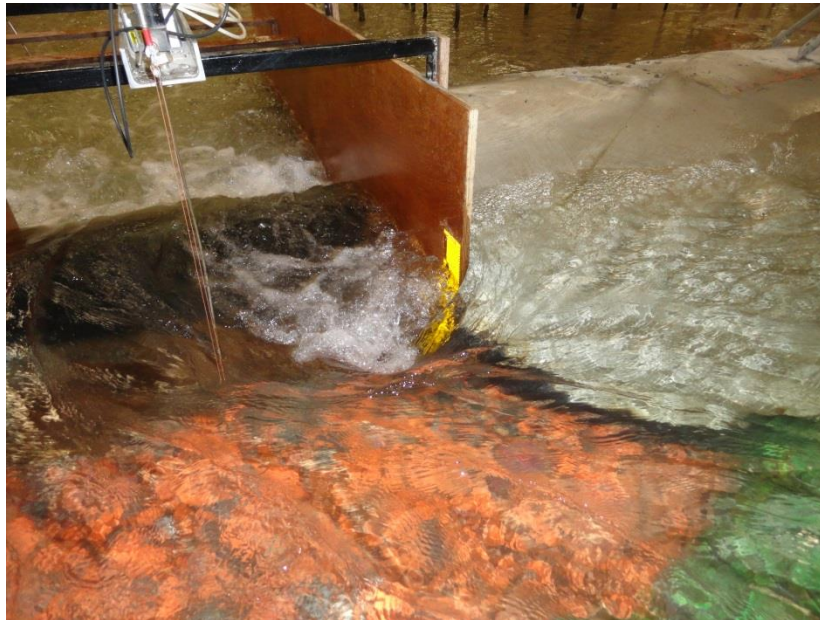
For these conditions the water level was slightly lower in the RHS of the service spillway than in the LHS, suggesting lesser discharge passing through the RHS. This was due in part to the flow recirculation caused by the flow spilling over the curved RHS retaining wall /abutment. The upstream flow travelling roughly parallel to the floodplain berm would accelerate in wrapping around the upstream end of the RH side wall, creating a zone of flow recirculation beside the RH side wall (see

Figure 92). Some rip-rap was displaced below the zone of local flow acceleration and recirculation, near the interface between the rip-rap and the concrete apron.

Figure 92. Local flow acceleration and recirculation at the right hand side of the service spillway.

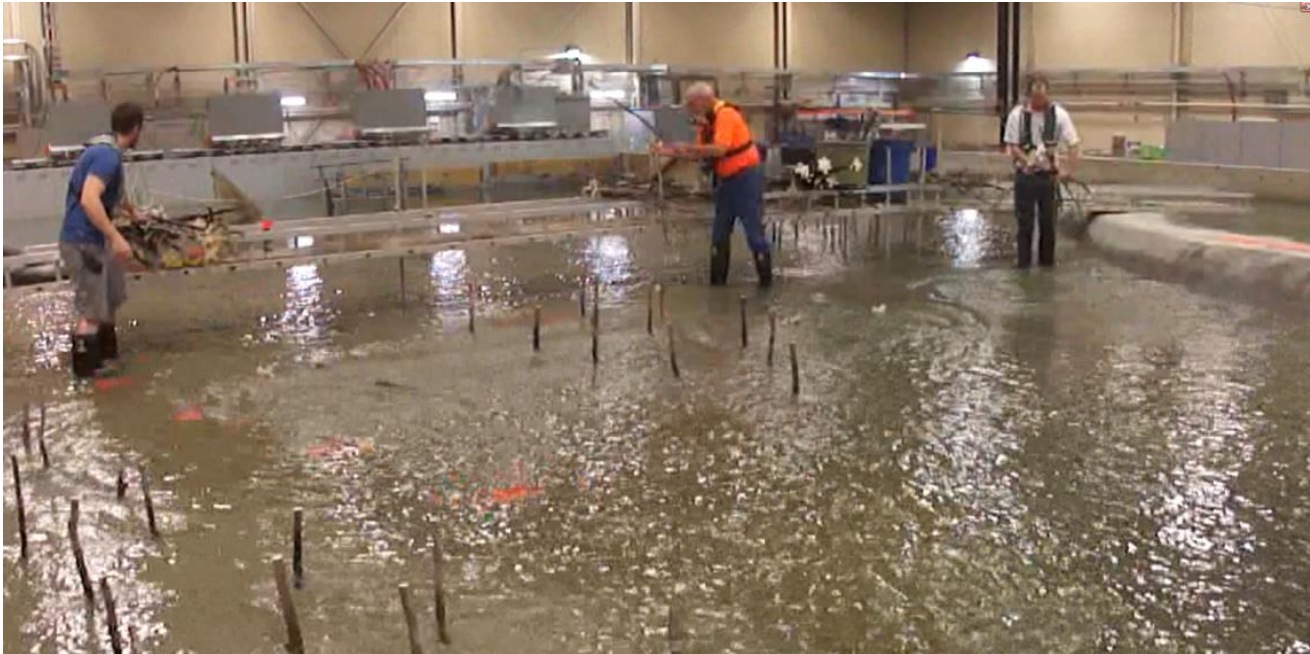
Figure 94. Debris loading locations for 100 trees in 60 seconds.

Test series B (TSB) investigated the interaction of water-borne woody debris with the two flow control structures, for both the 760 m³/s and 1240 m³/s flow conditions. The test program for TSB is summarized in Table 5. One set of gate settings was modelled with the 1240 m³/s flood (the same settings modelled in TSA), while two different gate settings were studied with the 760 m³/s flood. In one case the same settings modelled in TSA were used, while for the second case, the situation in which the service spillway Obermeyer gates were lowered to 1211.8 m (the setting used with the 1240 m³/s flow condition) was modelled. Model scale woody debris simulating uprooted conifer trees was introduced into the upstream flow at specific locations and the interaction of the debris with the structures was observed and recorded. The model debris was introduced in several ways: as individual trees released in series, as small rafts comprised of 10 trees arranged in random patterns, and as larger rafts comprised of 40 model trees arranged randomly. The final step in each debris test was to load the model with numerous model trees (approximately 100 trees in 60 seconds) released in three locations (main channel, secondary channel and a point between the two; see Figure 94).

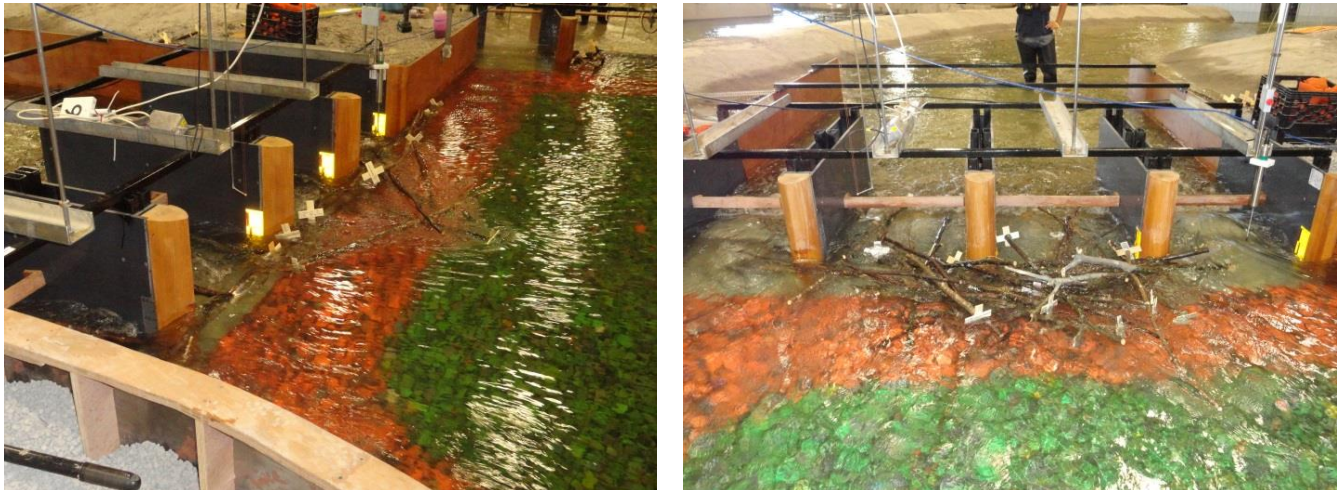
The debris generally followed the streamlines that had been mapped out using drogues and dye during test series A. Single trees were able to pass through the diversion inlet bays as long as they were oriented with the flow. Since the width of each diversion inlet bay was less than the length of the trees, the trees tended to catch on the piers whenever they approached a diversion inlet bay sideways. Trees with a root ball were more frequently caught than trees without root balls. Individual trees would sometimes rotate around the point of contact and then pass safely through the diversion. In other cases, the trees would end up spanning the width of the bay between two adjacent piers. Once one tree was caught on the piers it caused a snowball effect and the single tree would catch multiple trees regardless of their orientation (see Figure 95). Most of the trees in the larger rafts were caught on the piers with only a few individual trees passing through the diversion inlet bays.

Figure 95. Single trees (left) and a 40-tree raft (right) caught on the diversion inlet piers.

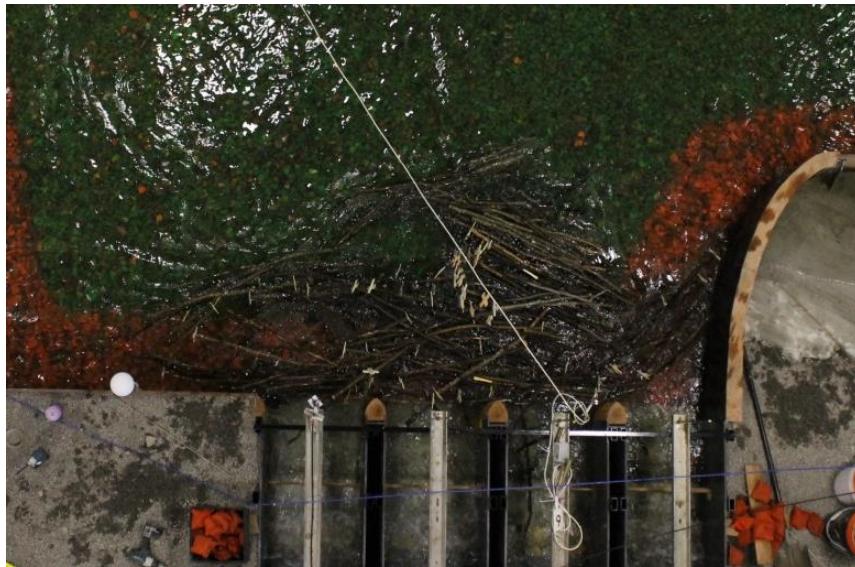
In the last debris test conducted for this flow condition, 122 trees were released into the upstream flow at a steady rate over 72 (model scale) seconds. Initially, some of the trees passed through the diversion inlet bays as long as they were aligned with the flow. However, once a single tree caught on the piers it trapped the majority of the following trees causing a large raft to form in front of the piers. Of the 122 trees released, 20 trees passed through the diversion inlet bays, while 102 were retained on the diversion inlet piers (16% passing rate). A further 80 trees were added to the existing debris raft/jam to create a large debris raft comprised of approximately 180 trees (see Figure 97). This large debris raft/jam decreased the flow through the diversion channel by approximately $100 \text{ m}^3/\text{s}$ (~18% reduction).

Figure 97. Debris jam of approximately 180 trees.

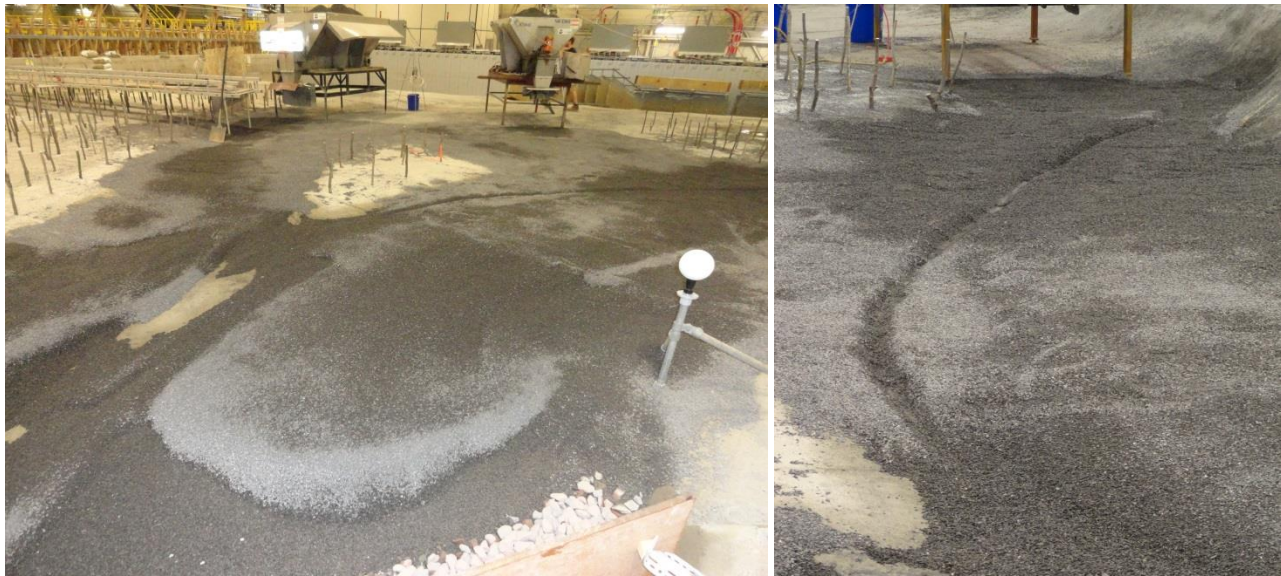
In preparation for the next experiment with 1240 m³/s discharge, the structure gates were configured as described in Section 5.1.5. Some of the sediment that was deposited in the upstream river channels during the previous test was removed and a quasi-uniform sediment preloading condition was restored (see Figure 114). The sediment in the forebay area was not touched. As before, a small “pilot channel” was formed in the bed of the main (left) upstream flow channel.

Figure 114. Initial upstream mobile bed conditions prior to the 1240 m³/s flow condition.
