**ALBERTA TRANSPORTATION SPRINGBANK OFF-STREAM RESERVOIR PROJECT
RESPONSE TO NRCB AND AEP SUPPLEMENTAL INFORMATION REQUEST 1, JULY 28, 2018**

Physical Model Study of the Springbank Off-stream Storage Project Diversion Structure on the Elbow River

Paul Knox, Andrew Cornett, Mitchel Provan
Ocean, Coastal and River Engineering
NRC Technical Report: OCRE-TR-2016-028

December 2016

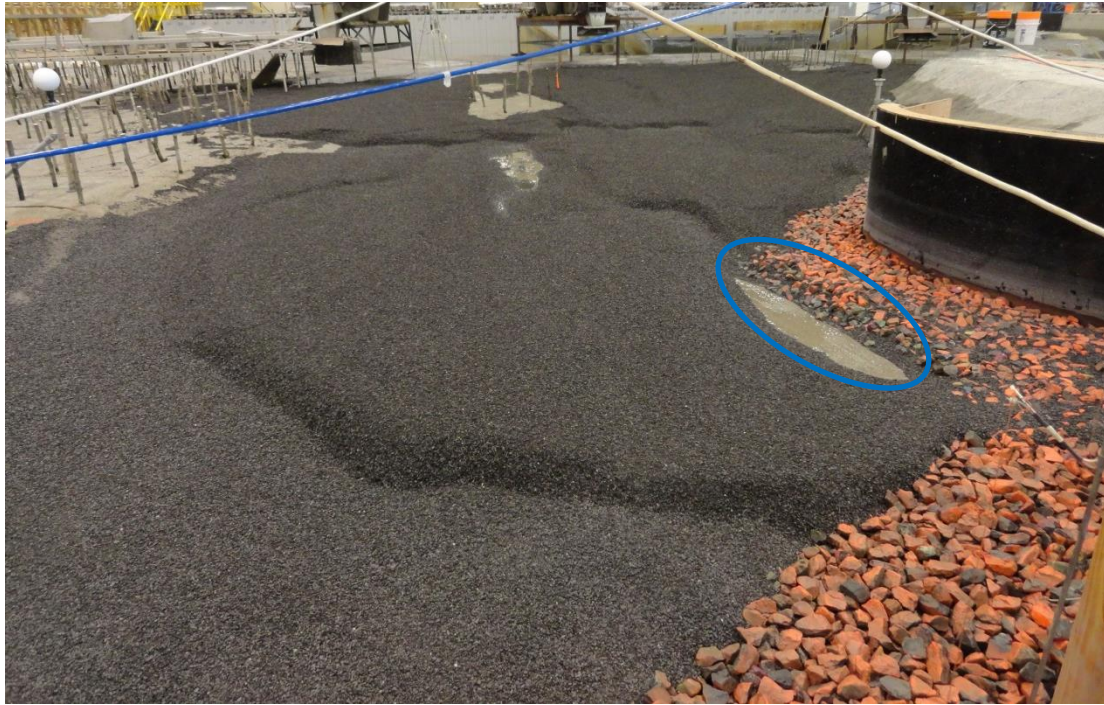
Figure 115. General view of the mobile bed in the forebay area after the 1240 m³/s flow condition (new scour hole highlighted).

Figure 115 shows the general condition of the riverbed in the forebay area at the end of testing. During the most recent test a sizeable new scour hole was formed beside the edge of the riprap apron protecting the toe of the curved guide wall on the LHS of the diversion inlet structure (see Figure 116). Some of the sediment eroded from this scour hole was deposited on the surrounding riprap apron, while a small quantity was also transported to the downstream side of the diversion inlet structure. The riprap itself did not appear to have been damaged in this area. While the riprap remained stable at the diversion inlet structure, the 1240 m³/s flood was able to dislodge approximately eighteen 440 kg stones from the riprap on the RHS of the service spillway structure, forming a scour hole in that location, see Figure 117. The 1240 m³/s flow condition was the only flow condition that transported any appreciable quantity of sediment through the two structures; however, the volume

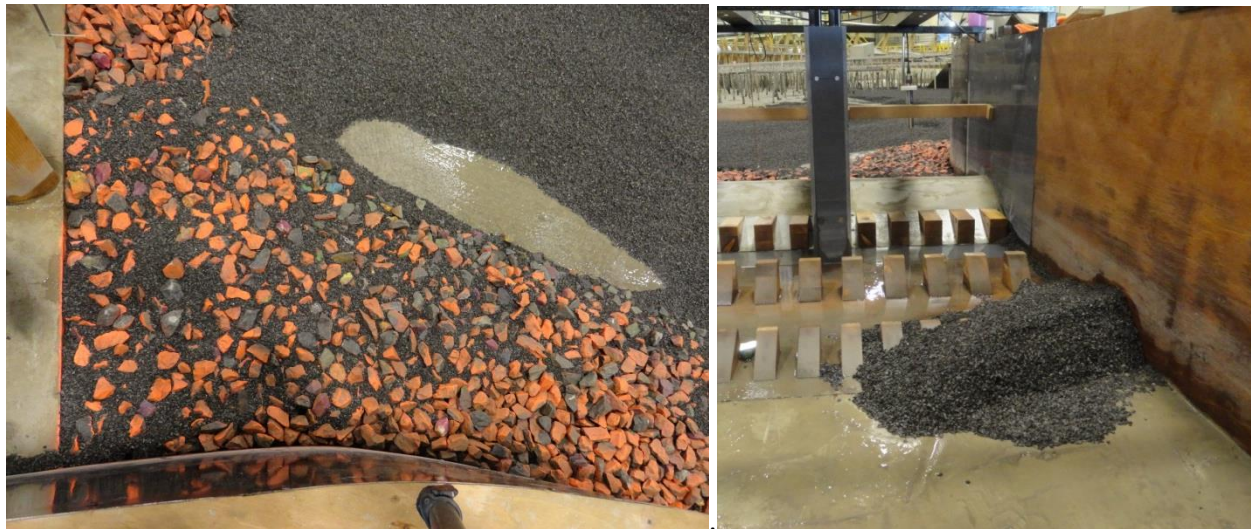
Figure 116. Scour hole on the upstream side of the diversion inlet structure (left) and corresponding sediment deposition on the downstream side (right).

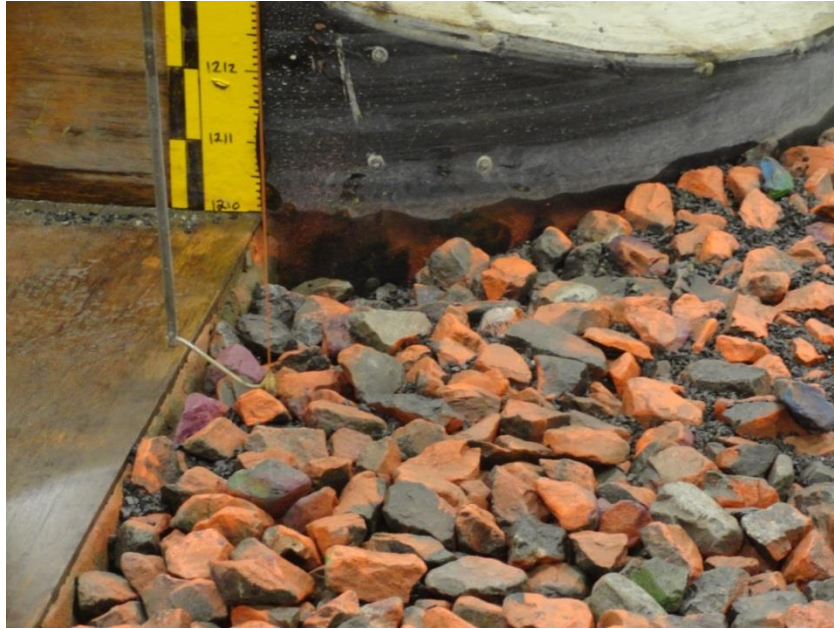
Figure 117. Scouring of the 440kg rip-rap at RHS of the service spillway inlet.

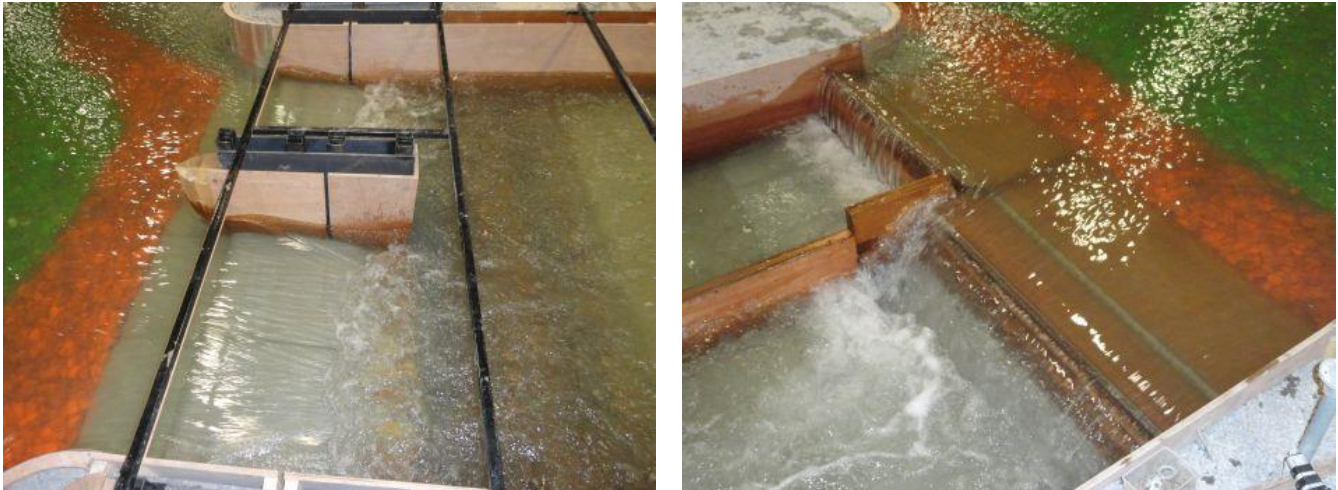
Figure 123. Flow conditions at the structure during the 760 m³/s event with the Obermeyer gates set to 1213.4m (LHS) and 1215m (RHS). Left - facing southwest at the diversion, right - facing southeast at the service spillway.

The pier nose 1 design drawings are shown in Section 3.4.3.3, and the main characteristics feature a curving arrow-head plan-shape with the apex of the point being 3.5m upstream of the front of the diversion/breast wall. Figure 123 shows pictures of the flow conditions at the diversion inlet and the service spillway. There was a slight wake on the RHS of the diversion inlet stemming from pier nose 1, however the hydraulic jump was relatively stable on both sides of the pier. On the service spillway, water barely spilled over the RHS gate as it was set to 1215m, and the waterfall was more energetic on the LHS.

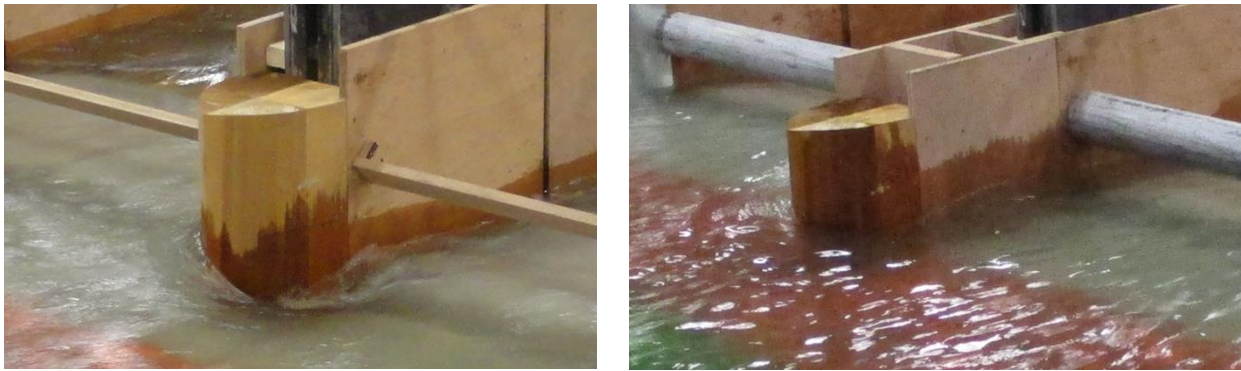
Figure 125. Flat breast wall on Pier Nose 1 (left) and curved breast wall (right) used for all future debris tests (Pier Nose 2 shown).

Debris was deployed at several points in the floodplain and tracked through the model. Again, refer to Figure 122 for the debris insertion locations and pathways, and Table 13 presents a summary the debris tests for pier nose 1. Model trees placed in the main river channel west of the small island of trees (locations A-C) passed through the LHS of the diversion, while debris inserted to the north of the small tree island (D) or in the secondary channel (E) passed through the RHS of the diversion. A percentage of the trees were caught in the pier nose, particularly those from the larger debris rafts (packs of 10 and 40 trees). The trees and their roots were caught on the pier nose itself as well as the breast wall (see Figure 124). The close proximity of the pier nose apex and the breast wall provided an area where a piece of debris could bridge and catch at two points simultaneously. The model representation of the breast wall was simply a flat piece of plywood set to the correct elevation. The sharp edges of the model plywood breast wall likely contributed to catching onto the root wads. Since the prototype breast wall is curved, the model breast wall was replaced with a 4" diameter (model scale) section of pipe after this test series (see Figure 125).

Design sketches for pier nose 2 are shown in Section 3.4.3.3. This structure re-uses the nose from pier nose 1 however the apex of the pier nose was offset 6m upstream placing it 9.5m upstream of the breast wall (see Figure 125 for a comparison). Figure 126 presents the flow conditions at the diversion channel and the service spillway. The flow conditions in each section of the diversion inlet were similar - there was a slight wake on the RHS of the diversion inlet stemming from pier nose 2, however the hydraulic jump was relatively stable on both sides of the pier. On the service spillway the flow patterns were the same as with pier nose 1 - water trickled over the higher RHS gate, and the waterfall was more energetic on the LHS.

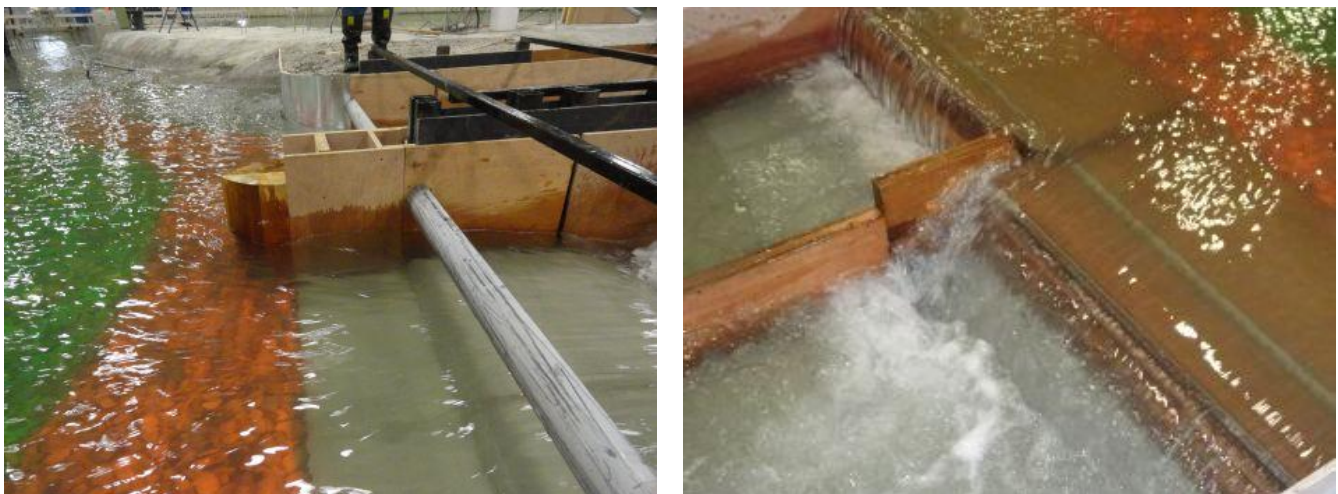
Figure 126. Flow conditions at the structure during the 760 m³/s event with the Obermeyer gates set to 1213.4m (LHS) and 1215m (RHS) and Pier Nose 2 installed. Left - facing southwest at the diversion, right - facing southeast at the service spillway.

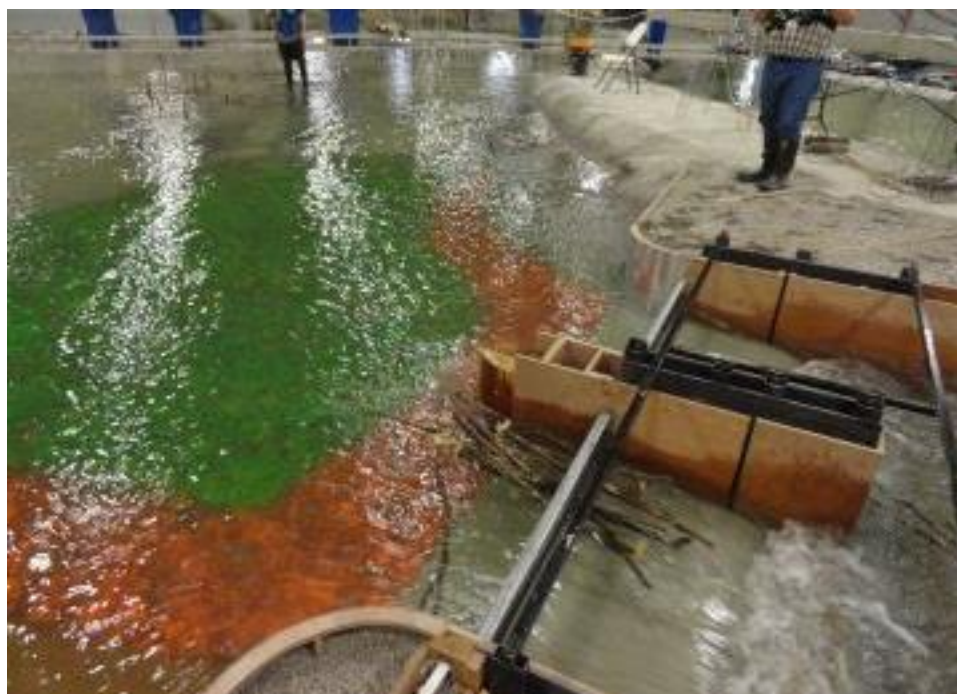
Figure 127. Debris pivoting around Pier Nose 2 while passing through the diversion.

As before, debris was deployed at several points in the floodplain and tracked through the model. Again, refer to Figure 122 for the debris insertion locations and pathways and Table 14 shows a summary of the debris behaviour and performance of the structures in the model with pier nose 2 installed in the diversion. Pier nose 2 was much more effective at passing the debris as no trees remained stuck on the pier during the testing (they only stalled on the pier nose for a short time). Since the apex of pier nose 2 was 6m further upstream than pier nose 1, and the breast wall now a truer curved representation of the prototype, the trees from these debris tests pivoted around the pier nose and passed through the diversion inlet without catching on the breast wall (see Figure 127).

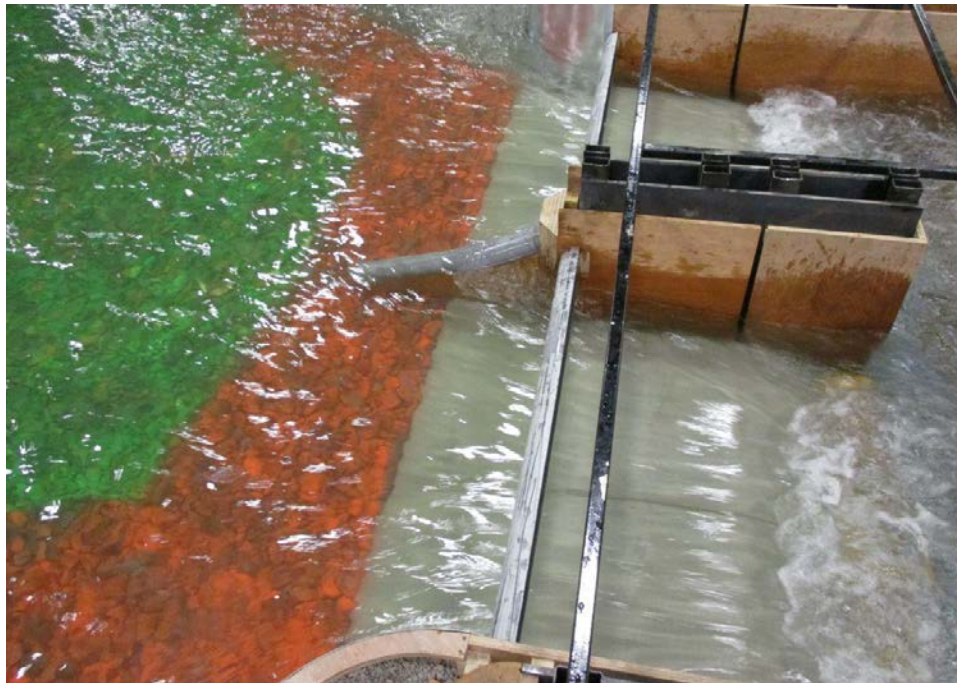
Figure 131. Flow conditions at the diversion inlet with Pier Nose 4 installed.

Designs for pier nose 4 are shown in Section 3.4.3.3 and it featured a semi-circular and narrower outer nose section that rose at a 2:1 slope. The bottom and top ends of the pier nose are 12m and 1m upstream of the breast wall, respectively. Figure 129 shows pictures of the flow conditions at the diversion inlet with pier nose 4 installed. The wake pattern emanating from the pier nose was rougher and more turbulent than that seen with any of the other pier noses, but otherwise the flow conditions at the diversion inlet and the service spillway were similar to those seen previously.

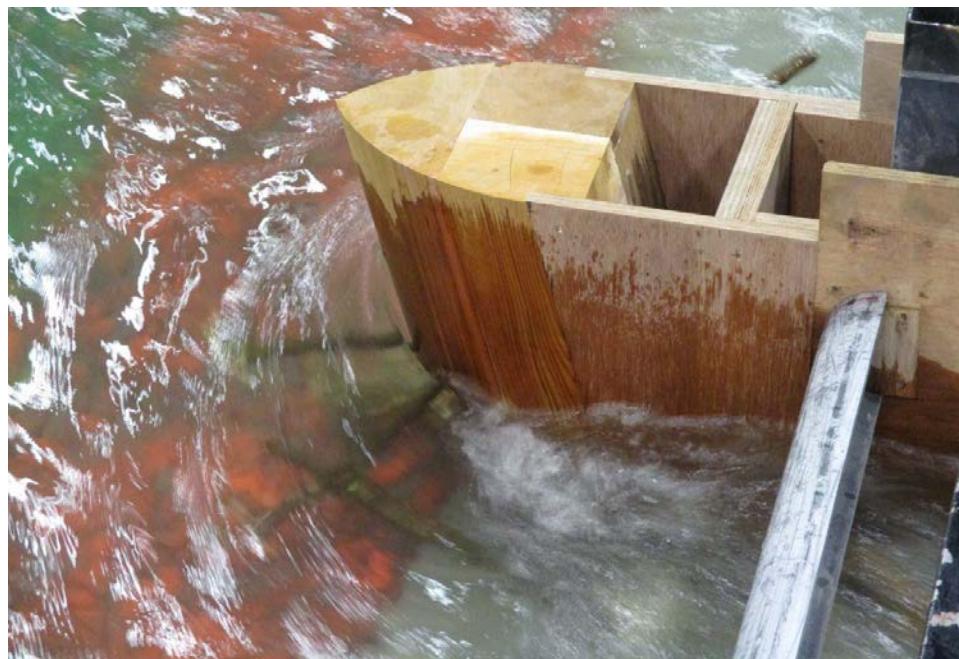
Figure 145. Debris caught on Pier Nose 3.

several points in the floodplain and tracked through the model (see Figure 143 for the insertion points and pathways). Table 23 shows a summary of the debris behaviour and performance of the model with pier nose 3 installed in the diversion. In general, the pier nose passed most of the debris through the diversion, with only a small portion of the trees of the 40-pack raft getting caught (see Figure 145).

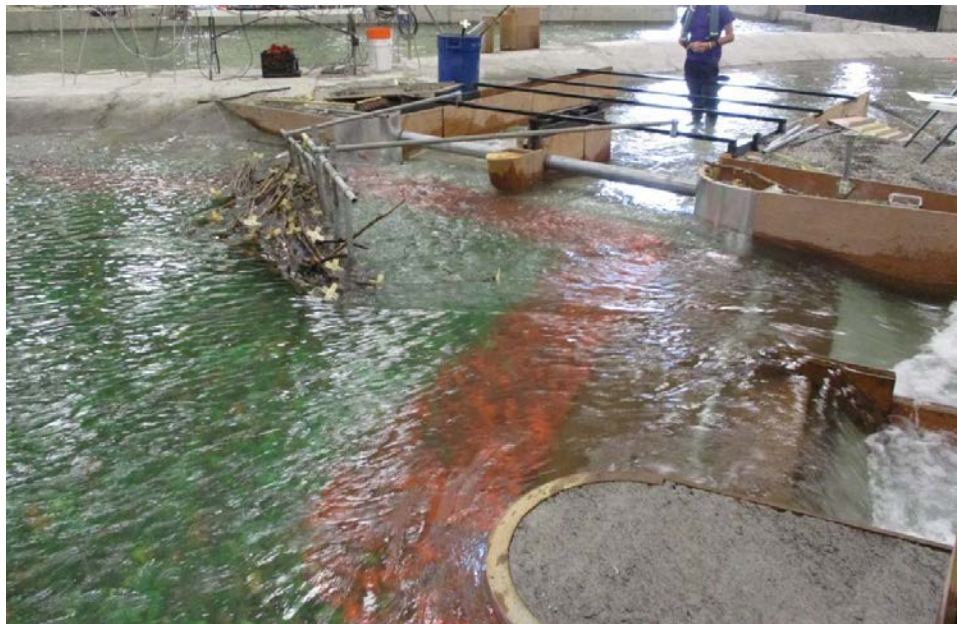
Figure 149. Debris collected on barrier C at the start of the tests.

The performance of Debris Barrier C and Pier Nose 3 under a flood flow of $1240\text{m}^3/\text{s}$ was investigated (refer to section 3.4.3.4 for the design and layout of the barrier). For this test, approximately 80 trees were already in place on the barrier from the previous tests run at $320\text{m}^3/\text{s}$ flow. The flow was increased to $1240\text{m}^3/\text{s}$ and only three trees were removed from the debris raft collected on the barrier (see Figure 149). Additional debris was then inserted in the model in locations D, E, F, and G and the debris paths through the model were noted (see Figure 143 for the debris insertion locations

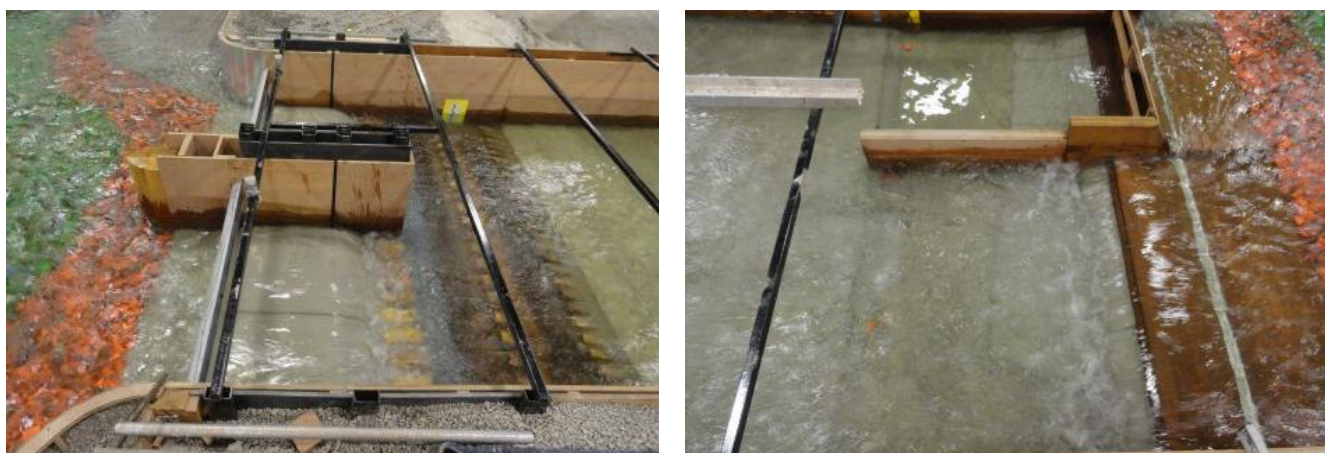
Figure 151. Flow conditions at the structure during the 320 m³/s event. Top – facing southwest at the diversion, bottom - facing southeast at the service spillway.

The flow conditions through both the diversion inlet and the service spillway were relatively benign for the 320m³/s flood condition. The flow depth through the diversion inlet and the chute blocks was shallow, and the hydraulic jump downstream of the LHS service spillway gate had little energy (see Figure 151). Debris was deployed at several points in the floodplain and tracked through the model (see Figure 150 for the insertion points and pathways). Table 27 shows a summary of the debris behaviour and performance of the structures in the model with pier nose 2 installed in the diversion. In general, the debris passed by the pier nose relatively unobstructed. However, there was often insufficient energy or depth to pass the debris over the chute blocks on the diversion inlet or through the hydraulic jump on the service spillway (see Figure 152). Of note, the tree debris stuck in the chute blocks in the diversion inlet often piled up where the diversion inlet gates would be closing, which may affect the gate operation (yellow arrow in Figure 152). At the end of the tests with the debris still caught in the structures, the LHS Obermeyer gate was raised to force all the flow through the diversion. The tree debris that was stuck in the hydraulic jump of the diversion inlet slowly floated down the channel, but the increased flow through the diversion inlet did not release the debris caught in the diversion inlet chute blocks.

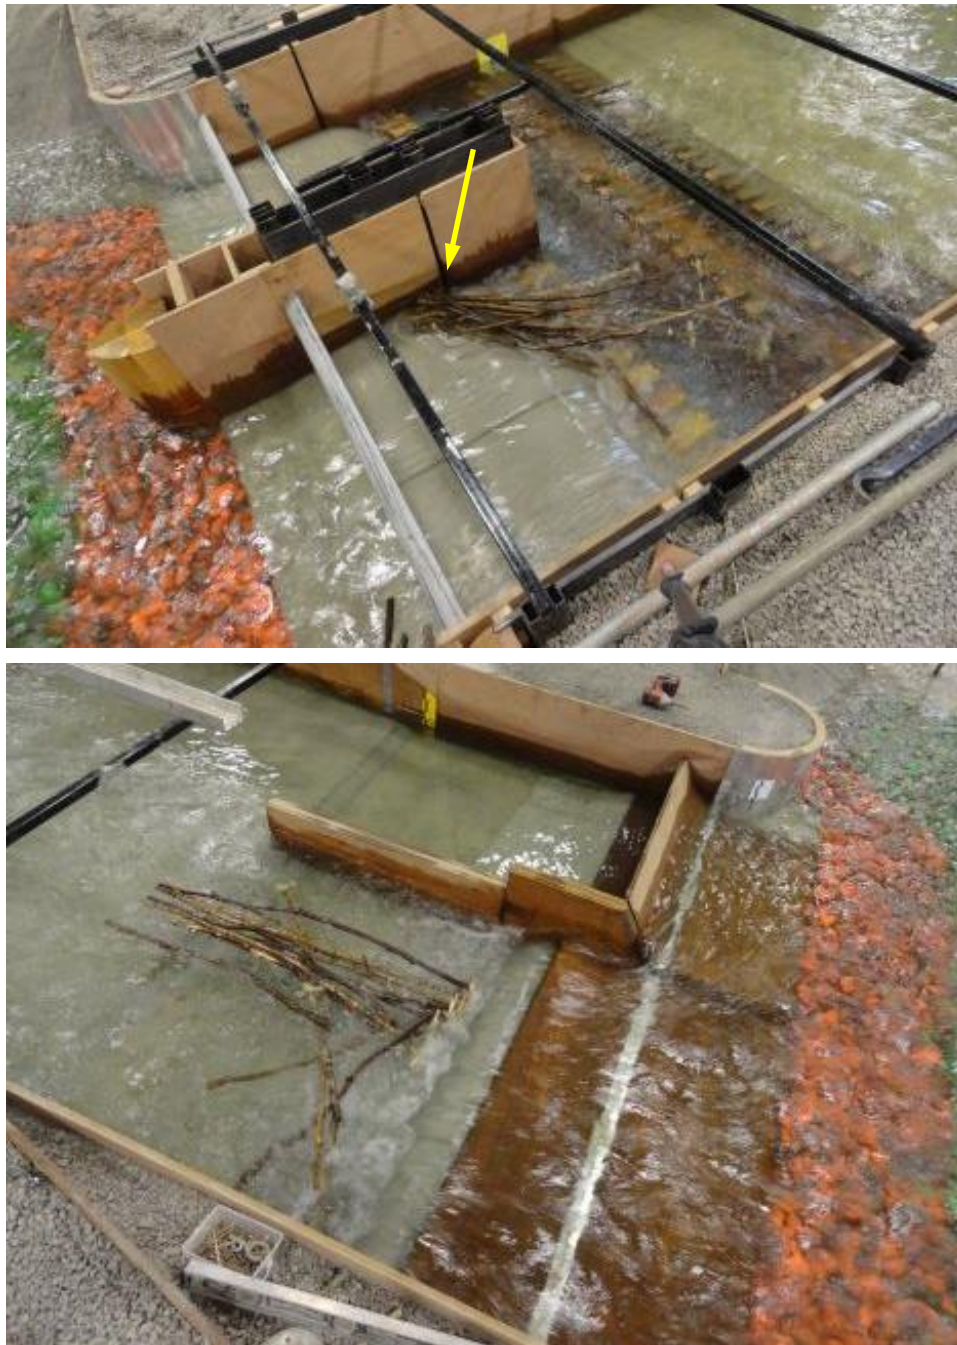
Figure 152. Debris caught in the structures during the $320\text{m}^3/\text{s}$ flow condition with pier nose 2.

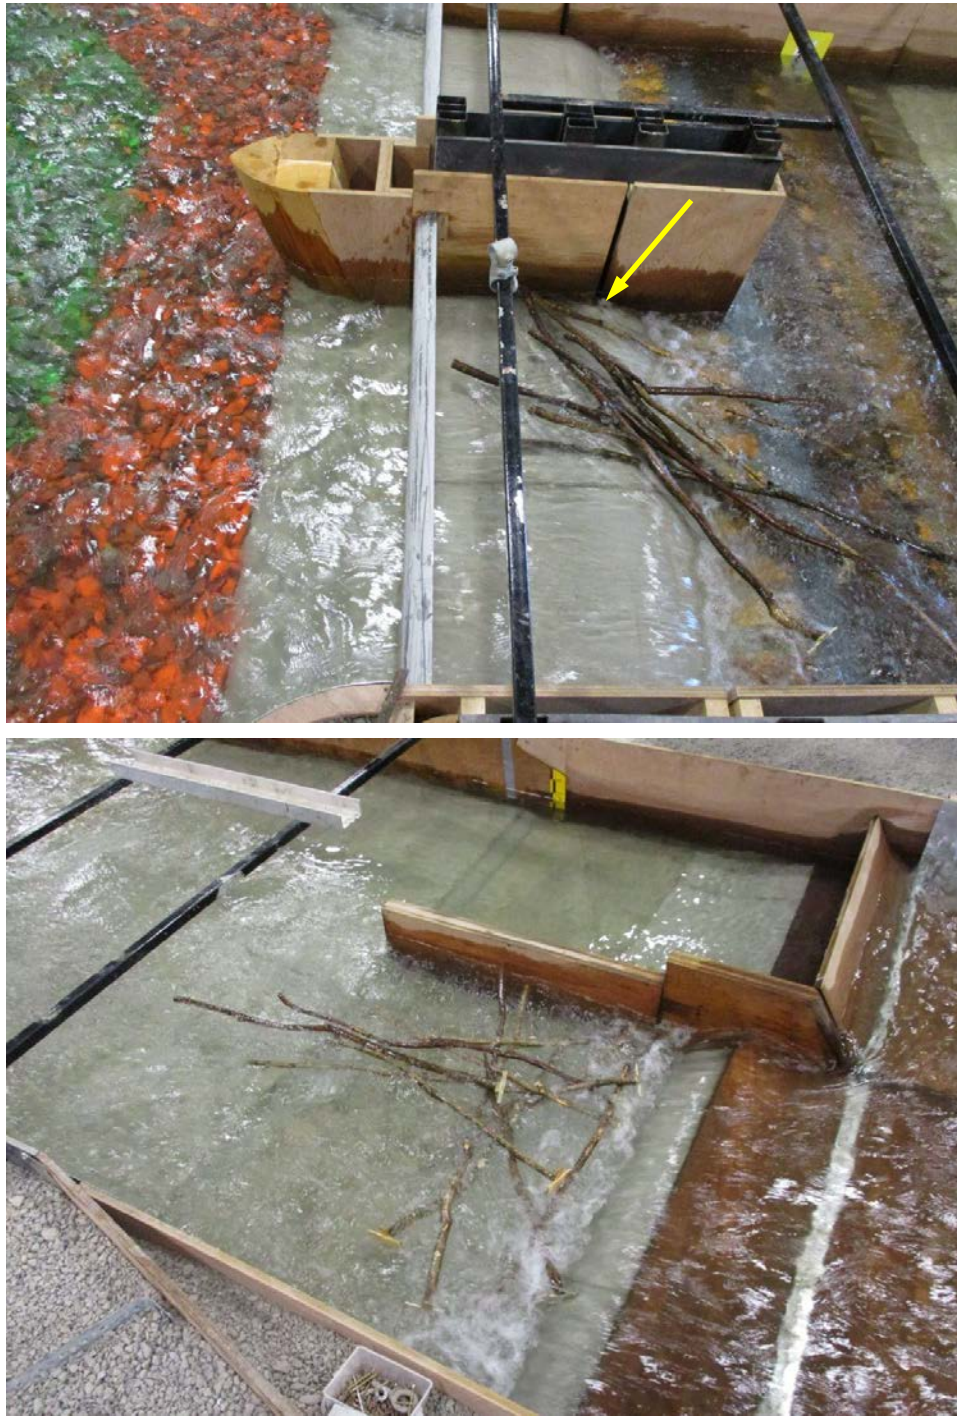
Figure 153. Debris caught in the structures during the $320\text{m}^3/\text{s}$ flow condition with pier nose 3.

structures in the model with pier nose 3 installed in the diversion. No debris was caught on the pier nose. As with the other 320m³/s test, there was often insufficient energy to pass the debris over the chute blocks on the diversion, or fully through the hydraulic jump on the service spillway (see Figure 153). Of note, the tree debris stuck in the chute blocks in the diversion inlet often piled up where the diversion inlet gates would be closing, which may affect the gate operation (yellow arrow in Figure 153).

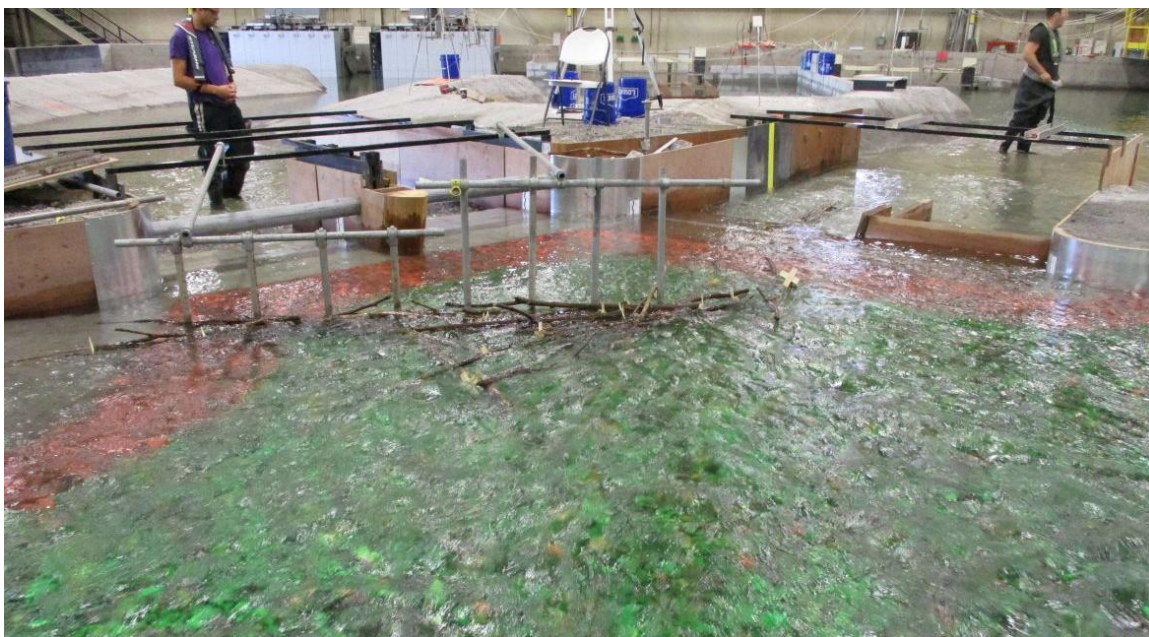
Figure 155. Model trees collecting on debris barrier C during the 320m³/s flow.

Debris Barrier C was re-installed in the model (refer to section 3.4.3.4 for the design and layout of the barrier) and debris was inserted into the model floodplain (refer to Figure 150 for a schematic showing the debris insertion points and pathways). The debris barrier was effective at blocking tree debris from the left-hand side of the floodplain (locations i, ii, iii, and iv), but debris placed at locations v, vi and vii bypassed the barrier and flowed into the service spillway. Figure 155 and Table 30 illustrate the debris behaviour and summarize the performance of the debris barrier for this flow rate.

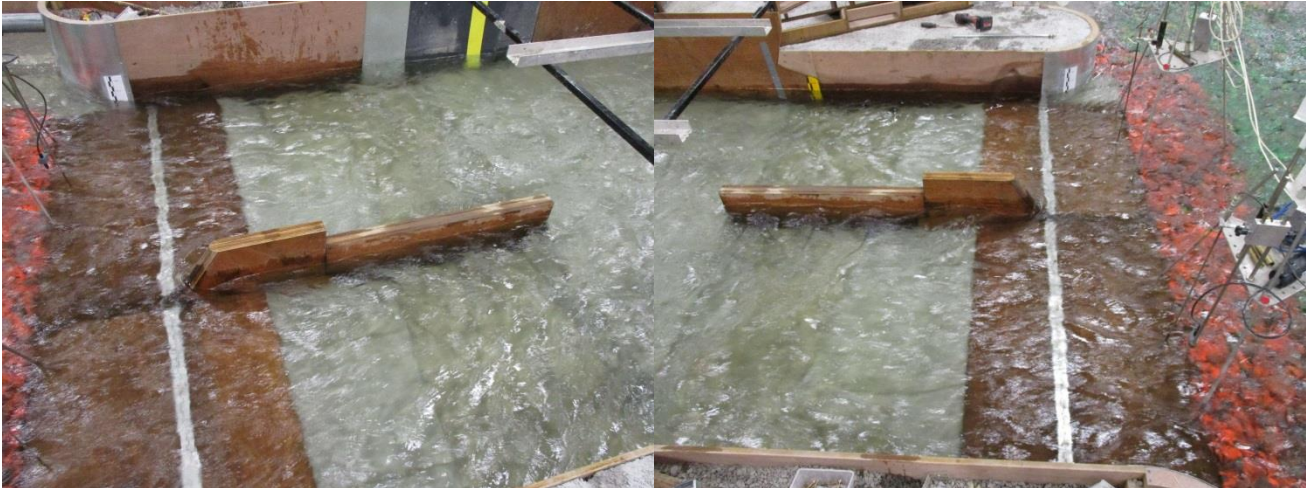
- Diversion inlet gates were fully lowered (closed).
- Left hand side service spillway Obermeyer gate set to 1210 m.
- Right hand side service spillway Obermeyer gate set to 1210 m.

Figure 158. Flow through the service spillway during the 320 m³/s case (b) flood condition with the diversion inlet closed.

The flow through the service spillway was fairly evenly distributed between the RHS and LHS as the water levels measured at the structure were 1212.44 m and 1212.45 m, respectively. Closing the diversion inlet gates raised the tail-water elevation downstream of the service spillway by 0.48 m to 1211.7 m.

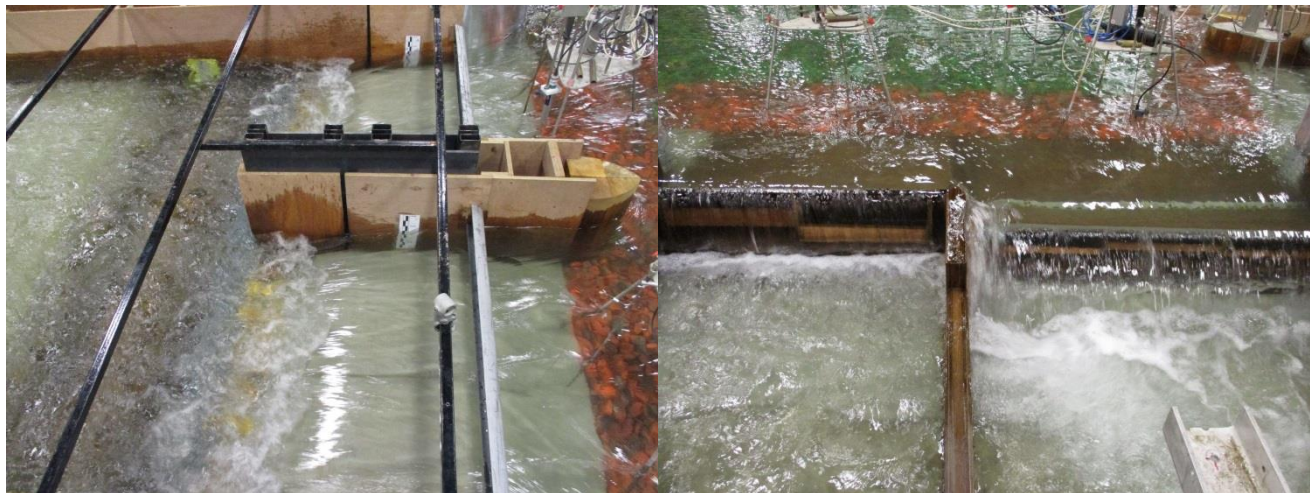
Figure 159. Flow through the diversion inlet structure (left) and service spillway (right) during the 760 m³/s case (a) flood condition.

The target flow split for the 760 m³/s flow condition is to have 600 m³/s in the diversion channel and 160 m³/s in the main channel. The gate settings provided by Stantec provided a flow split that reasonably matched the targets; the recorded flow over the diversion channel weir was 575 m³/s and the recorded flow over the main channel weir was 191 m³/s (the total flow was 766 m³/s - refer to Table 31 for the flow splits and the water levels). The head at the upstream end of the each bay of the diversion inlet (WP6 and WP7) were very even between the LHS and RHS (1215.27 m and 1215.25 m). This was also the case upstream of the service spillway (WP8 and WP9 each read 1215.55 m). The flow barely crested the RHS crest gate on the service spillway (elevation 1215 m).

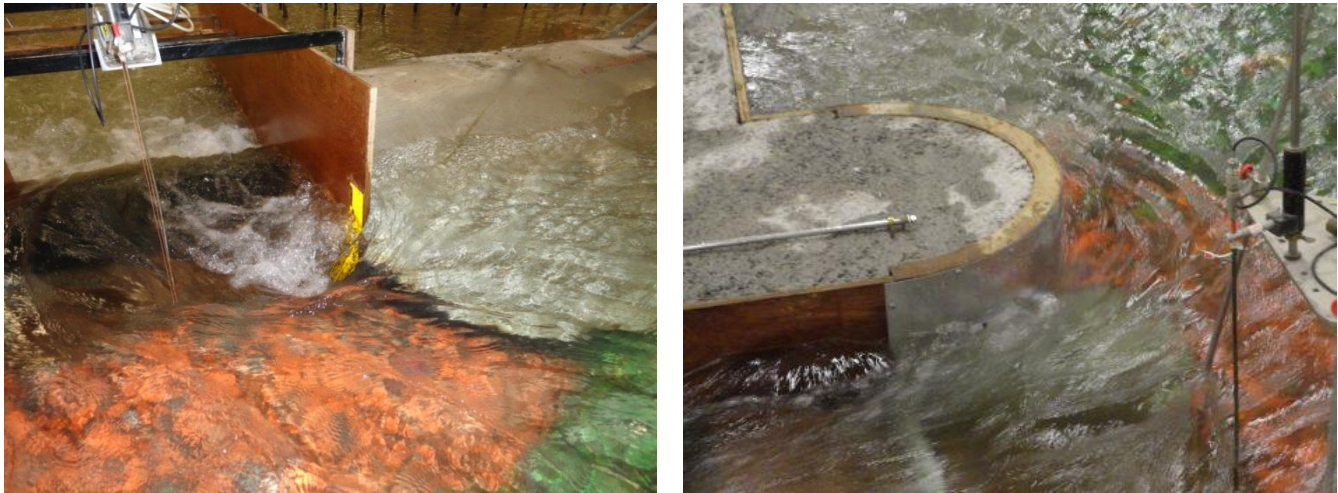
Figure 163. Wakes generated by the retaining wall on the RHS of the service spillway – left: straight wall of the initial design, right – circular design for TSD-H.

of Figure 162). High velocities were observed along the LHS training wall of the service spillway indicating the potential for erosion or scour at this location. The modification to the RHS retaining wall, changing the plan shape to a circular design, showed an improvement on the entrance flows over the straight wall design used in test series A-C (see Figure 163).

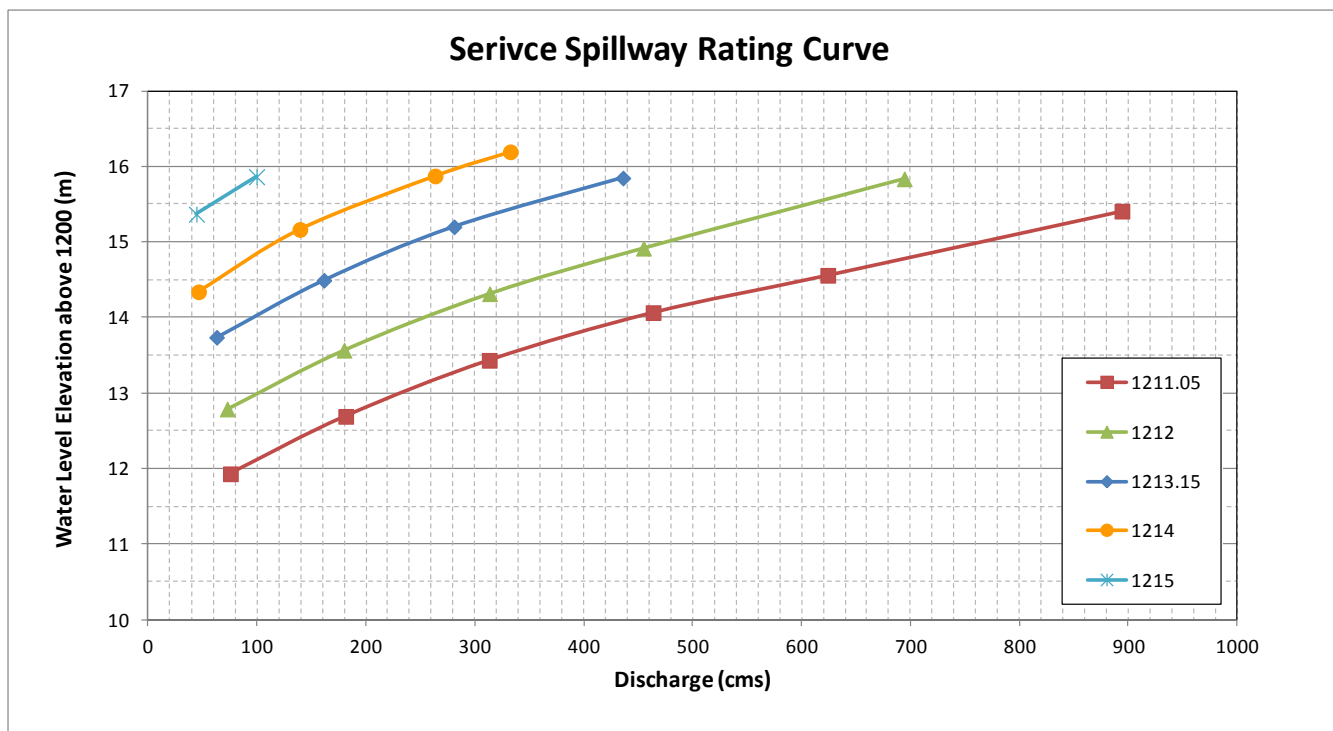
Figure 166. Rating curves for the service spillway Obermeyer gates - upstream water level elevation versus discharge for the various gate setting elevations.

Test series F investigated the water level elevation at the upstream end of the service spillway for various flows and settings on the Obermeyer gates. Rating curves were developed that relate the water level elevation (stage) to the flow discharge for an array of gate settings. Both of the Obermeyer gates on the left and right side of the service spillway were set to the same elevation for each test. The instruments were arranged in Sensor Layout 5 and their location can be seen in Figure 77. Only the flow over the service spillway was of interest during this test series, therefore the diversion inlet gates were closed. The data measured by the water level probes just upstream of the service spillway were used (WP8 and WP9) and their rating curve information is given in Table 32 and Figure 166. Note that the water level information is given in metres above the 1200m elevation, therefore a water level of 11.94m corresponds to a water level elevation of 1211.94m.

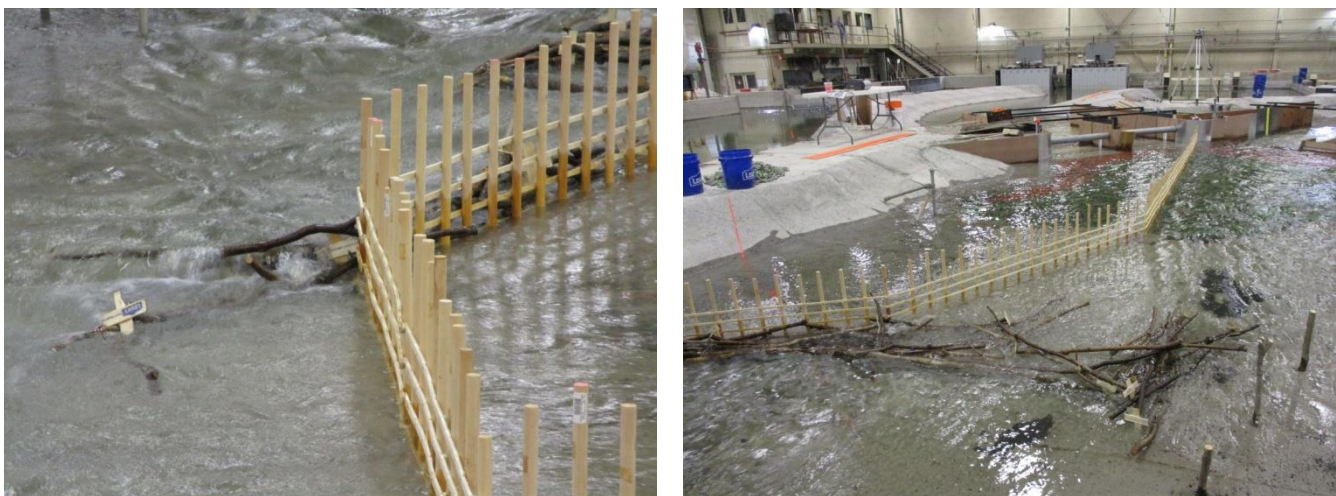
Figure 168. Debris being caught on the barrier and protruding out into the river (left), and this phenomenon continuing to bridge across the river against the standing trees producing a jam (right).

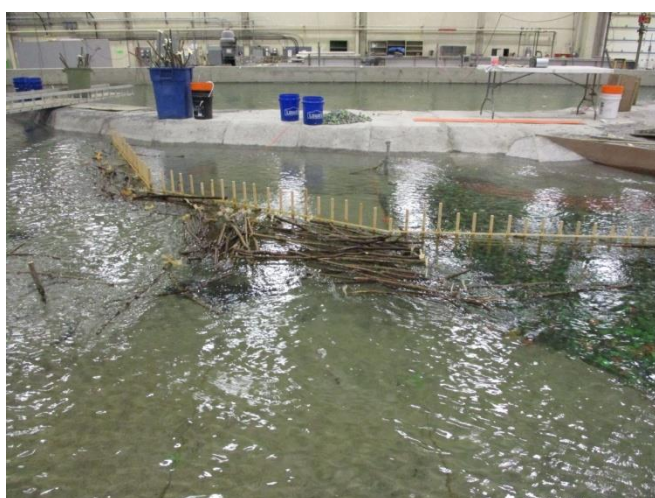
Figure 170. Debris left on barrier at the end of the 760m³/s tests for leg AB and BC (left) and at the end of the barrier on leg CD (right).

through the service spillway. At the end of the tests much debris remained on the barrier on all three legs (see Figure 170).

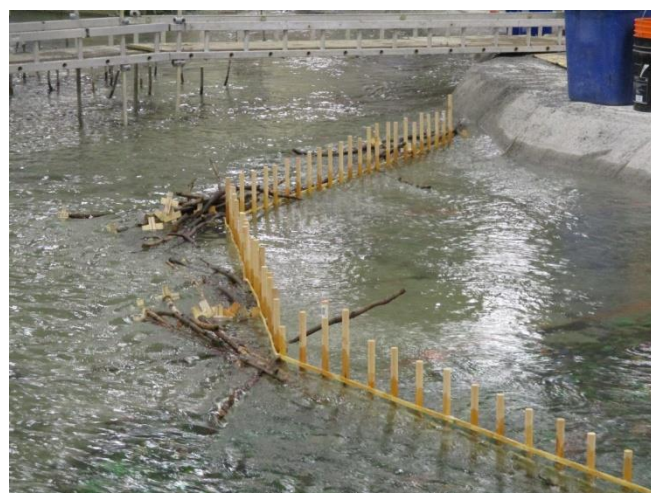
Figure 172. Left - Debris being caught on the barrier and protruding out into the river and this phenomenon continuing to bridge across the river against the standing trees producing a jam. Right – debris trapped in the barrier at the end of the tests.

thus blocking the river channel (see Figure 172, left). At the end of the tests at 1240m³/s, there was debris caught in the barrier at the B and C vertices (see Figure 172, right). The model tree debris rafts ran along the straight legs of the barrier and then became trapped as the raft pivoted around the corners at points B and C. Leg CD was clear of model debris at the end of the tests.

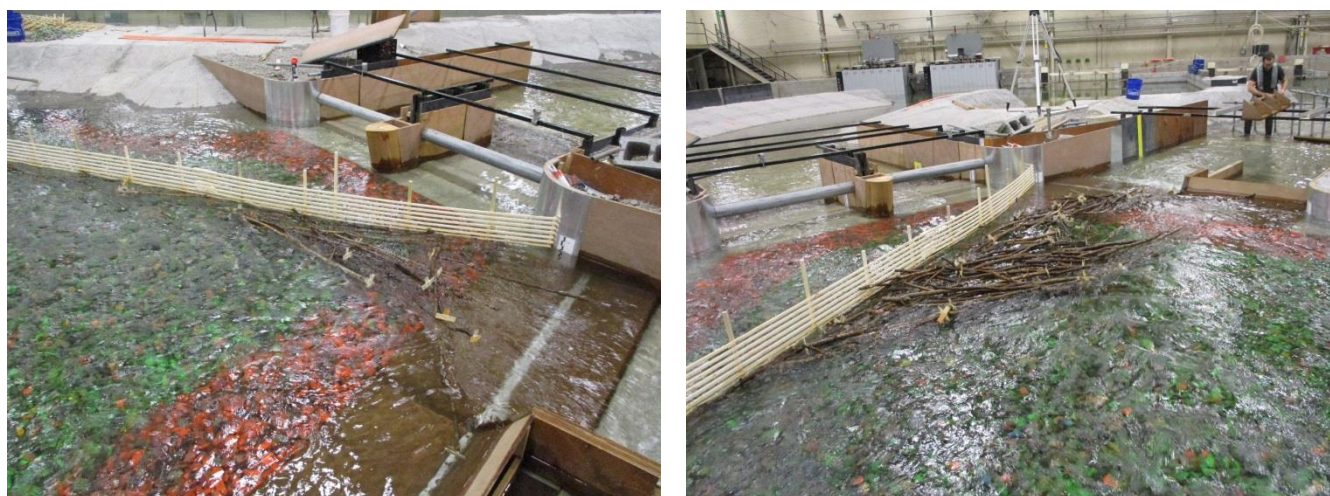
Figure 174. Debris being caught at the downstream end of the barrier and bridging across the LHS of the service spillway to start a jam (left), and the jam building through the testing program (right).

The gate settings for the 320m³/s flow utilized the diversion inlet gate in the fully raised position, and the service spillway Obermeyer gates set to 1211.05m on the 24m wide left-hand side (LHS) and 1215m on the 18m wide right-hand side (RHS). These settings were intended to direct 160m³/s through the service spillway and 160m³/s through the diversion, which was close to the measurements made in the model (178m³/s in the diversion and 142m³/s through the main channel). Again, model tree debris was inserted into the model in one of seven locations (1-7) as shown in Figure 173 during the tests. Table 36 shows a summary of the debris behaviour at this flow condition. For ease of description, debris barrier E was divided into legs AB, BC and CD. Debris inserted into the left hand side of the western floodplain (locations 1 and 2) bounced along leg AB before coming to rest close to point B. At other debris deployment locations, the model trees would often catch in the debris barrier at leg CD. During the deployment of the rafts of ten debris units, the trees bridged across from the barrier and jammed at the LHS of the service spillway. This jam did not permit the passage of any further debris causing a larger jam by the end of the tests at this flow rate (see Figure 174).

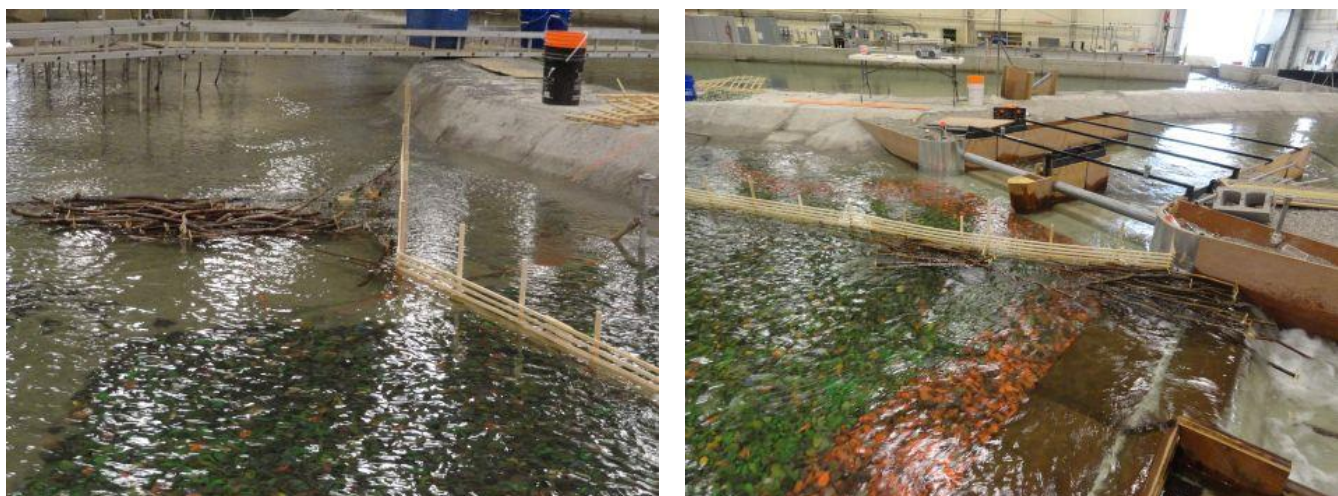
Figure 176. Debris caught on the upstream end of the barrier (leg AB) and protruding out into the river (left), debris caught at the downstream end of the barrier (leg BC) and on the LHS Obermeyer gate (right).

this flow condition. For ease of description, debris barrier F was divided into legs AB, BC and CD. Debris inserted into the left hand side of the western floodplain (locations 1 to 4) was trapped on the barrier along leg AB and created a debris jam at point B. Some of the debris in the jam eventually drifted off and collected on the barrier at the downstream end (leg CD). At other debris deployment locations, the model trees would often catch in the debris barrier at leg CD, and a second debris jam was created in front of the LHS of the service spillway (see Figure 176).

At the end of the tests, the upstream debris jam consisted of approximately 90 trees (see Figure 176, left) and the downstream jam was slightly smaller (~ 35 trees - see Figure 176, right). Gate operations were undertaken to try and remove the trees from the barrier. Initially the LHS Obermeyer gate was lowered to 1210m and this removed approximately 20 of the 35 trees from the jam close to the diversion inlet and passed them through the LHS of the service spillway. The diversion inlet gates were then closed and the other 15 trees drifted off the debris barrier and through the LHS as well. As the backwater effect raised the water level in the upstream floodplain, the large raft at Point B on the barrier moved slightly downstream and away from the barrier. The diversion inlet gates were then opened and approximately 60% of this jam floated downstream and through the LHS of the service spillway.

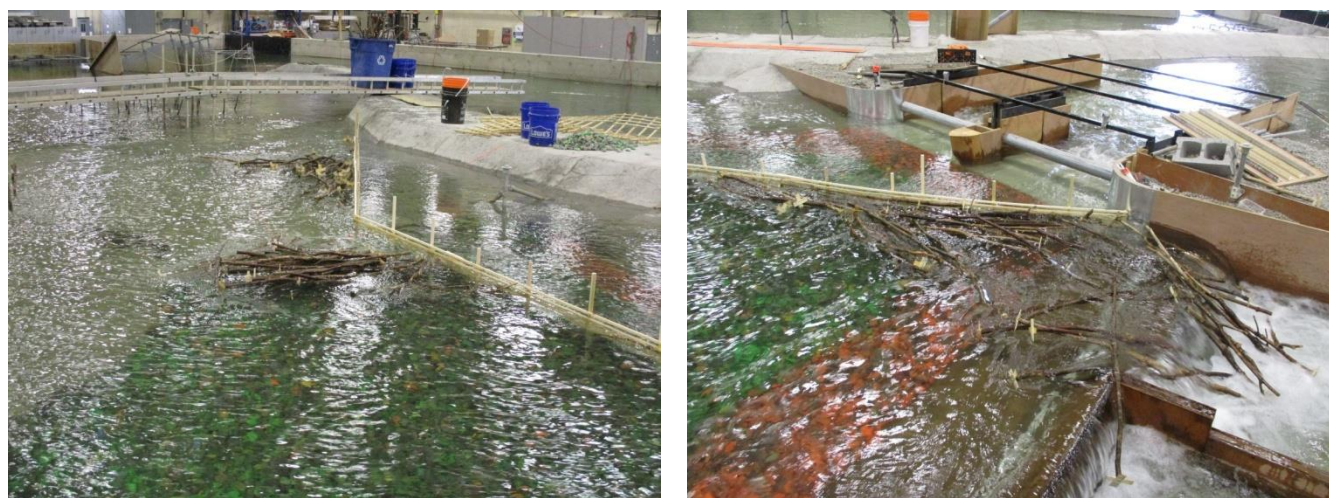
Figure 180. Debris left on barrier at the upstream end (left) and at the end of the barrier bridging across to the central pier in the service spillway (right).

The diversion inlet gate was in the fully raised position, and the service spillway Obermeyer gates were set to 1213.4m on the 24m wide left-hand side (LHS) and 1215m on the 18m wide right-hand side (RHS) for the case (a) tests. The setting was intended to direct $160\text{m}^3/\text{s}$ through the service spillway and $600\text{m}^3/\text{s}$ through the diversion, and this was represented well in the model ($563\text{m}^3/\text{s}$ through the diversion inlet and $188\text{m}^3/\text{s}$ through the service spillway). Again, tree debris was inserted into the model in one of seven locations (1-7) as shown in Figure 179 during the tests. Table 38 shows a summary of the debris behaviour at this flow condition. The relatively larger amount of flow passing through the diversion inlet (behind the barrier) compared to the service spillway drew the woody debris into the debris barrier much more than the other flow conditions. Debris originating from the left hand side of the western floodplain (locations 1, 2 and 3) collected on leg AB. On almost the entire floodplain (locations 1-6) the debris was sucked into and pinned up against the debris barrier by the flow. Only debris inserted in the model near the floodplain berm at the RHS of the service spillway (location 7) had a significant portion pass through the service spillway. At the end of the tests much debris remained on the barrier on all three legs (see Figure 180).

At the end of the 760m³/s case (a) debris tests, with the large debris raft (~100 trees) caught in front of the diversion, efforts were made to drop the diversion inlet gates as well as the LHS Obermeyer gate to try and clear the debris jam. The diversion inlet gates were lowered first and some of the debris that was caught on the Obermeyer gate was freed. Also the jams further upstream on the barrier at AB and BC floated off of the debris barrier and came further downstream. After lowering the Obermeyer almost all (~90%) of the debris trapped on the debris barrier was freed and passed through the LHS of the service spillway.
