**ALBERTA TRANSPORTATION SPRINGBANK OFF-STREAM RESERVOIR PROJECT
RESPONSE TO NRCB AND AEP SUPPLEMENTAL INFORMATION REQUEST 1, JULY 28, 2018**

Physical Model Study of the Springbank Off-stream Storage Project Diversion Structure on the Elbow River

Paul Knox, Andrew Cornett, Mitchel Provan
Ocean, Coastal and River Engineering
NRC Technical Report: OCRE-TR-2016-028

December 2016

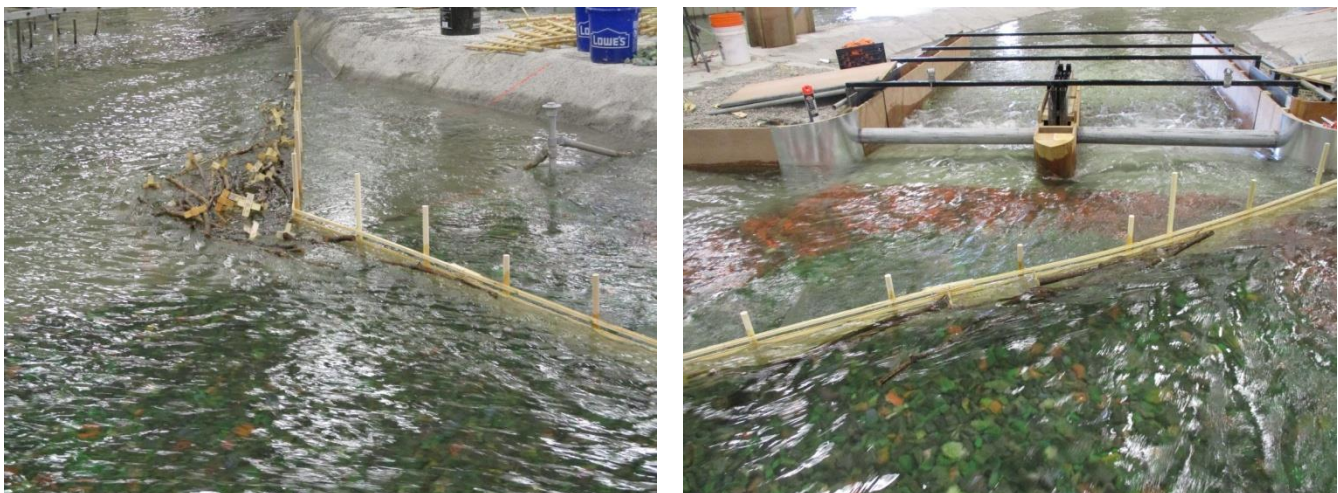
Figure 184. Debris jam at point B (left) and debris caught in the barrier in front of the diversion inlet structure (right) at the end of the TSH tests at 1240m³/s.

The gate settings for the 1240m³/s flow utilized the diversion inlet gate in the fully raised position, and the service spillway Obermeyer gates set to 1210m on the 24m wide left-hand side (LHS) and 1213.5m on the 18m wide right-hand side (RHS). The setting was intended to allow 640m³/s through the service spillway and 600m³/s through the diversion, and these targets were reasonably produced in the model (584m³/s through the diversion inlet and 654m³/s through the service spillway). Model tree debris was inserted into the model in one of seven locations (1-7) as shown in Figure 183 during the tests. Table 39 shows a summary of the debris behaviour at this flow condition. For ease of description, debris barrier F was divided into legs AB, BC and CD. Debris inserted into the left hand side of the western floodplain (locations 1, 2 and 3) collected on leg AB and along this leg debris tended to tumble along the barrier coming to rest at point B. Very little debris collected on legs BC and CD during the tests. At the end of the tests, the debris jam at point B was comprised of about 50 trees, and there were 5 trees snagged in the barrier in front of the diversion inlet structure (see Figure 184).
