RECAPP Facility Evaluation Report

Centennial Centre - Geriatric Psychiatry Centre

B0636V

Ponoka

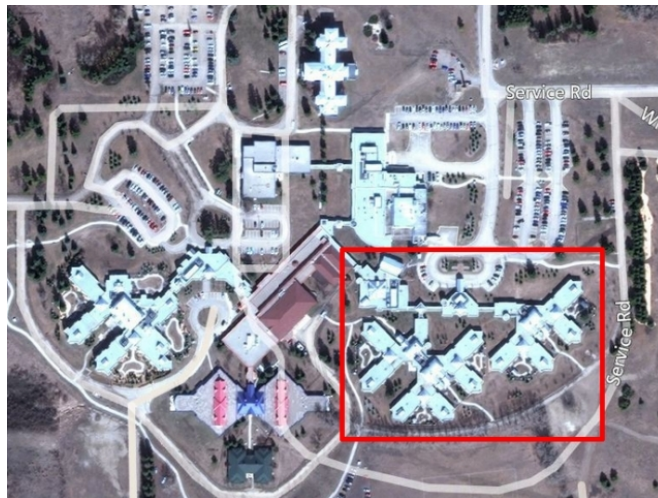
SiteOverview.jpg

An asphalt paved driveway network is provided to connect the buildings and parking lots amongst each other and to the main access road (46 Street S). The Parking lots and the buildings are connected via concrete pedestrian sidewalk and walkway system. The majority of the site is landscaped with grass, trees and shrubs.
