RECAPP Facility Evaluation Report

Queen Elizabeth II Hospital - Power Plant

B1064D
Grande Prairie

Facility Details	
Building Name:	Queen Elizabeth II Hospital
Address:	10409 - 98 Street
Location:	Grande Prairie
Building Id:	B1064D
Gross Area (sq. m):	2,015.00
Replacement Cost:	\$0
Construction Year:	1981

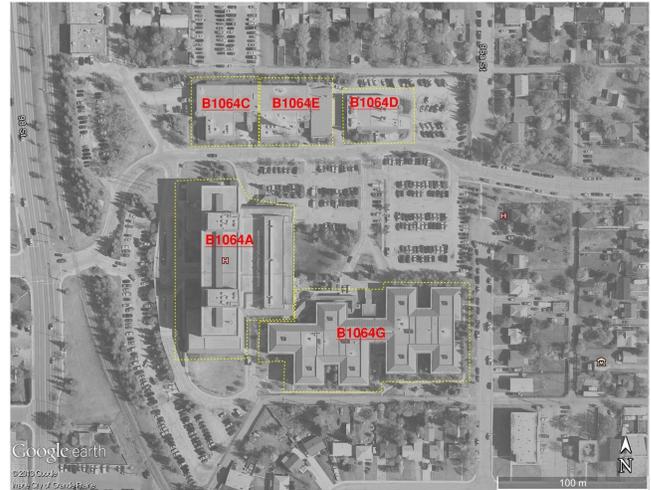
QEII.jpg

The Queen Elizabeth II Power Plant building is a one storey facility located at 10409 98th Street in the City of Grande Prairie, Alberta.

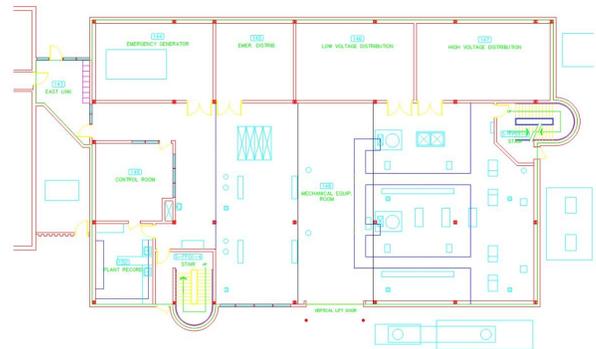
Power Plant Page 001.jpg

Alberta Health Services | 5055E QUEEN ELIZABETH HOSPITAL- POWER PLANT | 10409-98 ST, GRANDE PRAIRIE, AB T8V 2E8 | MAIN FLOOR PLAN | SCALE: N.T.S. | DATE: 2012-OCT-0
