RECAPP Facility Evaluation Report

David Thompson Regional Health Authority

Elnora Community Health Centre

B1045A

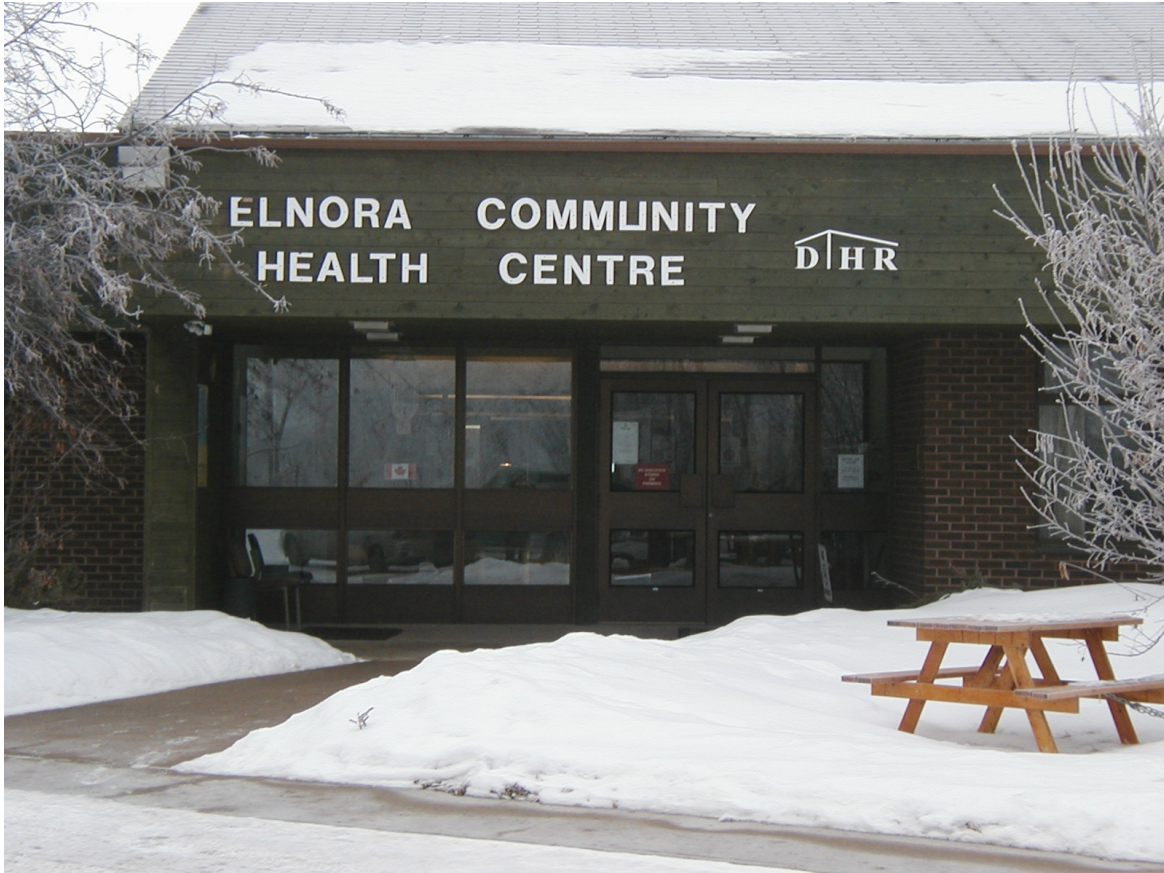
This building is a ~30 bed care facility that is currently being used for office space and is under utilized. The patient rooms have been let go and will require complete repaint. As well all plumbing fixtures will likely require repair if usage changes. Only minimal maintenance has been done in years. Many systems have been disabled and no information was available to determine the current state of them.
