Investigation Report

Worker Fatally Crushed by
Pipe Rolling into Trench

July 16, 2013

Final Report

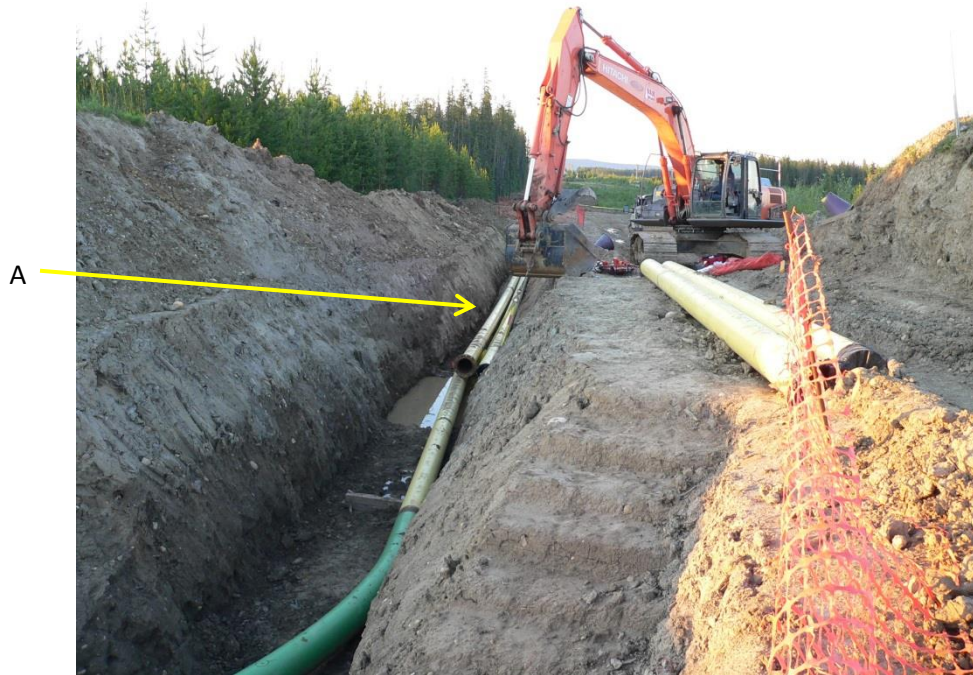
The hydraulic excavator is manufactured by Hitachi Construction Machinery C. Ltd. Tokyo, Japan. The excavator is a Hitachi ZX270LC-3 (Figure 1).

The pipe used was manufactured by Shaw Gateway Tubulars, Calgary Alberta. The pipe is of the Fuseabond style (meaning they can be joined together) and is 32 metres (m) in length, 324 millimeters (mm) in diameter, and a total weight of 1795 kilograms (kg) (Figure 1).

Figure 1. The image shows the trench where the Foreman was struck. Also shown are the pipes, excavator, and the blue pipe support stands.

A: Foreman's approximate location when struck by the pipe.

A steel pipe had been resting on pipe support cones in preparation to be placed in the trench. At approximately 2:45 p.m., workers in the area heard a crash as a result of the excavator counter weight striking the steel pipe. The strike caused the steel pipe to roll off the pipe support cones and into the trench. The crew foreman was struck by the pipe with enough force to cause fatal injuries.

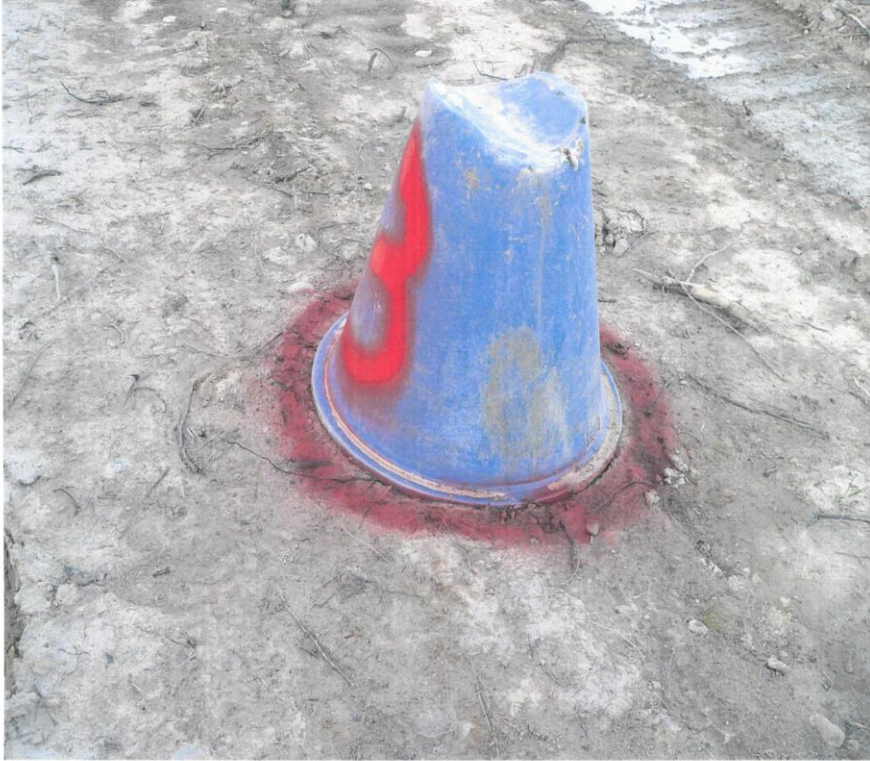
The pipe support cones (Figure 2), used to support the above-mentioned pipes, were manufactured by the Paddle Plastics Ltd. Mayerthorpe, Alberta. They are the Proline model and are designed to accommodate 20 to 30 centimetre pipe and have a maximum load of 1580 kg per cone.

Figure 2. A pipe support cone.
