McGregor Reservoir Erosion Protection

Fact Sheet

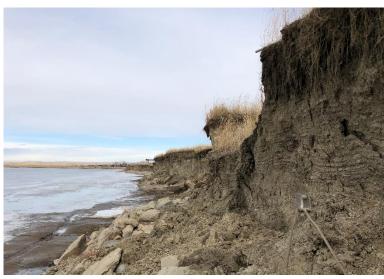
Bluffs along the northeast shoreline of McGregor Reservoir (March, 2021)

Severe winds typical to this area often cause high waves on the reservoir. The action of the waves then causes shoreline erosion and the formation of bluffs. The breaking waves along the shoreline saturate, disturb, and erode the clay-rich soil, causing erosion.

McGregor Reservoir was built in 1920; it is one of three main water storage reservoirs in the Carseland-Bow Headworks system. The Travers and Little Bow Reservoirs are downstream of Lake McGregor Reservoir. The shoreline has been eroding more than one meter per year, including considerable yearly variation based on climate and reservoir levels.
