**ENVIRONMENTAL OVERVIEW OF
THE CONCEPTUAL ELBOW RIVER DAM
AT MCLEAN CREEK**

**Alberta Environment and Sustainable Resource
Development
Resilience & Mitigation Branch
Edmonton, Alberta**

**AMEC Environment & Infrastructure
Calgary, Alberta**

February 2015

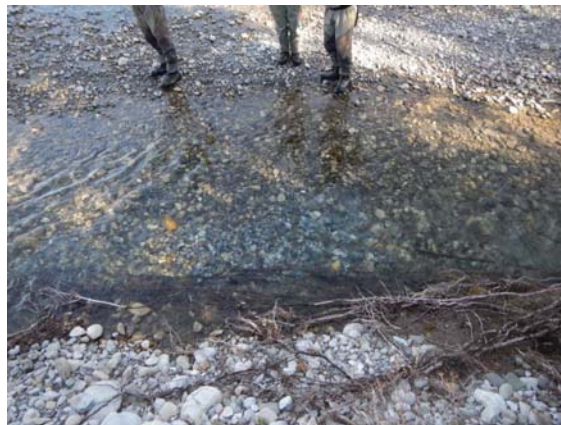
Plate 11: Redd observed in side channel near transect 13. Note clean gravel substrate and cover provided by small woody debris. 20 October 2014

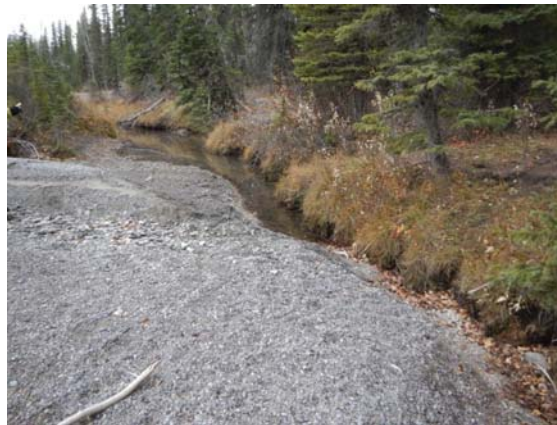
Plate 1: Subterranean flow through large gravel bar immediately upstream of confluence with Elbow River resulting in a fish migration barrier. 21 October 2014

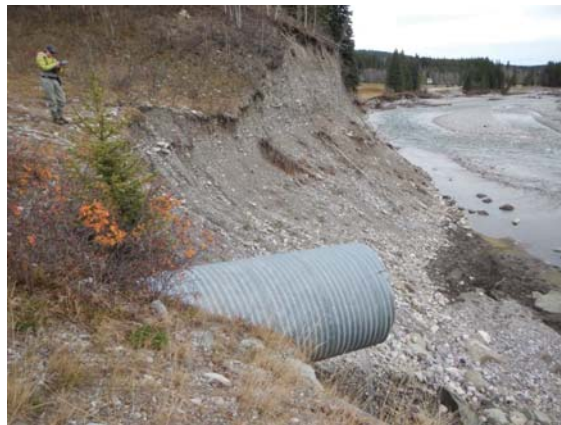
Plate 1: 5 m perched culvert at confluence with Elbow River presenting a fish migration barrier. 21 October 2014

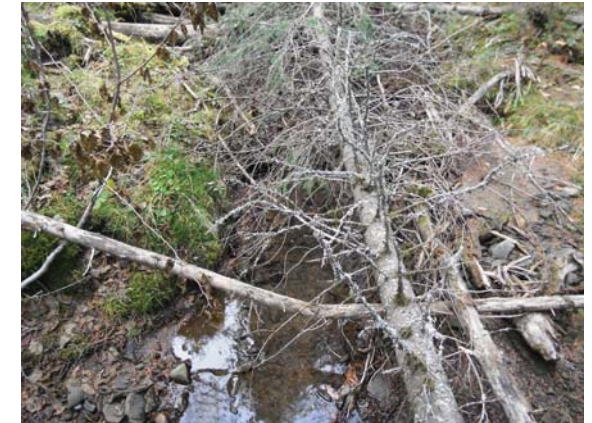
Plate 4: Large Woody debris near transect 4. Slumping and unstable valley walls resulted in fallen mature trees into the channel. 21 October 2014
