Provincial Flood Damage Assessment Study

Prepared for Government of Alberta
ESRD - Resilience and Mitigation
by IBI Group
February 2015

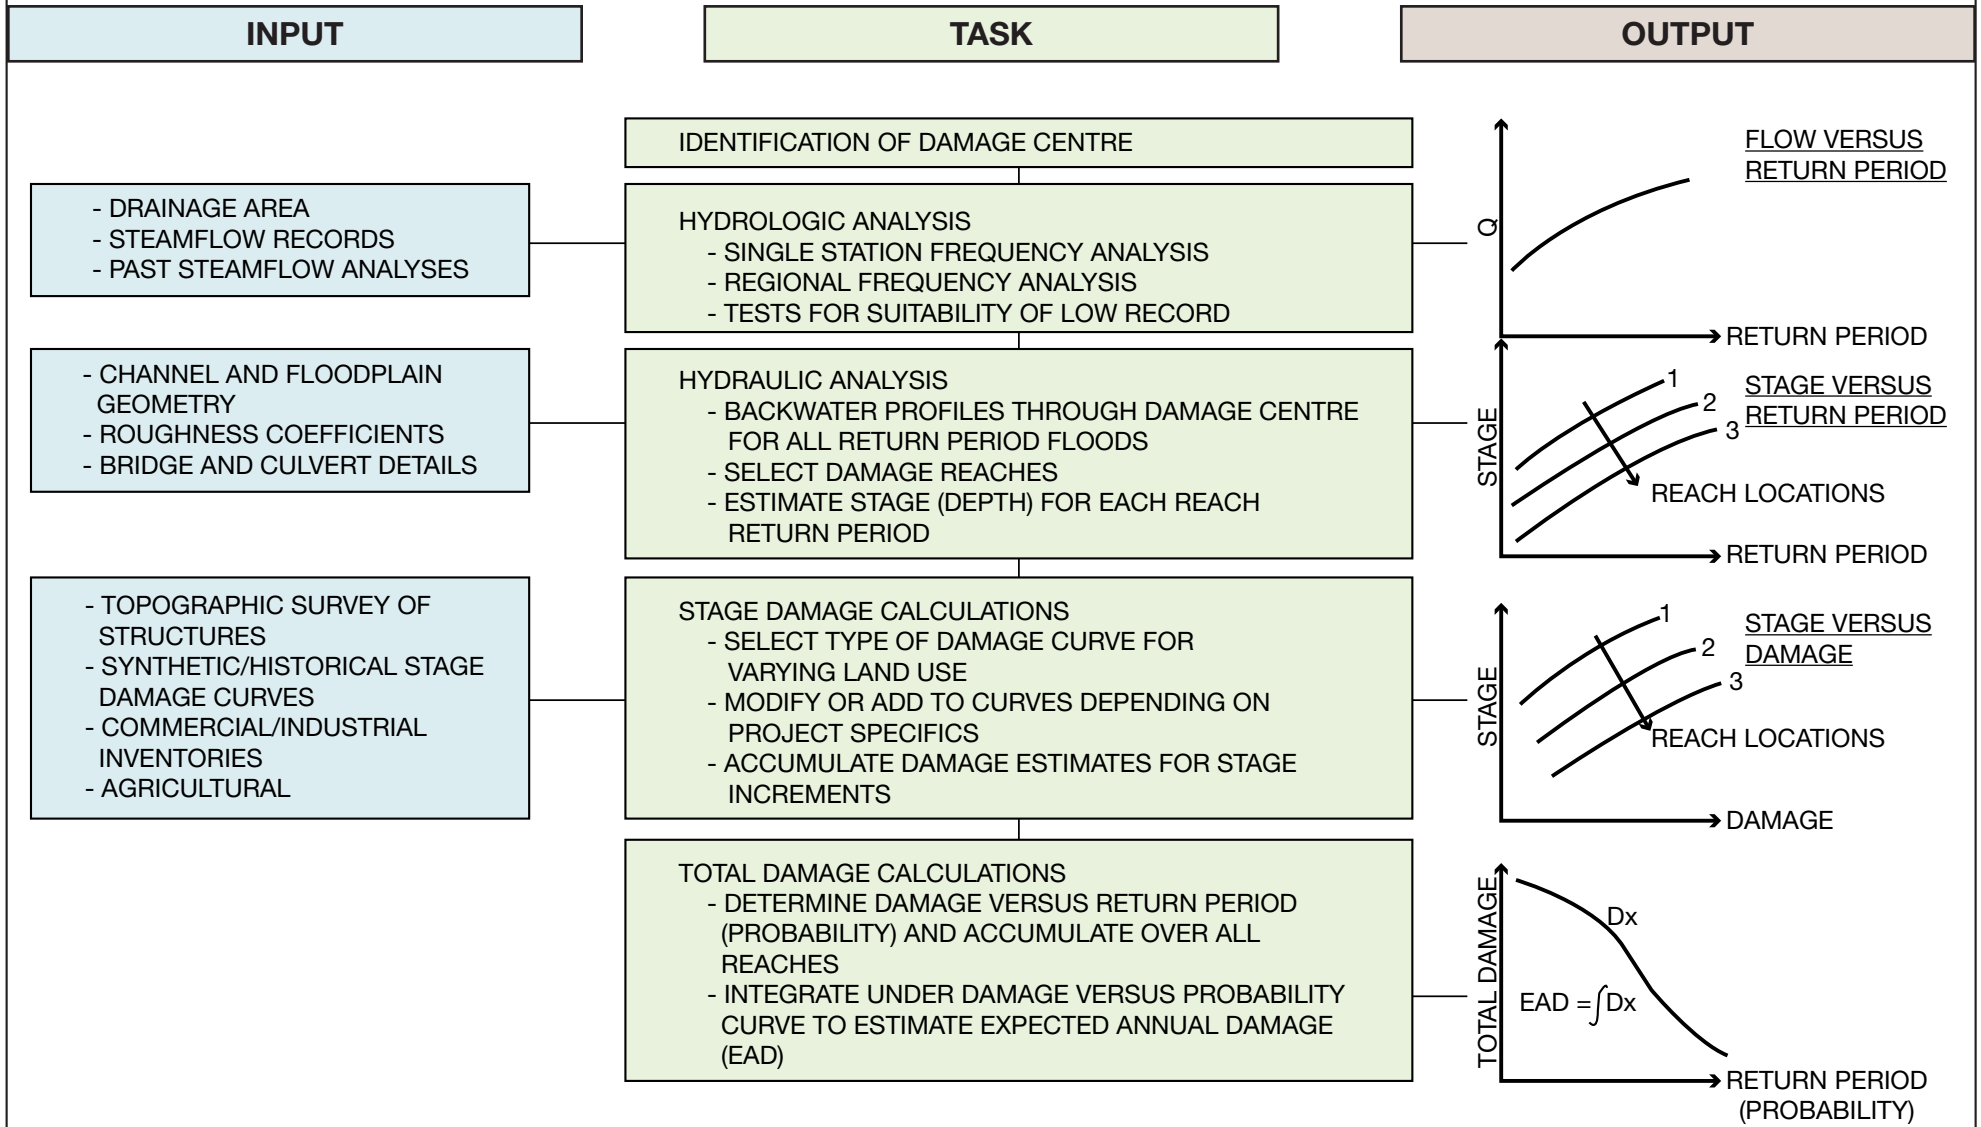
General Flood Damage Calculation Methodology

these curves involve structural and contents damages to residential and commercial/industrial/institutional buildings. Structural damages refer to damages to the building and to building components that are not taken when an individual is moving, such as the furnace, hot water heater, wall-to-wall carpeting, etc. Conversely, contents damages are damages to moveable contents of a structure.⁴

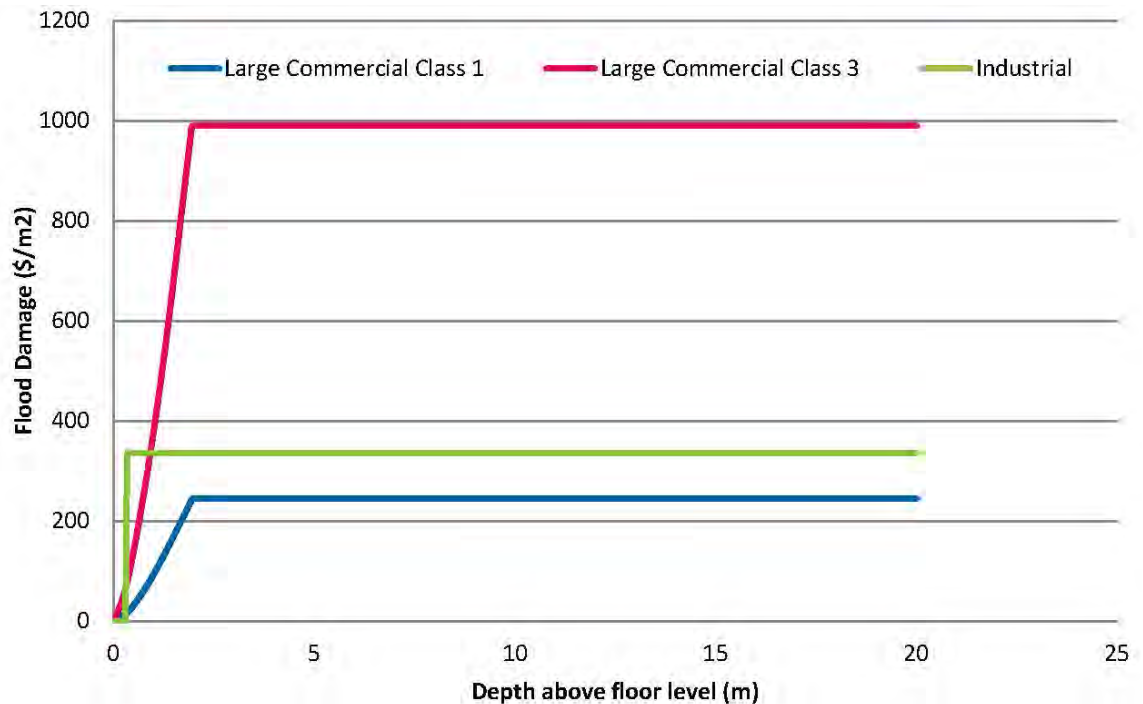
Stage-Damage Curve for Large Commercial and Industrial Properties

Industrial damages were estimated using the suggested damages for the Rapid Appraisal Method (RAM) for Floodplain Management. This accords \$302/m² where depth is greater than 0.3 metres.

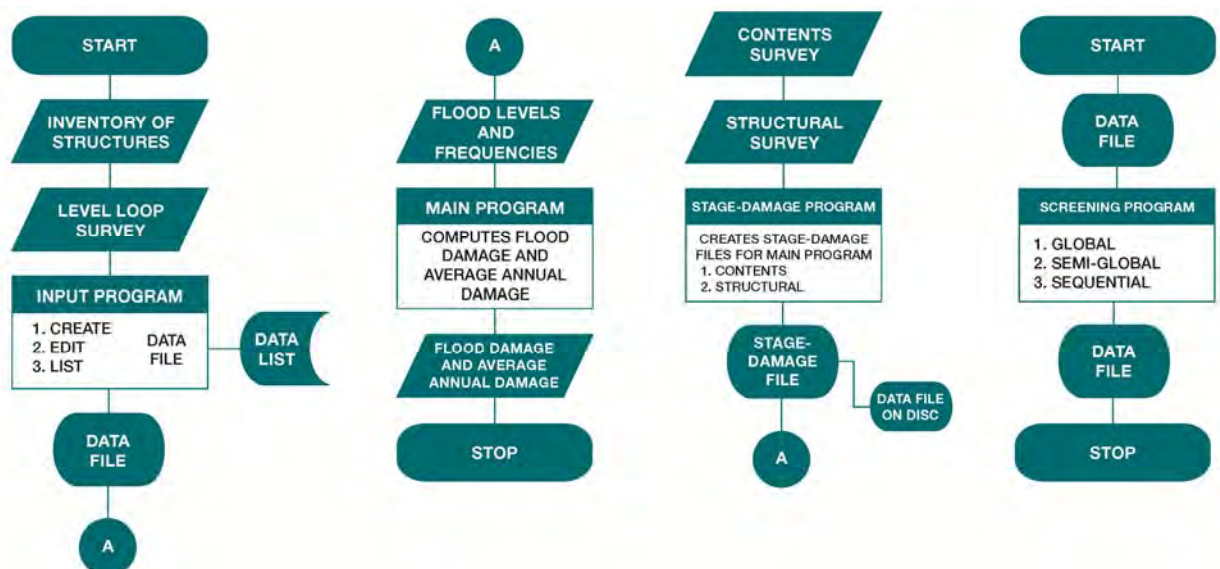
Exhibit 5.1: FDDBMS Application Flow Diagram

The stage-damage module is used to input multiple content and structural damage curves, which are applied to the building inventory in the flood affected areas. Each damage curve is assigned a classification that is related to the units in the building inventory. The main difference between FDDBMS and CFDEP was that the latter was designed to apply multiple damage curves to the same building structures for comparative analysis of curves.

The main module applies the flood levels for different reaches (zones) from the different return floods computed from the U.S. Army Corps of Engineers HEC-2 application to the building database. It computes the flood damages using the assigned depth-damage curves and combines a set of flood frequencies to compute average annual damages (AAD) for an area to be used in benefit/cost analysis.

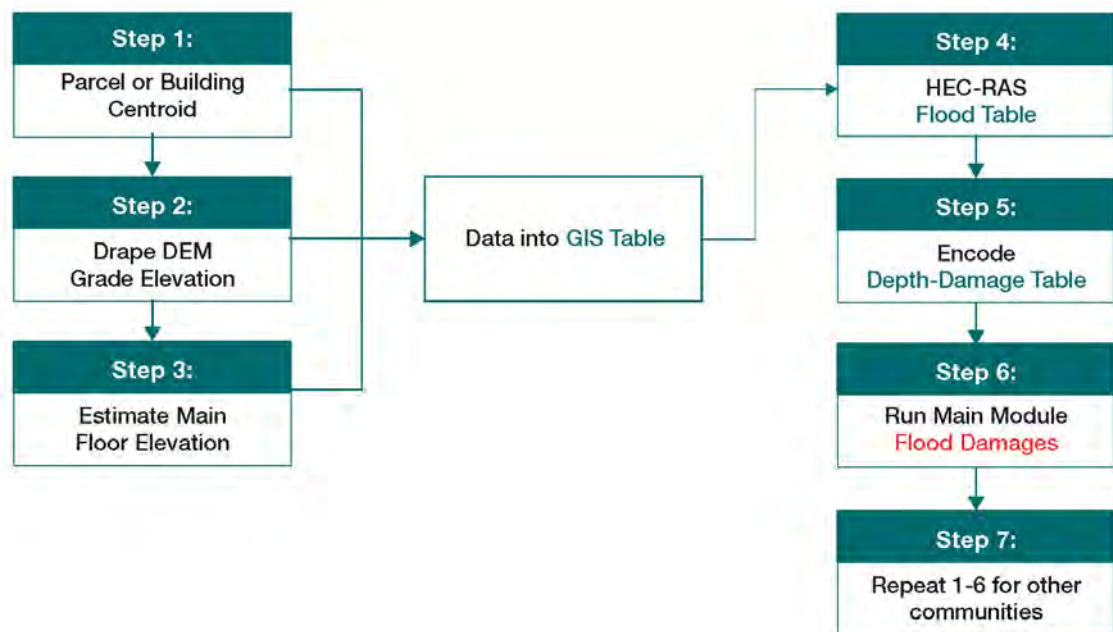
Exhibit 5.4: RFDAM Damage Estimate Steps

It is therefore possible to integrate the hardcopy mapping components of FDDBMS with a completely digital approach using GIS and DEMs. The process for estimating flood damages using the model is shown in **Exhibit 5.4** and is described on a step-by-step basis as follows:

1. Load parcel base map coverage in GIS to generate centroid for draping. If the main floor area is available from assessment then this value should be used. This is available in larger communities but may not be readily available in smaller ones. In addition the building outline may be available. If not the building area could be digitized and automatically computed using GIS if necessary.
