Backcountry Trail Flood Rehabilitation Program

O'Hagen/Carbondale Connector Trail

Competition Date: October 2015

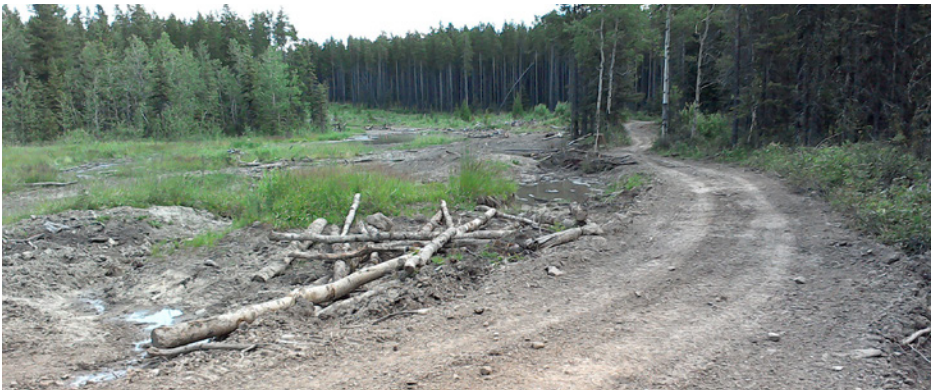
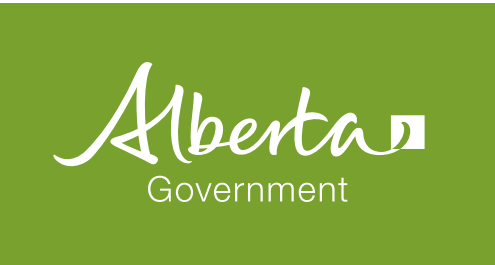
Mud hole before construction

This trail is used as a connector trail between the O'Hagen road and the network of trails along the Carbondale River at marker 30. The trail was heavily eroded with several large mud holes. The trail also had a ford on a tributary to the Carbondale River which contributed to added sediment in Westslope Cutthroat Trout habitat.

Approximately 2.5kms of erosion control features were installed to mitigate problems along the trail, and a native timber bridge was built to eliminate the creek crossing. Small sections of the trail were relocated to bypass heavily damaged areas and mud holes.

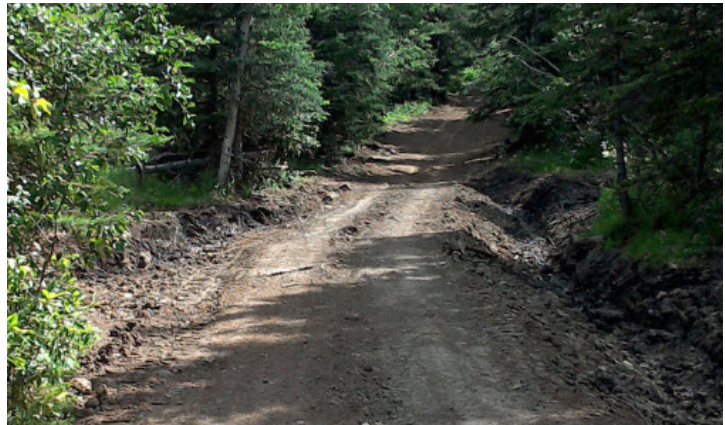
Dry trail after construction.
