Report #112835

Provincial Flood Damage Assessment Study – Town of Stettler: Damage Estimates

Submitted to Alberta Environment and Parks
by IBI Group and Golder Associates Ltd.
March 2019

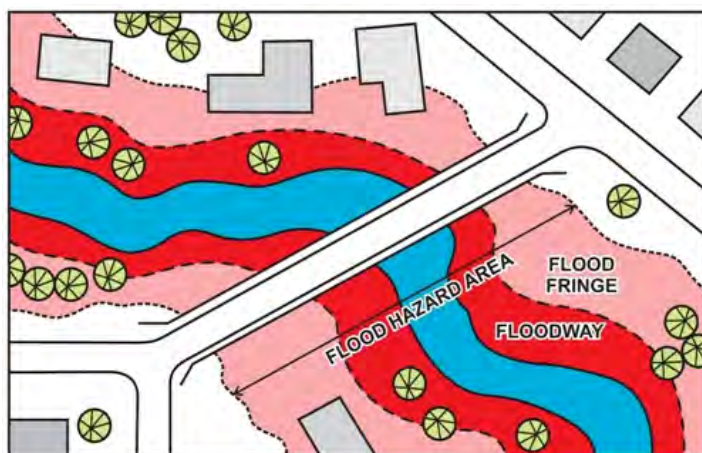
Exhibit 2.2: Aerial View of Flood Hazard Area (Alberta Environment and Parks, 2017)

The accompanying exhibits (**Exhibit 2.2** and **Exhibit 2.3**) describe the criteria employed in defining the floodway/flood fringe and adjacent-to area. The floodway is typically defined as the area of deepest and fastest flows, with the flood fringe being that area within the overall floodplain which may suffer only shallow flooding and consequently may accommodate development with the provision that floodproofing measures are implemented.

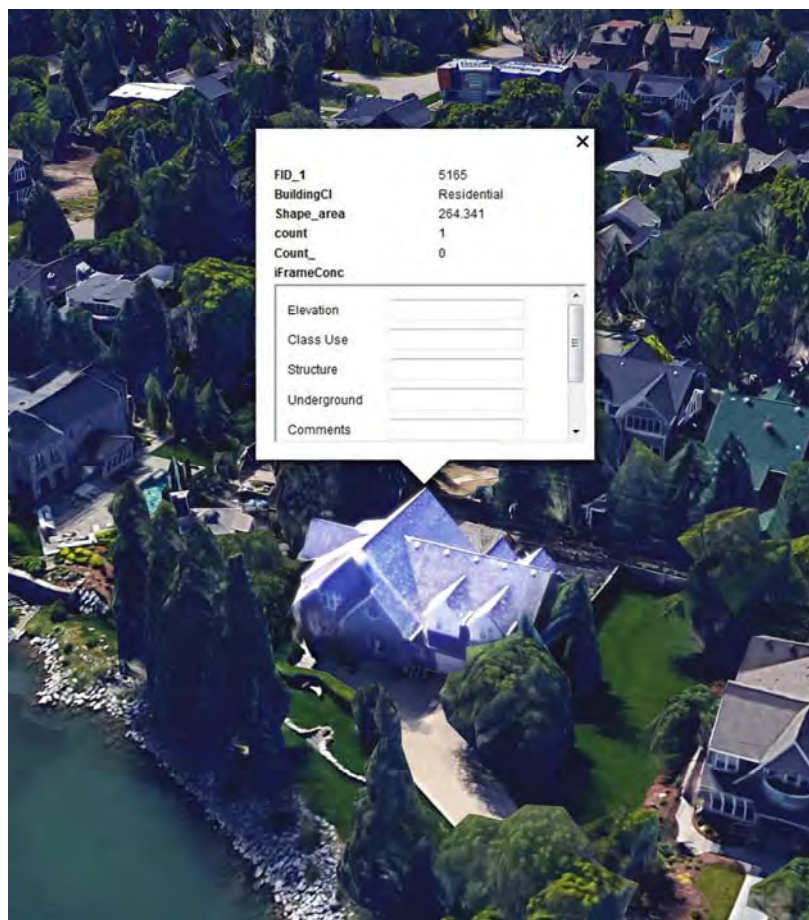
Exhibit 2.5: Building Classification Tool in Google Earth

To facilitate the visual classification of buildings, IBI Group has developed a tool that allows entry of building attributes directly from Google Earth. The shapefile was converted to a KML file, a file type appropriate for importing into Google Earth Pro. In that file, one of the fields contains HTML code that creates a pop-up portal with the required fields when a user clicks on a building. The Google Earth tool is illustrated in **Exhibit 2.5**.

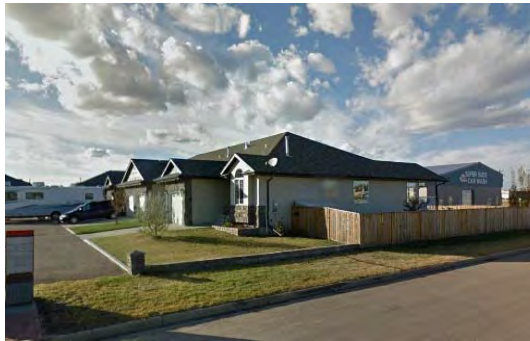
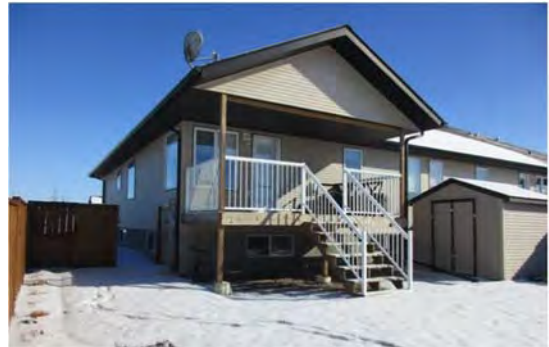
Exhibit 3.6: West Park Estates

West Park Estates is an 18 unit townhouse development between the Creek and 62 Street, south of Highway 12. It was built in 2006, after the available DEM was obtained and some fill was added to the site. Therefore, building elevations were estimated from surrounding grade and photos of the development. Examples are provided in **Exhibit 3.6**.

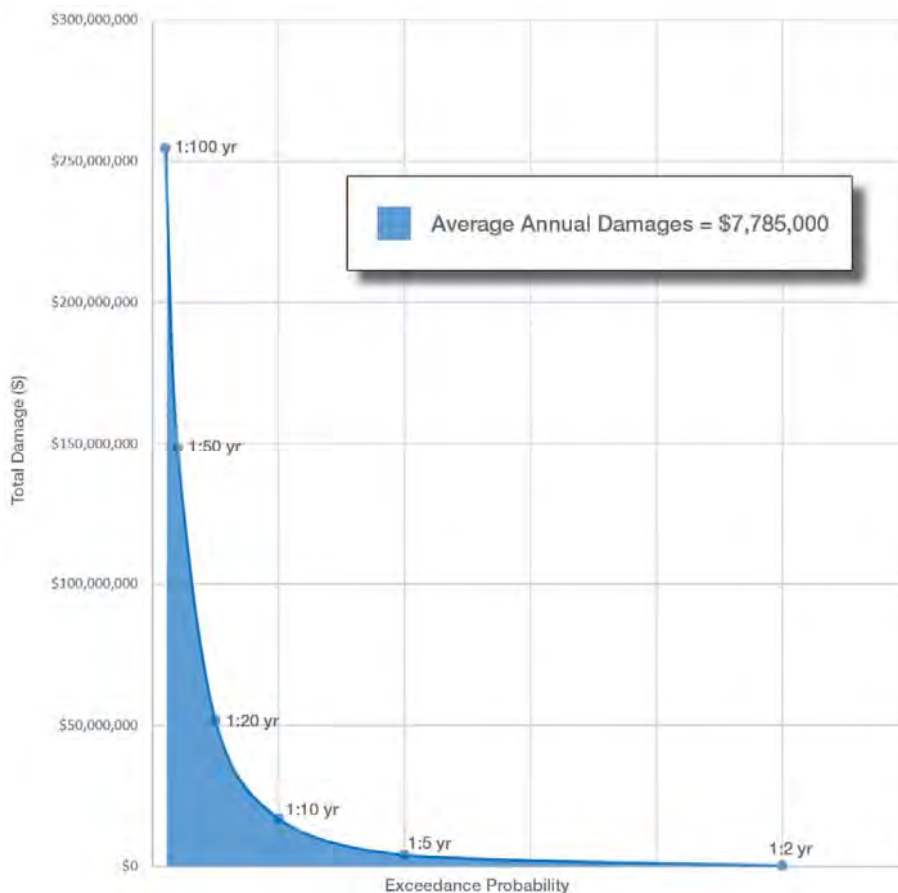
Exhibit 3.13: Flood Damage Probability Distribution

AAD is the cumulative damages occurring from various flood events over an extended period of time averaged for the same timeframe. The AAD is obtained by calculating the area under a damage-probability curve which depicts total damage versus probability of occurrence, as illustrated in **Exhibit 3.13**.

As illustrated, the unmitigated total potential flood damages amount to \$7.8 million in AAD. This is the AAD of events between 1:2 and 1:100-year probability. Of this, approximately \$1.4 million is from isolated flooding and \$2.8 million is a result of sewer backup or groundwater infiltration risk. The isolated flooding amount indicates the importance of stormwater management and the disconnection of water pathways across the highway. The relatively high proportion of sewer backup or groundwater damage amounts indicates potential vulnerability for basement flooding as a large number of homes have developed space below adjacent overland flood risk. The isolated amount indicates the potential risk of seepage or stormwater accumulation in the absence of pumps and/or gates.
